YOUR INSPECTION REPORT

4523 Carpinteria Ave #E
Carpinteria, CA 93013

Tuesday, June 4, 2013

Report No. 1056, v.0

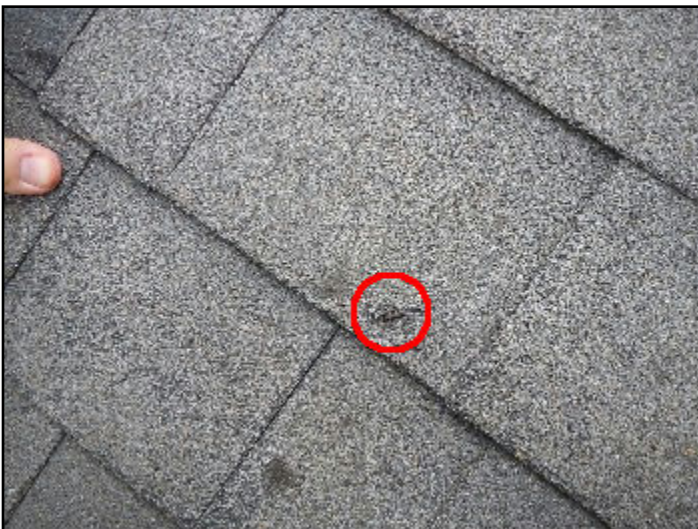
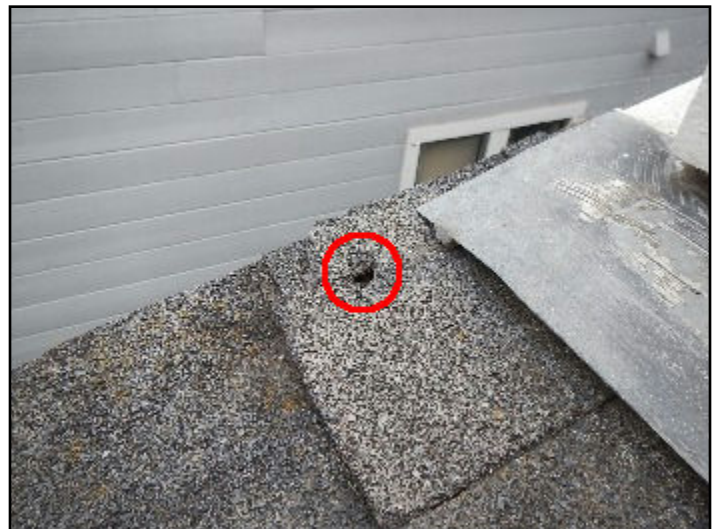
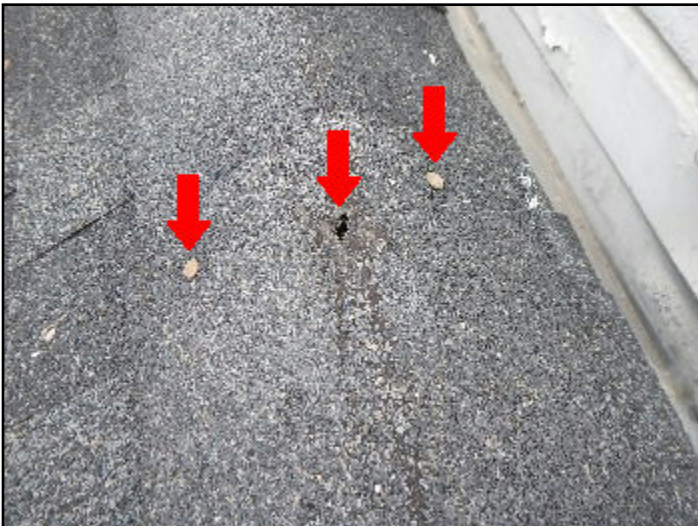
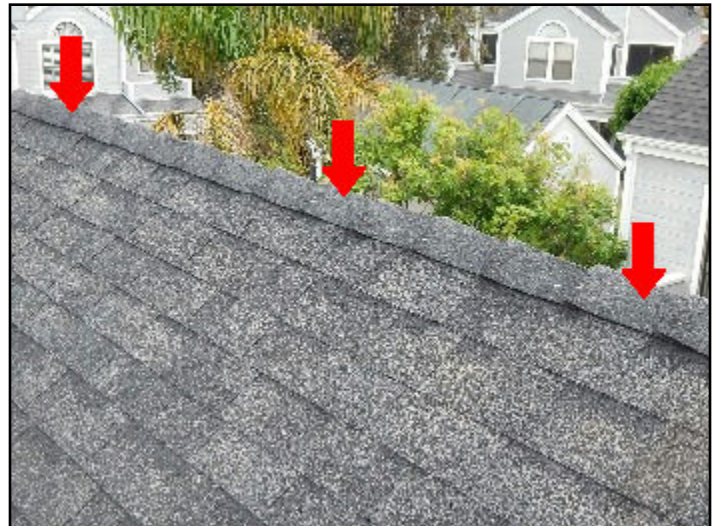
1. **Condition:** • [Exposed fasteners](#)

Many exposed fasteners were observed on shingles throughout the roof. Recommend looking over the entire roof and sealing exposed fasteners where found with silicone or asphalt to prevent moisture intrusion.

Location: Upper ridge caps and west lower roof

Task: Seal with appropriate caulking

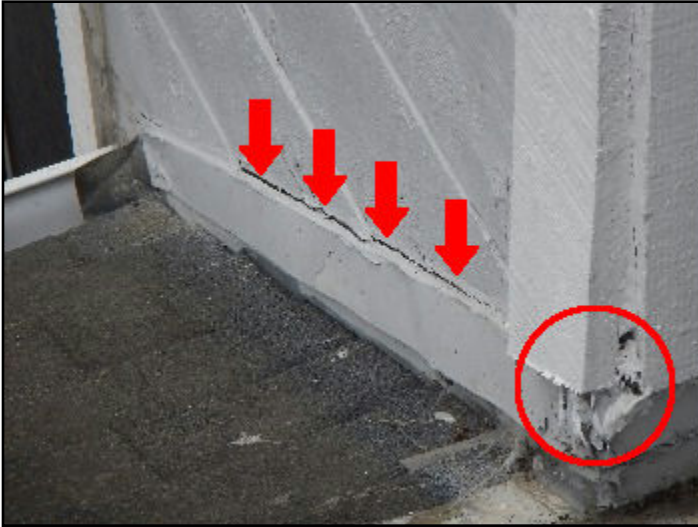
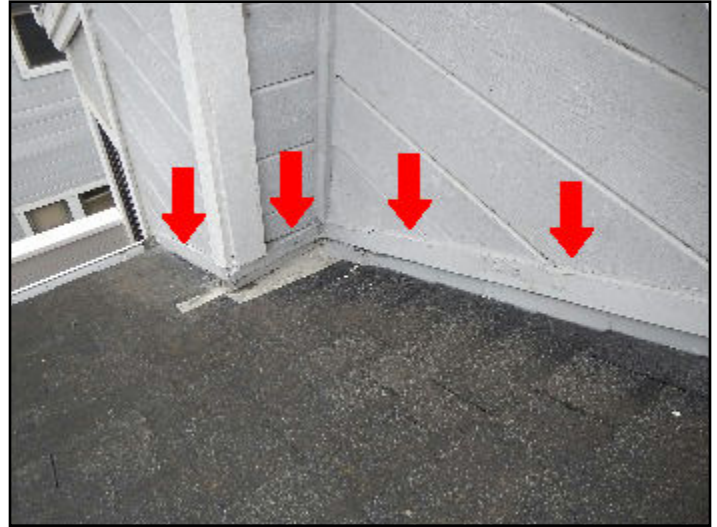
2. Condition: • [Damage, loose, open seams, patched](#)

Shrinkage and cracking was noted on caulking at roof/wall flashing joints.

Location: West Roof

Task: Seal with appropriate caulking

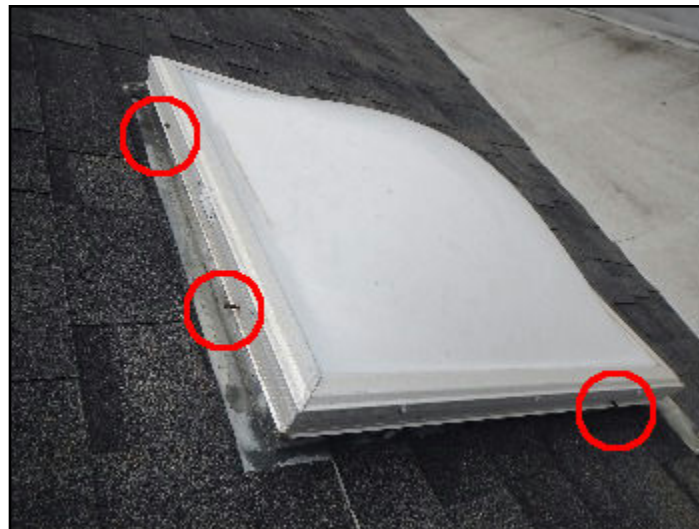
9. Skylight poorly secured to roof

3. Condition: • [Skylight poorly secured to roof](#)

Improper fasteners were noted at skylight.

Task: Use proper fasteners

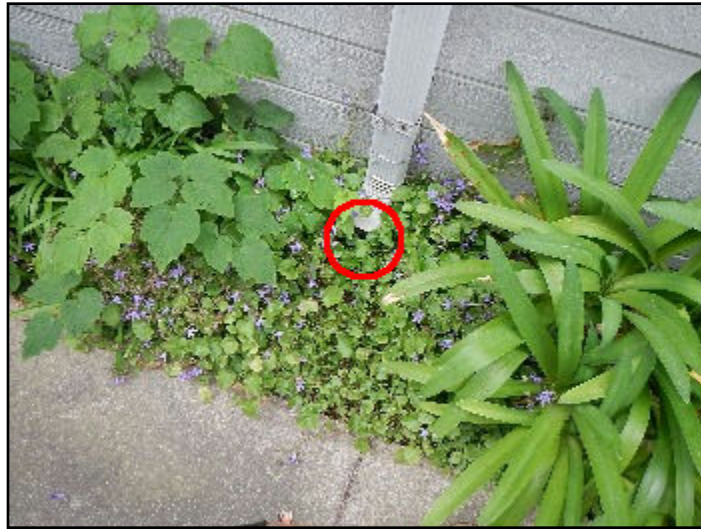
10. Downspouts end too close to building

4. Condition: • [Downspouts end too close to building](#)

The downspouts were observed discharging too close to the structure. Recommend elongating end of downspout to direct run-off further away from structure.

Task: Extend

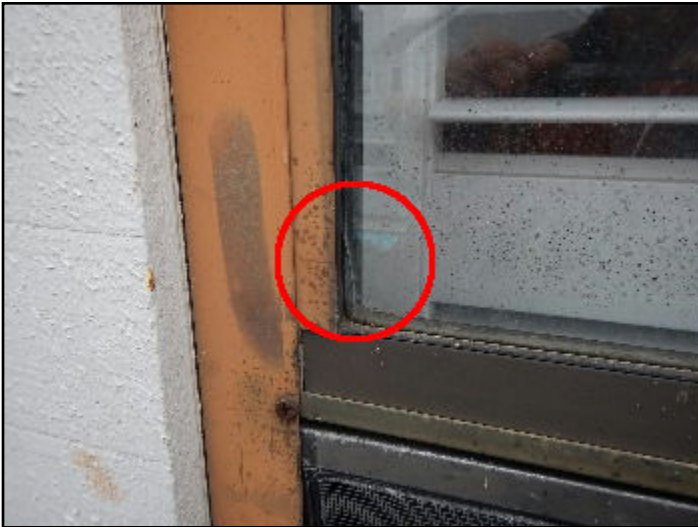
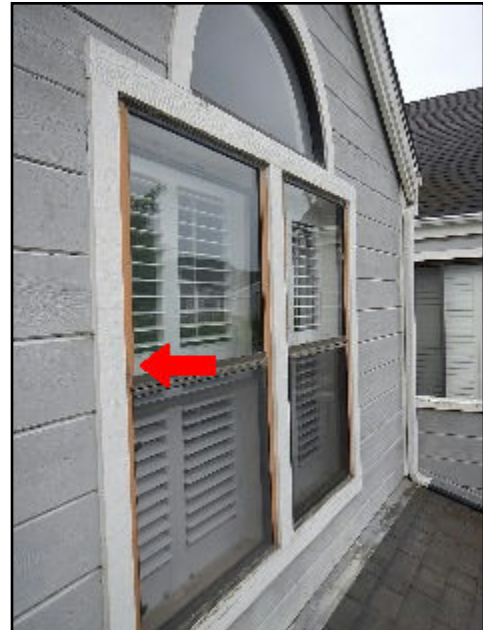
5. Condition: • [Cracked](#)

Small crack noted in glass.

Location: Second Floor Master Bedroom

Task: Repair or replace

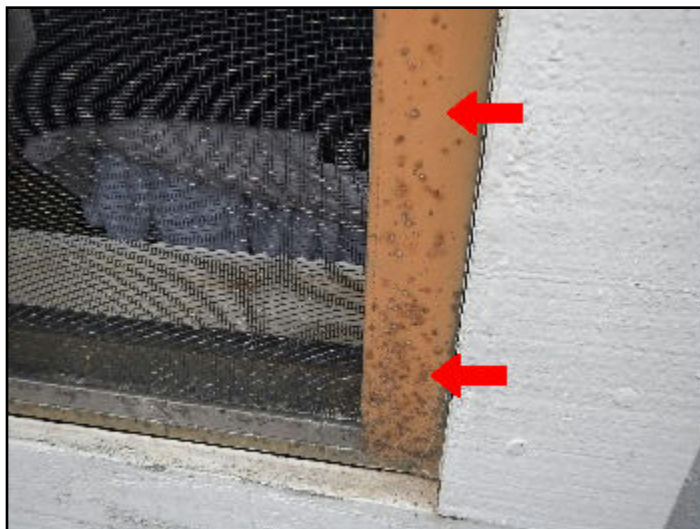
13. *Rust*

6. Condition: • [Rust](#)

Rust and discoloration noted on exterior window frames.

Location: West Second Floor Master Bedroom

Task: Clean and protect

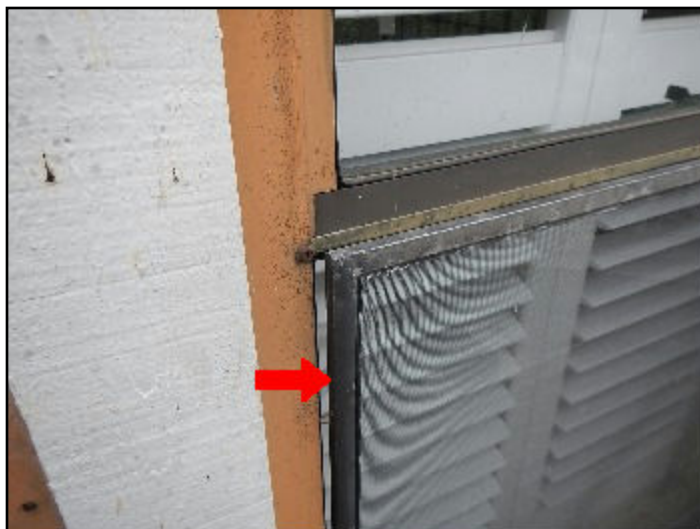
14. *Screens broken, torn or missing*

7. Condition: • Screens broken, torn or missing

Poor fitting and dented screens noted on several windows.

Location: West Second Floor Master Bedroom

Task: Repair or replace

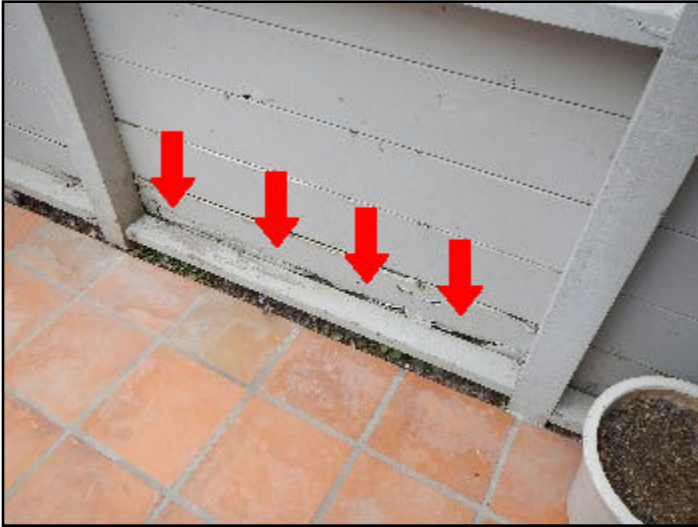
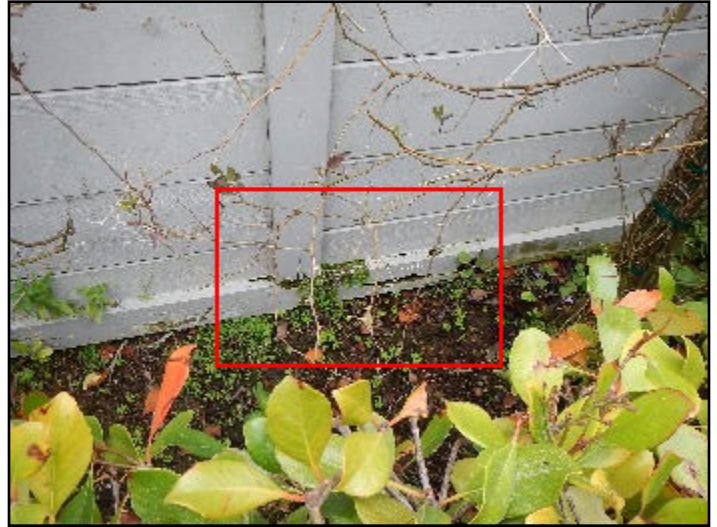
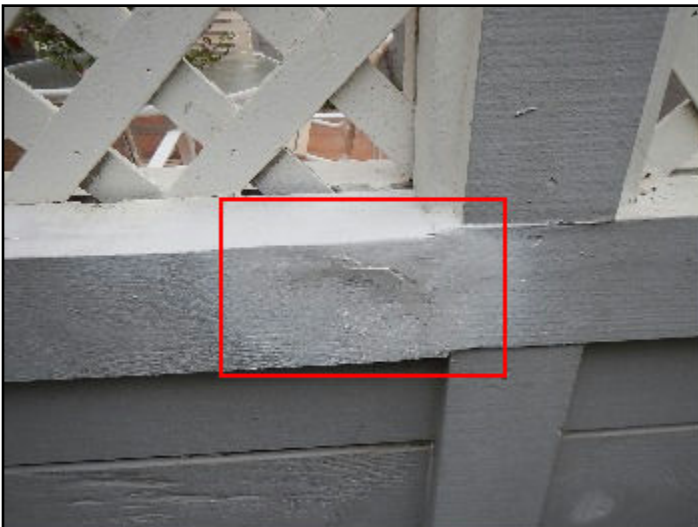
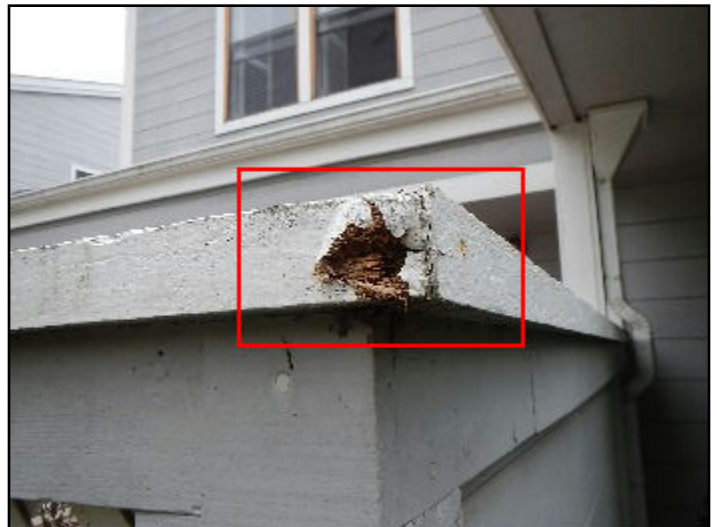
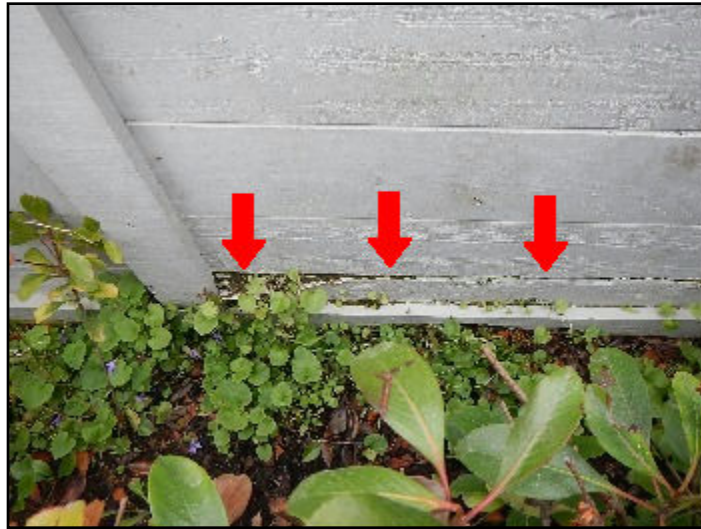
8. Condition: • Rot

Several areas of rot were observed on the rear patio fence.

Location: Rear patio

Task: Repair

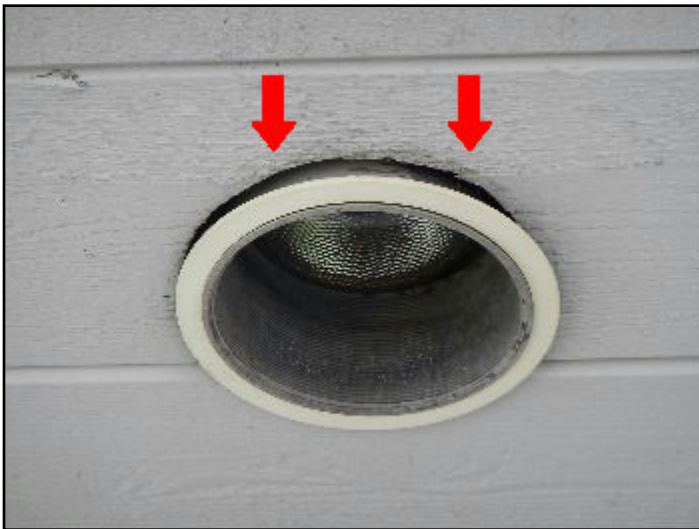
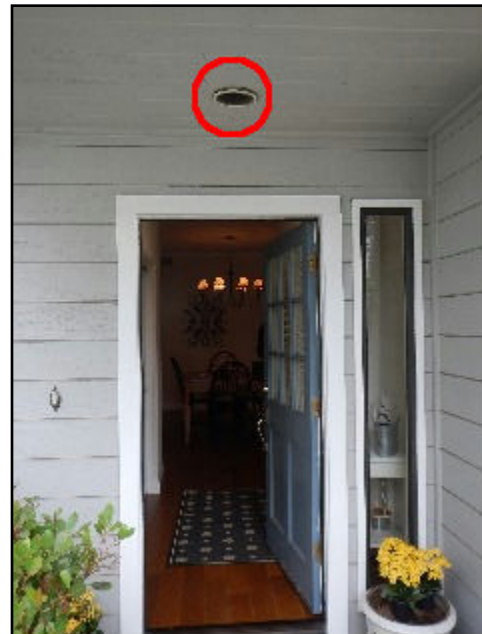
11. Condition: • [Loose](#)

The recessed lighting fixture was loose in the soffit above the entrance.

Implication(s): Electric shock | Fire hazard

Location: Front entrance

Task: Repair

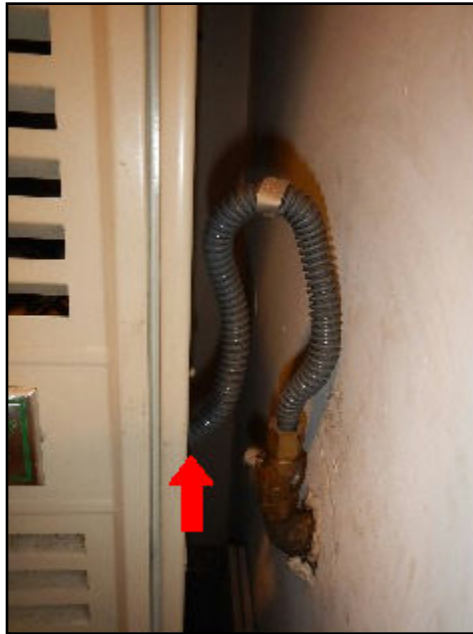
29. *Inappropriate materials*

13. Condition: • [Inappropriate materials](#)

Flex gas line was run through furnace cabinet which is improper. Must be replaced by hard pipe until outside cabinet.

Implication(s): Equipment not operating properly | Fire or explosion

Location: Utility closet

Task: Upgrade

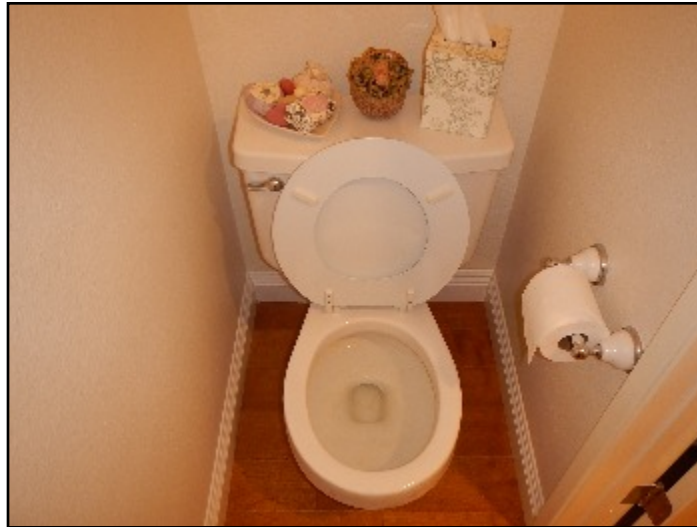
34. *Obstructed or weak flush*

15. Condition: • [Obstructed or weak flush](#)

Slow flush accompanied by air bubbles observed at first floor toilet. Generally indicates waste line partially clogged.

Location: First Floor Bathroom

Task: Further evaluation and repair

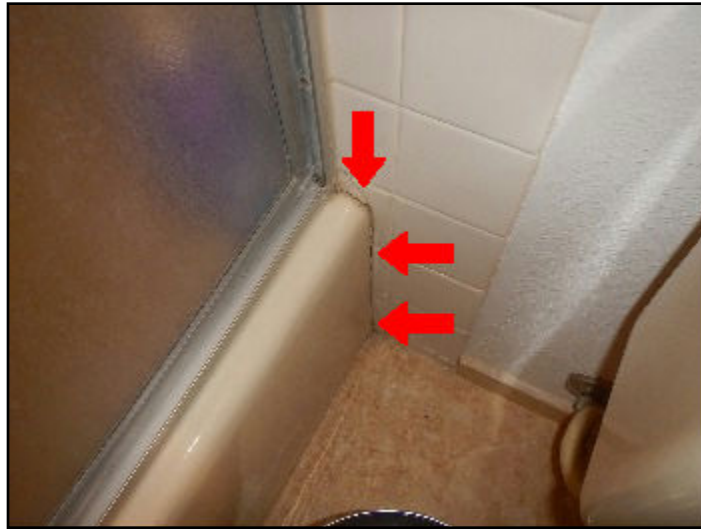
35. *Caulking loose, missing or deteriorated*

16. Condition: • [Caulking loose, missing or deteriorated](#)

Location: Second Floor North Bathroom

Task: Repair

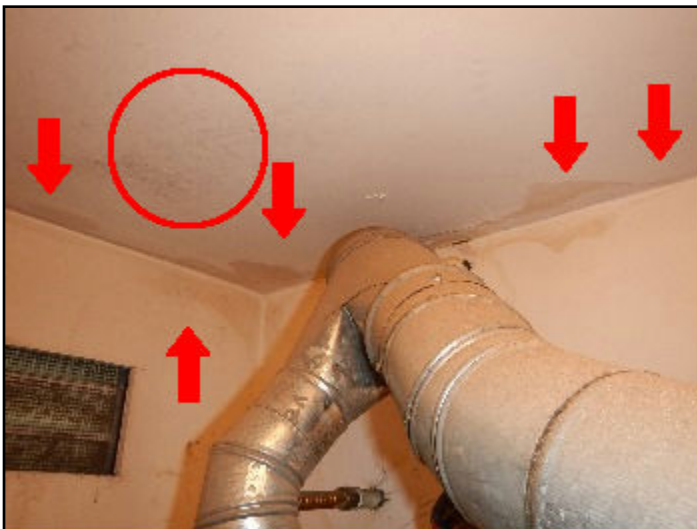
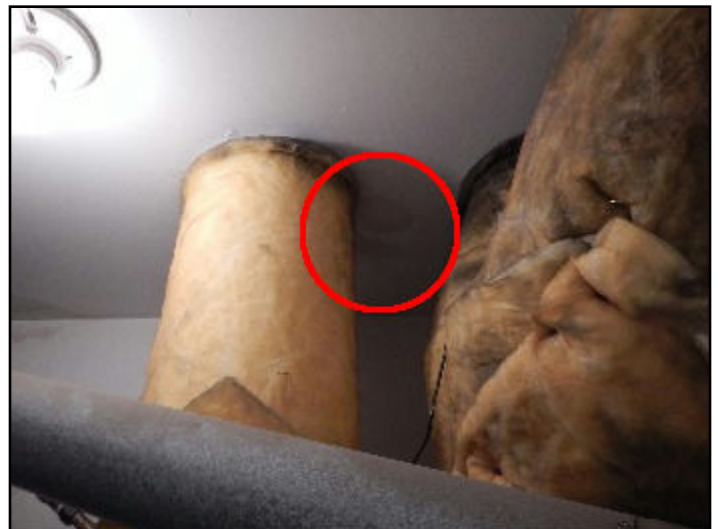
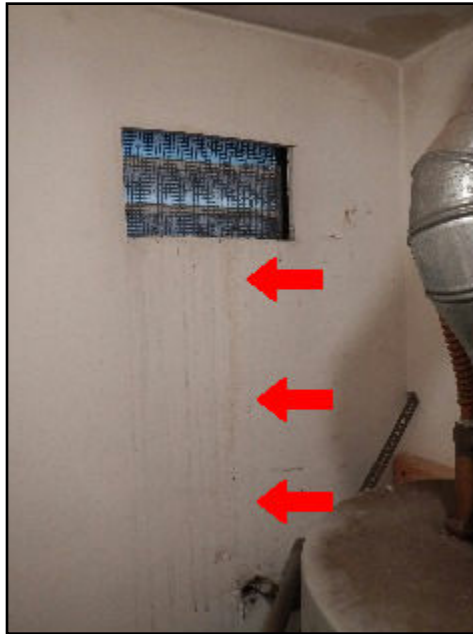
17. Condition: • [Water damage](#)

Evidence of moisture intrusion observed on the ceiling and walls of the utility closet.

Location: Utility closet

Task: Request disclosure/repair

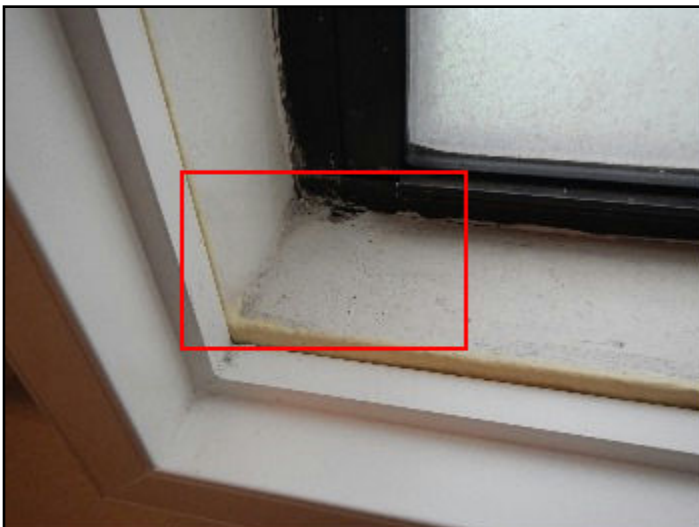
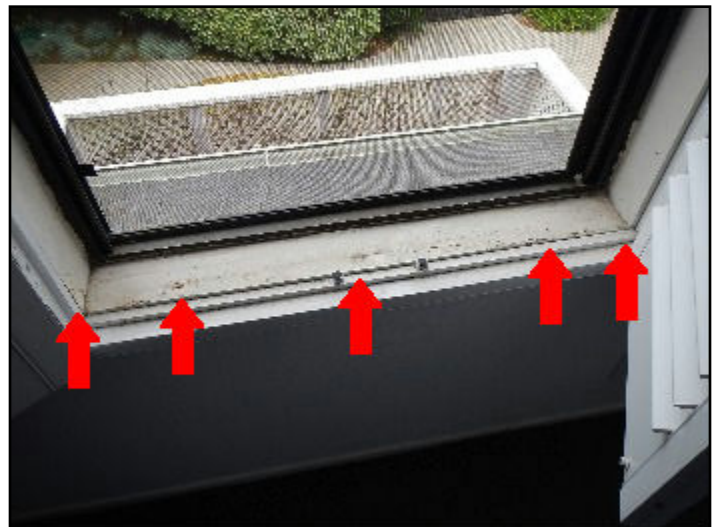
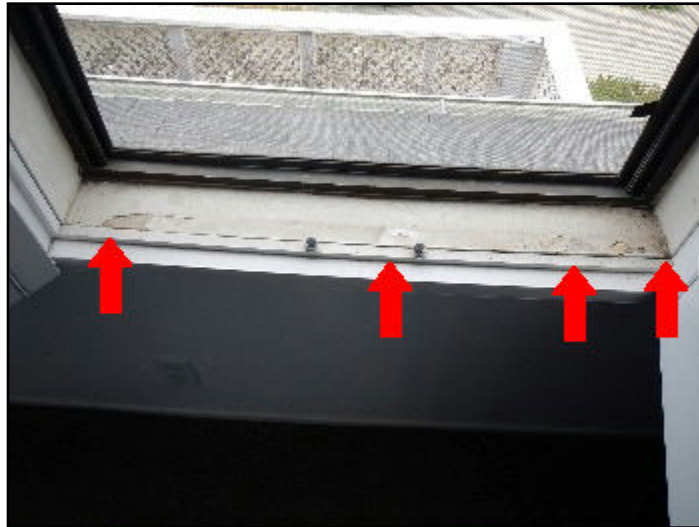
18. Condition: • Moisture damage noted at several window sills.

Location: Dining room, Master bedroom

Task: Repair

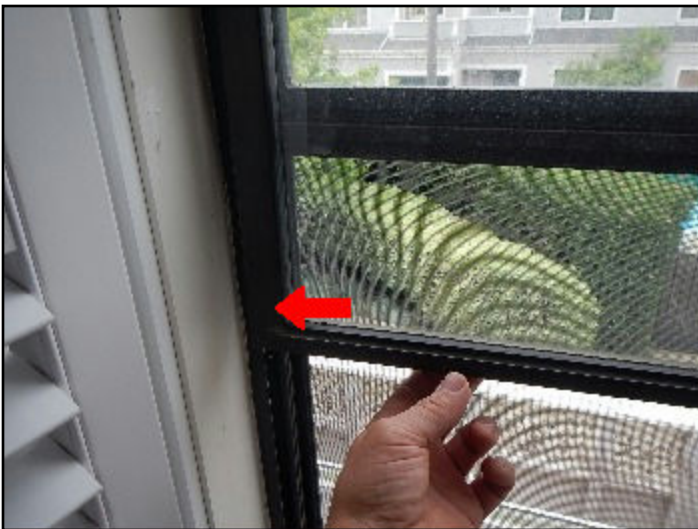
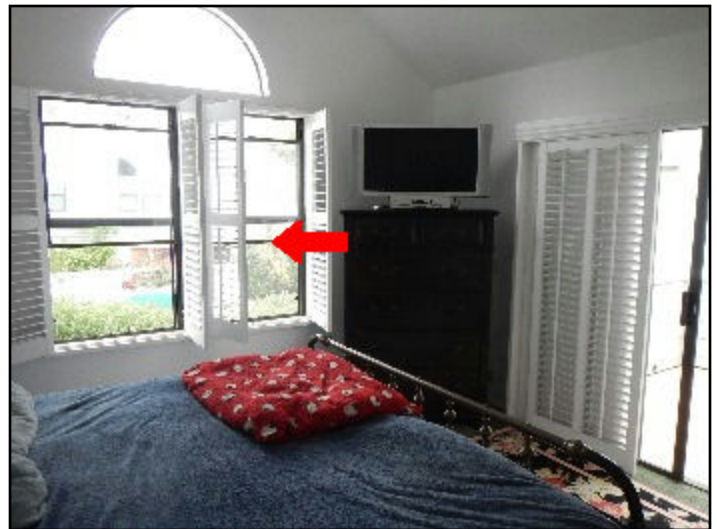
19. Condition: • [Loose fit](#)

Location: Master Bedroom

Task: Repair
