# YOUR INSPECTION REPORT

743 Woodland Drive  
Santa Barbara, CA 93108

Tuesday, May 14, 2013

Report No. 1043, v.2

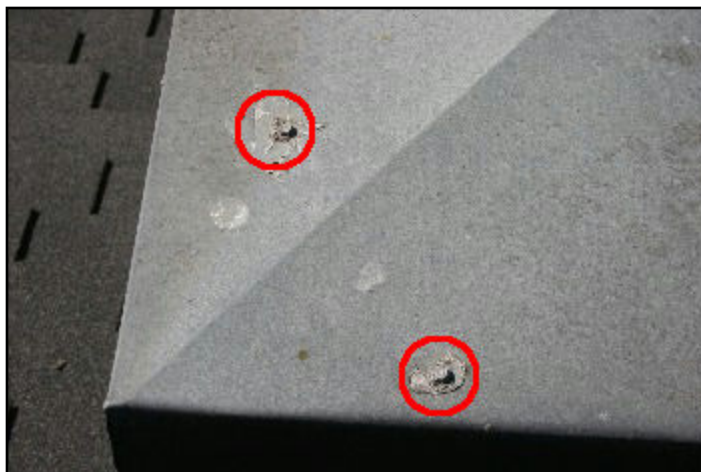
2. Exposed fasteners

**1. Condition:** • Exposed fasteners

Exposed fasteners were observed on a variety of roof flashing including pipe/stack, chimney, and roof/wall. The pictures in this report give you a general idea of locations where the observations were made. Recommend locating and sealing all exposed fasteners on the roof.

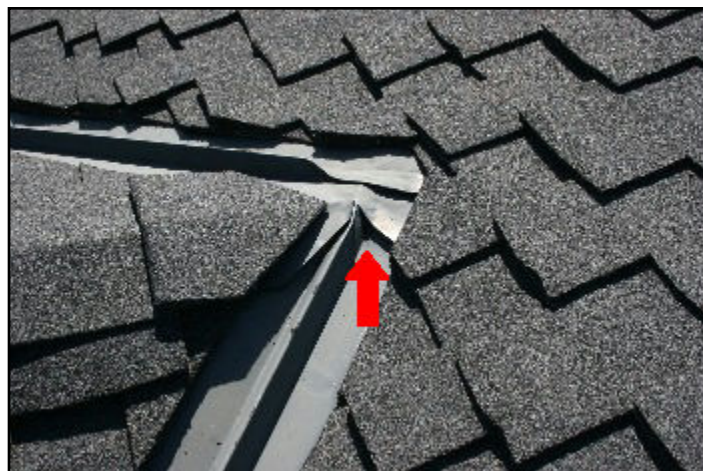
11. Gap

**2. Condition:** • Large gaps were noted on several pieces of the valley flashing overlap joints. Recommend caulking to prevent seasonal moisture intrusion.

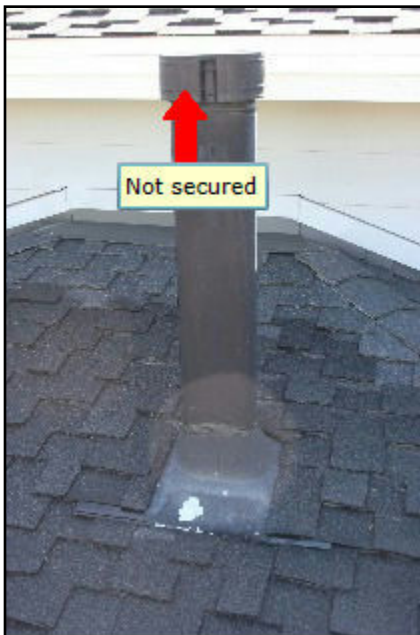
**4. Condition:** • Loose or broken vent cap

2 loose vent caps were observed on the roof. Caps should be held in place by at least 3 screws to prevent cap from blowing off in the wind.

14. Loose or broken vent cap

**Task:** Fasten properly

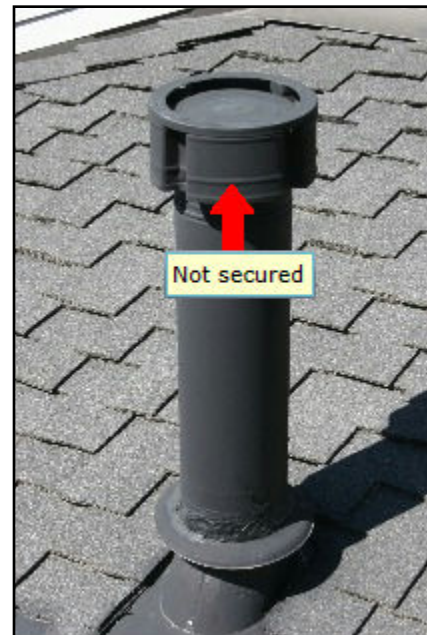
15. Loose or broken vent cap

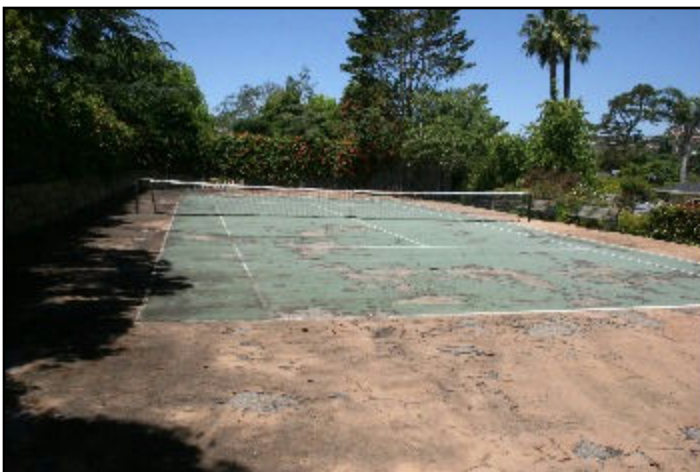
16.

5. • Condition: The tennis court surface was heavily deteriorated and the gates to the court were in need of adjustment. Recommend if resurfacing and repairing that a plan to manage seasonal runoff is implemented to prevent water from ponding and deteriorating the surface.

**Task:** Repair as needed

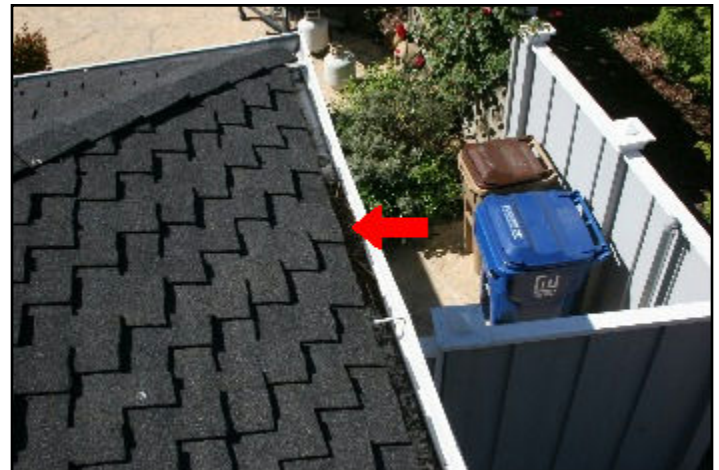
19. Clogged

Some areas of gutter had a layer of seasonal debris clogging flow. Recommend cleaning to ensure proper flow.

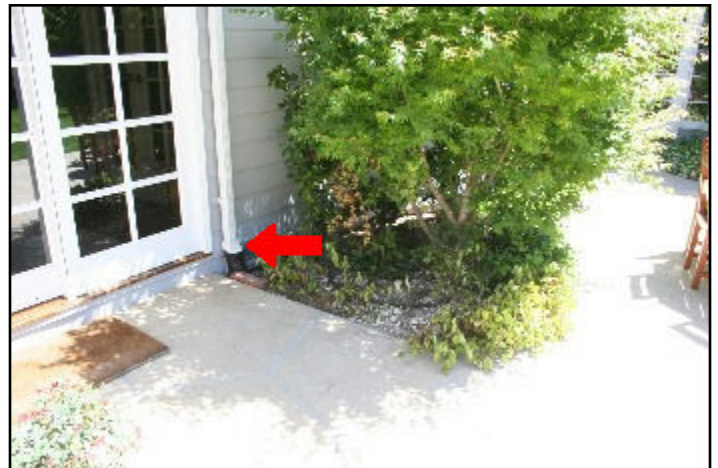
23. Downspouts discharging below grade

Several downspouts were observed discharging below grade. It is important to ensure proper water flow when discharging below grade as clogs often go unnoticed. Recommend testing and ensuring termination point is satisfactory.

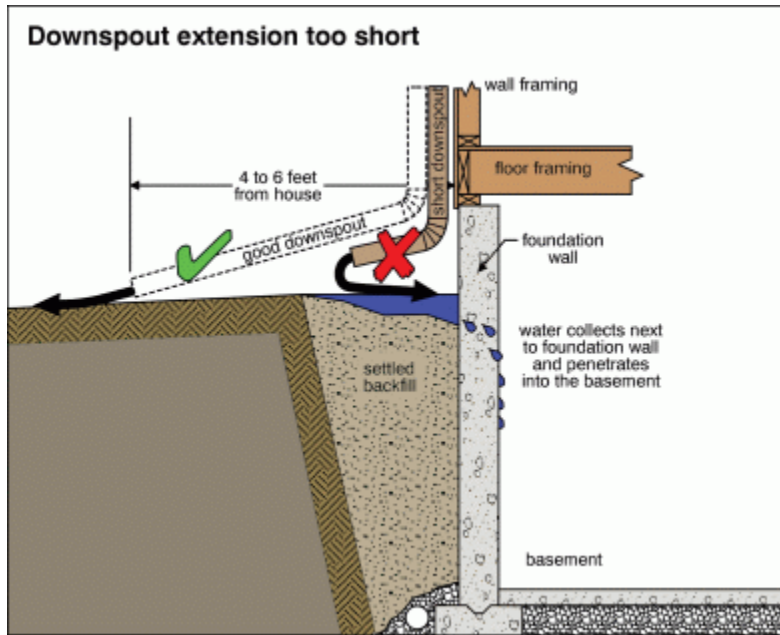
8. Condition: • [Downspouts end too close to building](#)

The downspout by the garage was observed discharging too close to the structure. Recommend elongating end of downspout to direct run off further away from garage and plant bed.

Task: Improve

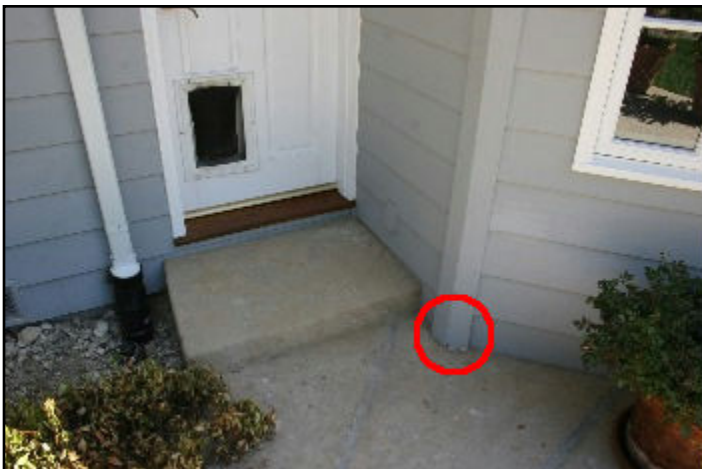
**9. Condition:** • [Rot or insect damage](#)

27. Rot or insect damage

**Task:** Repair

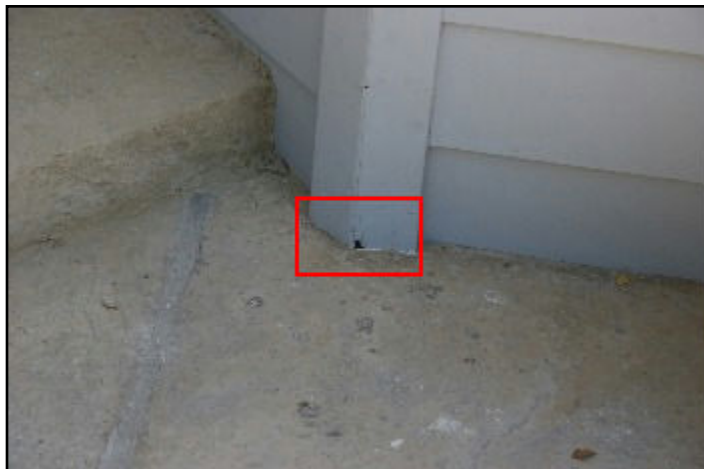
28. Rot or insect damage

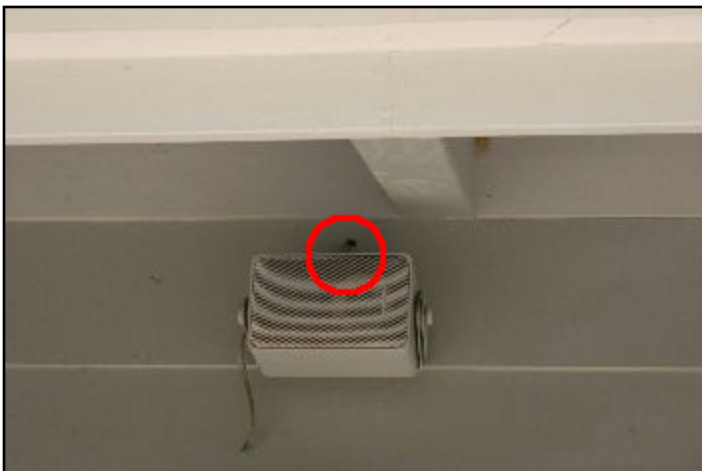
**10. Condition:** • Holes through the siding were observed at an exterior light fixture and speakers. Recommend sealing to prevent moisture or pest intrusion.

29. Pest intrusion point

**Task:** Seal with caulking

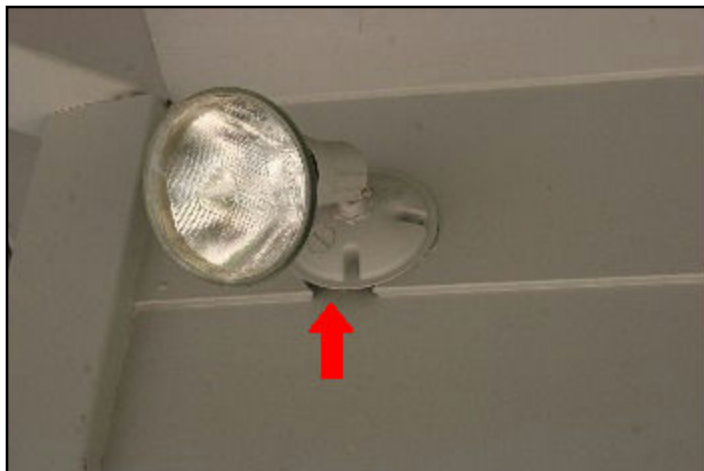
30. Pest intrusion point

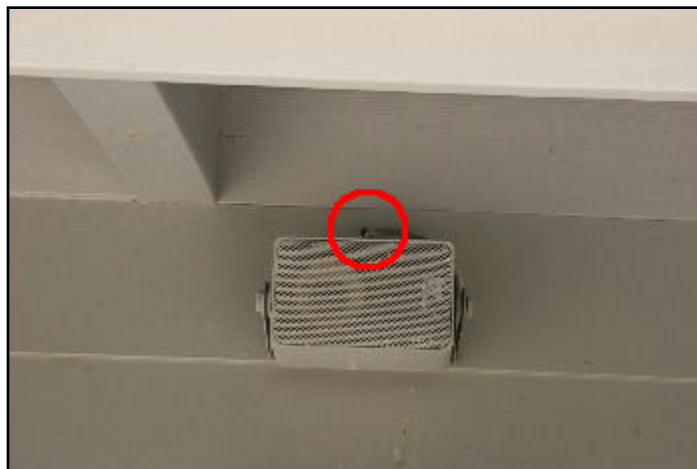
31. Pest intrusion point

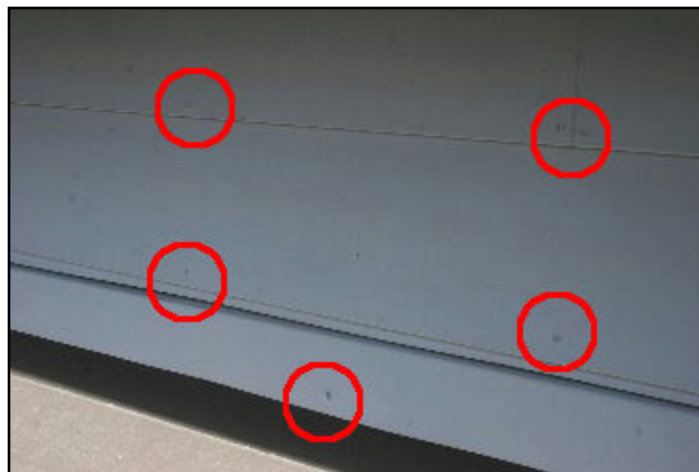
32. Exposed fasteners

**11. Condition:** • The wooden siding had exposed fasteners in a variety of different areas. Recommend sealing the exposed nail heads with caulking or countersinking and patching as needed.

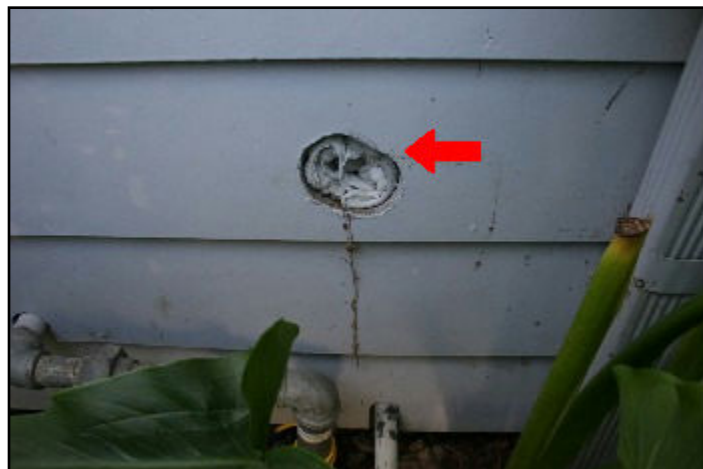
34. Hole in siding

**12. Condition:** • A hole in the siding was observed at the north exterior wall above the main water shut off. It appears to have been inadequately patched.

**Task:** Repair

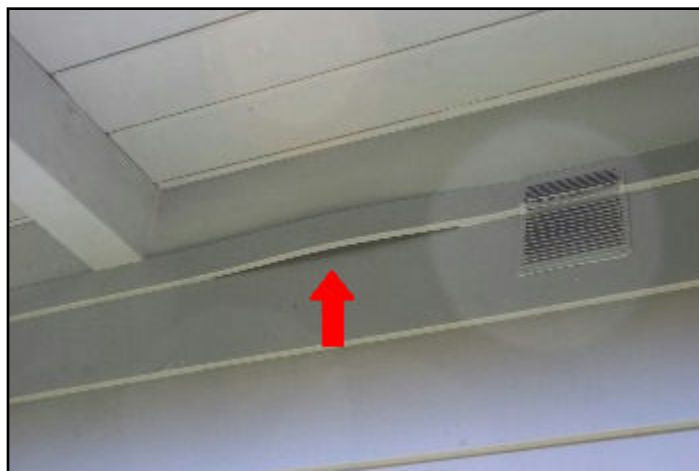
13. Condition: • [Warping](#)

36. Warping

Task: Repair

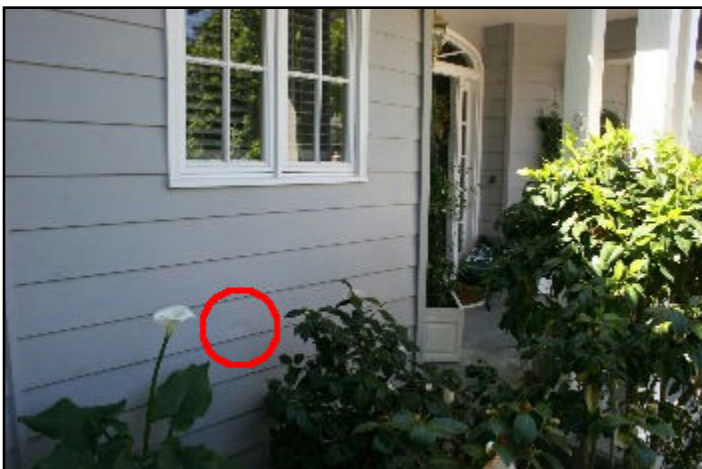
14. Condition: • [Rot](#)

37. Rot

Task: Repair

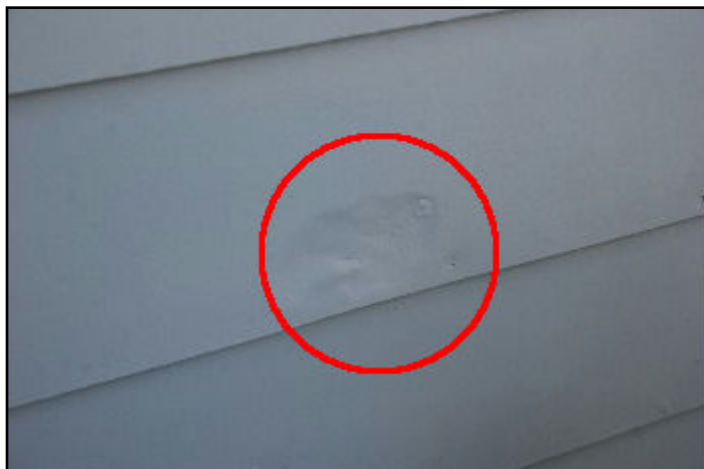
38. Rot

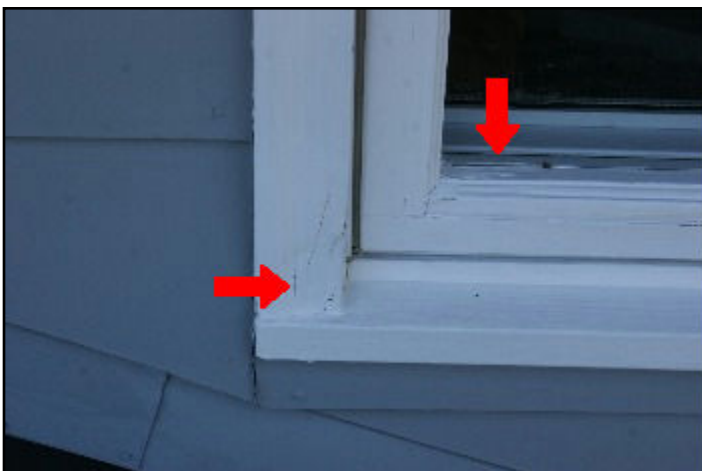
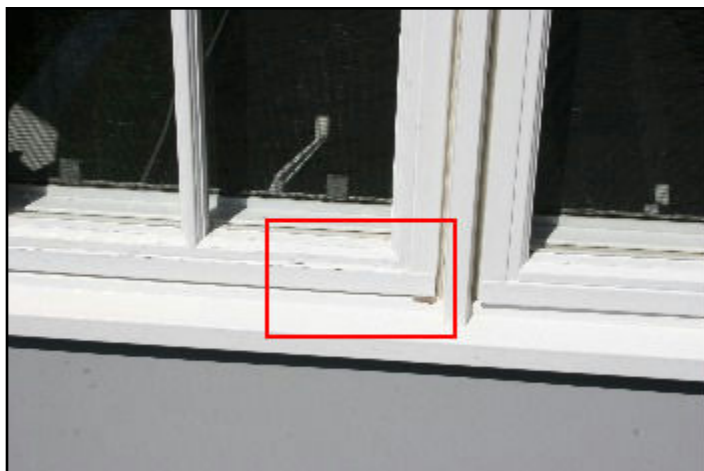
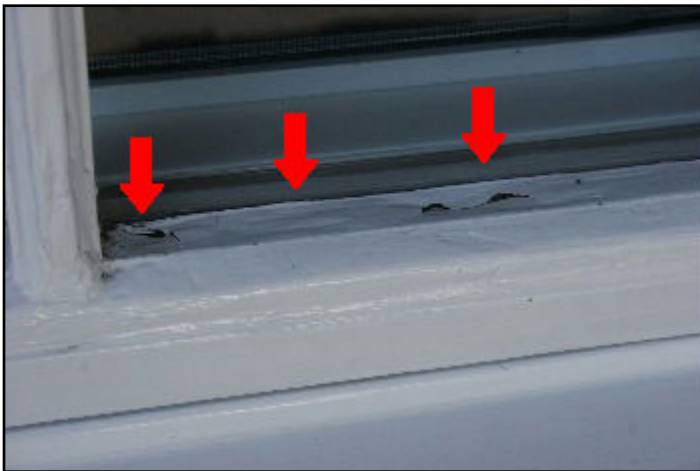
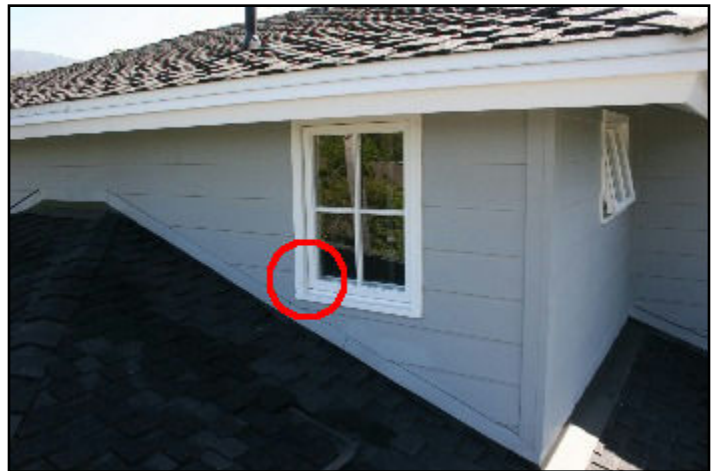
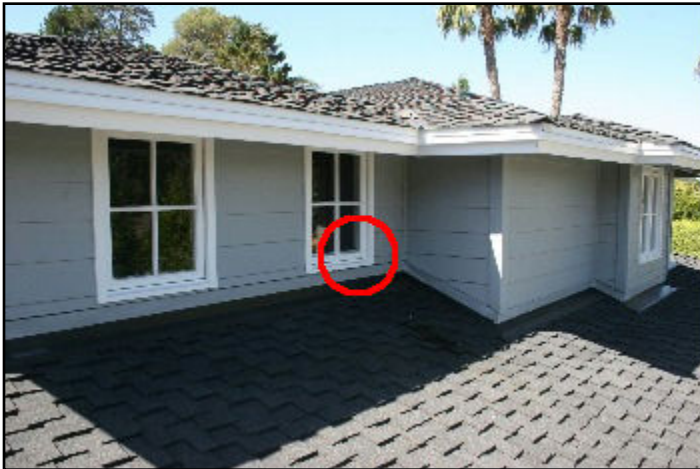
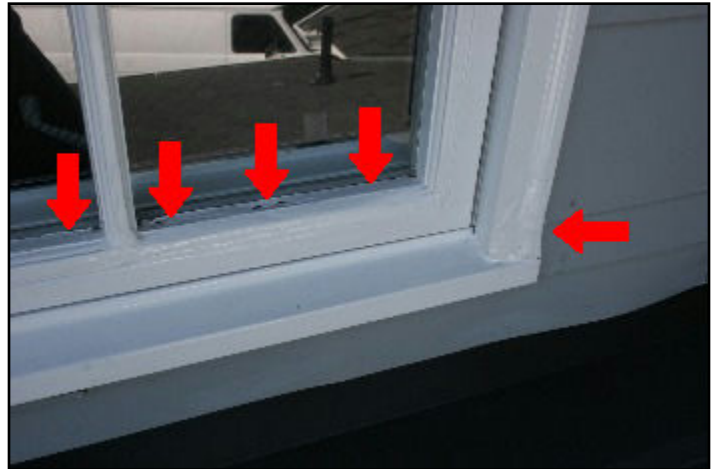
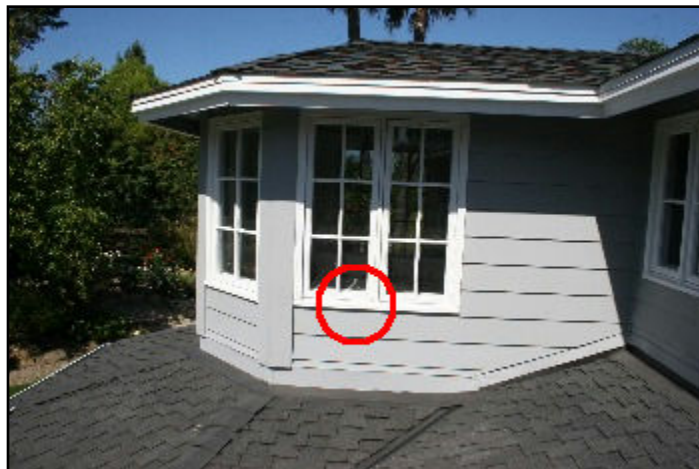
### 15. Condition: • [Rot](#)

Rot or insect damage was observed on 3 upper floor windows.

**Task:** Repair

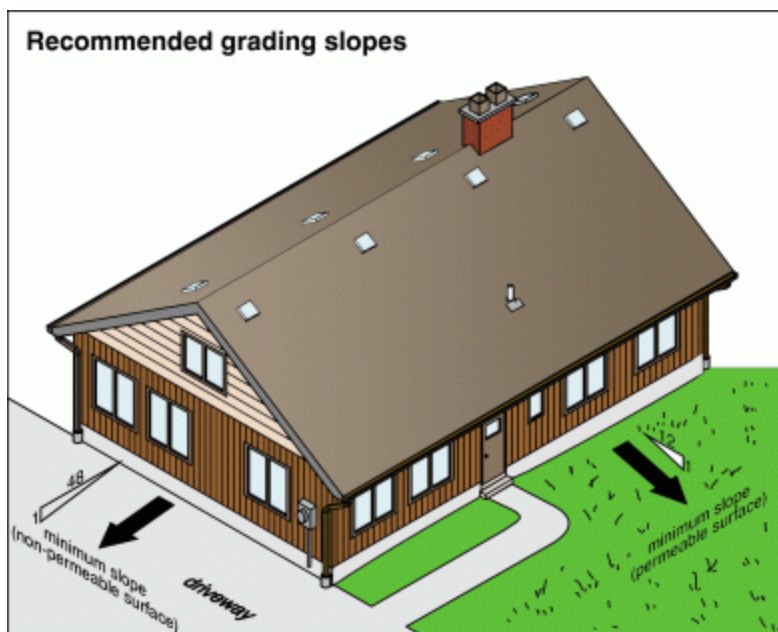
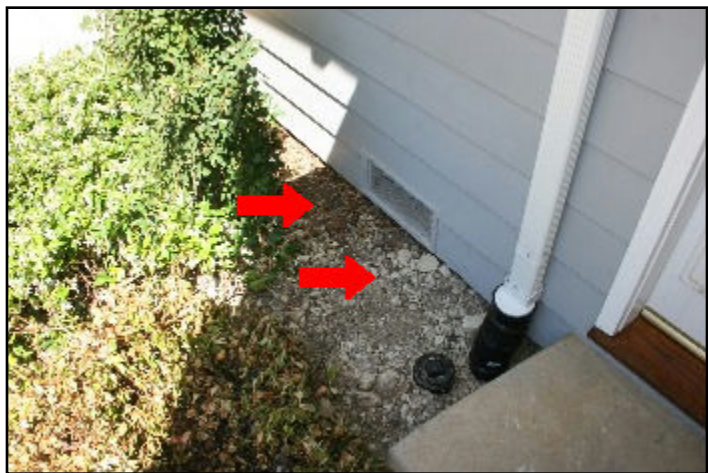
### 17. Condition: • [Improper slope](#)

Planter beds directly beside exterior walls should not be sloped toward the home as the risk of foundation undermining increases. Recommend regrading to direct water away from foundation,

47. Improper slope

**Task:** Regrade as needed.

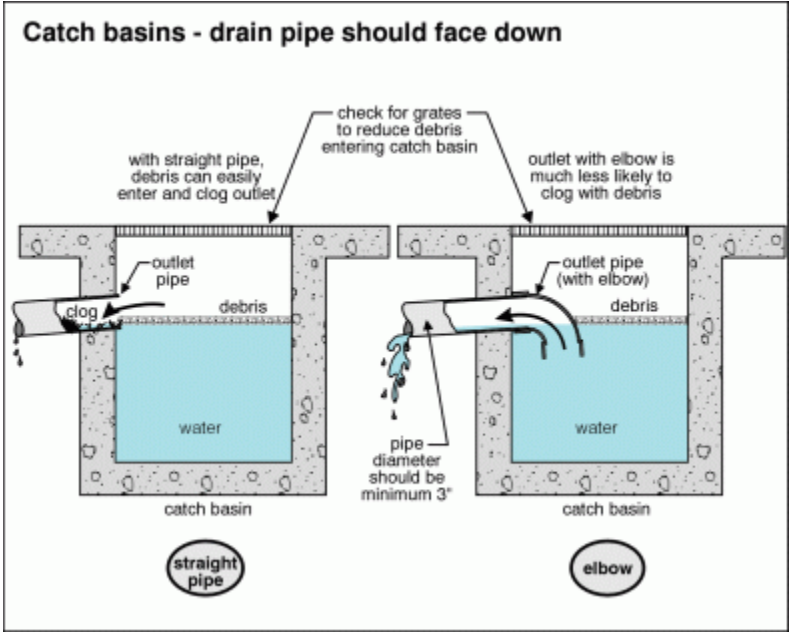
**18. Condition:** • [Clogged catch basins](#)

**Task:** Clean out as needed

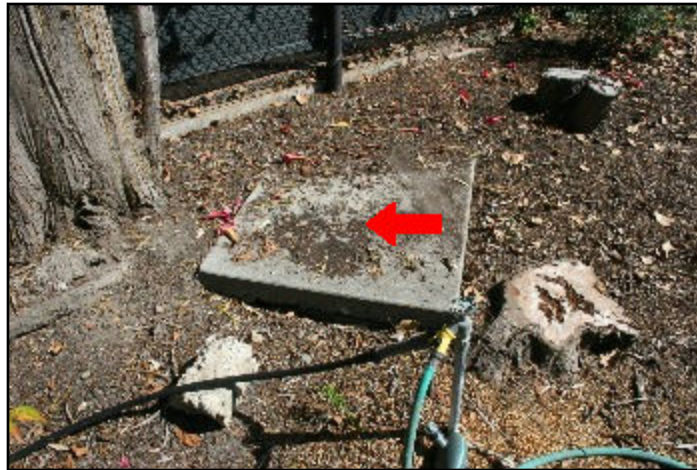
50.

**19. Condition:** • A concrete pad was observed by the hose in the orchard. Recommend requesting disclosure as to what may be under it.

**Task:** Request disclosure

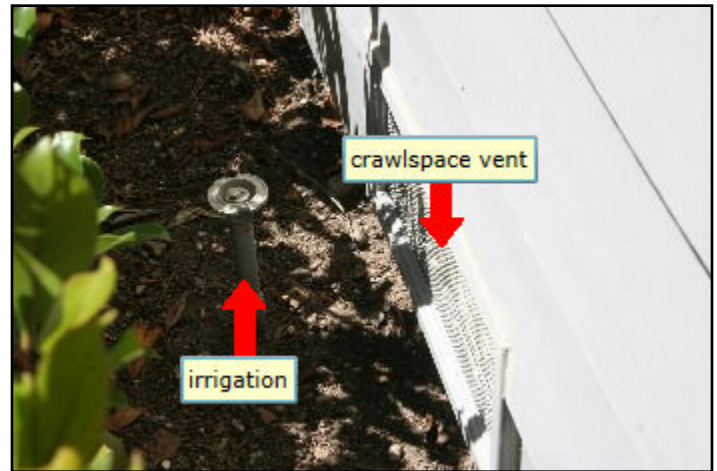
**20. Condition:** • [Trees or shrubs too close to house](#)

52. Improper irrigation

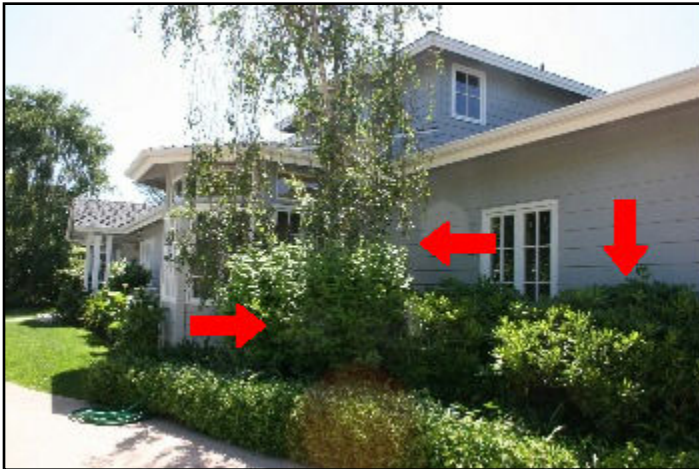
53. Trees or shrubs too close to house

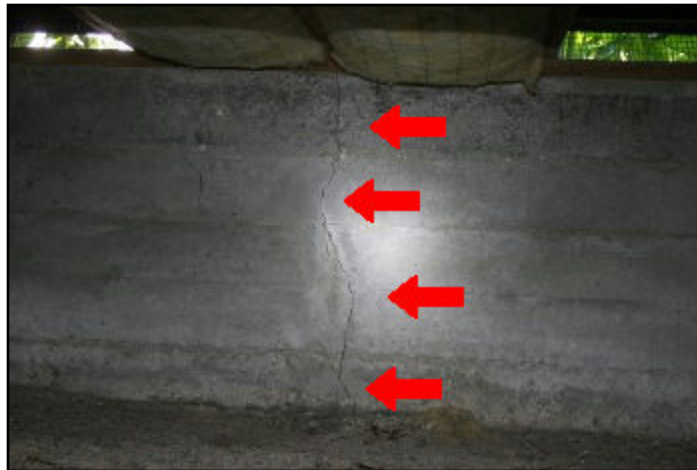
A typical settling crack was noted on the north side of the foundation wall. Sealing the crack will prevent moisture from deteriorating the re-bar inside thus preventing any further deterioration of the wall.

**21. Condition:** • Typical minor cracks

**62.** *Typical minor cracks*

**Task:** Seal and monitor

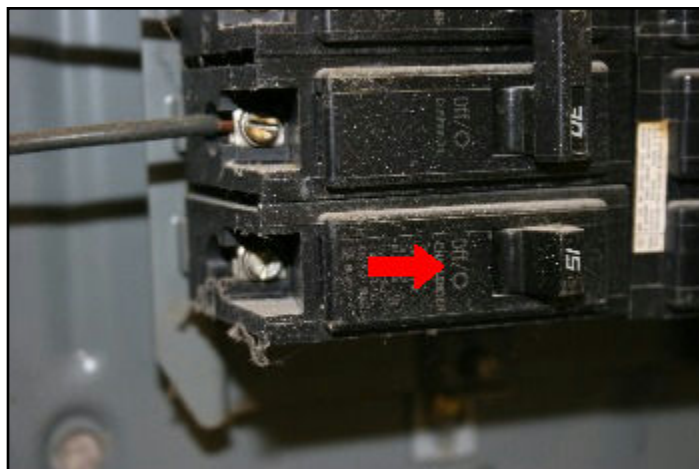
**Condition:** • 2 circuit breakers were observed in the on position but no live wire was attached.

72. On but not in use

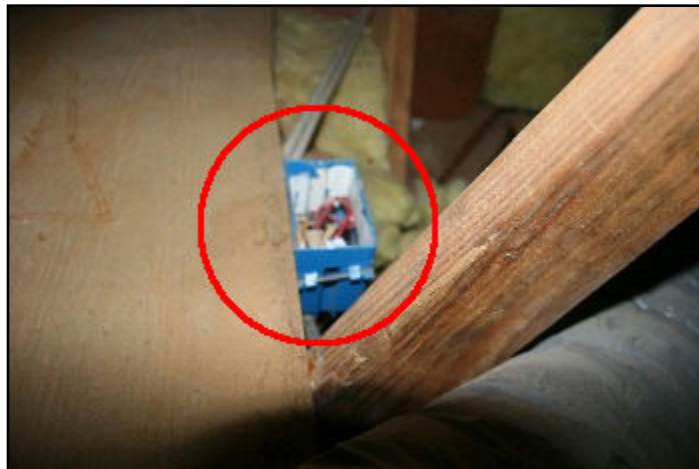
75. Cover loose or missing

**Task:** Provide

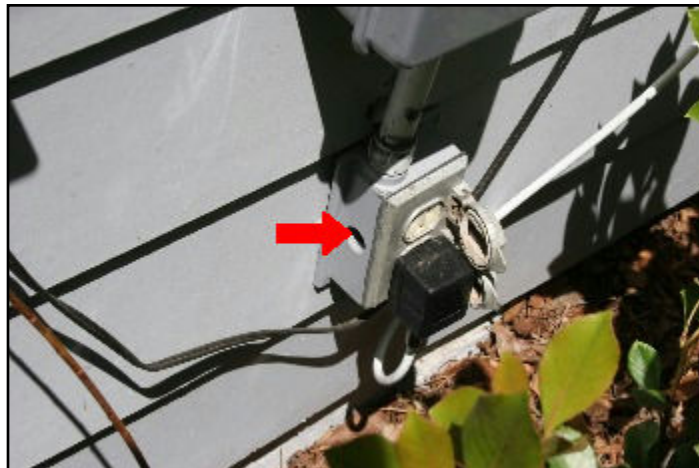
**Condition:** • An unprotected opening was observed at the receptacle under the Service panel. Recommend having a licensed electrician plug hole properly to prevent electric shock.

76. Unprotected opening

**Task:** Plug hole

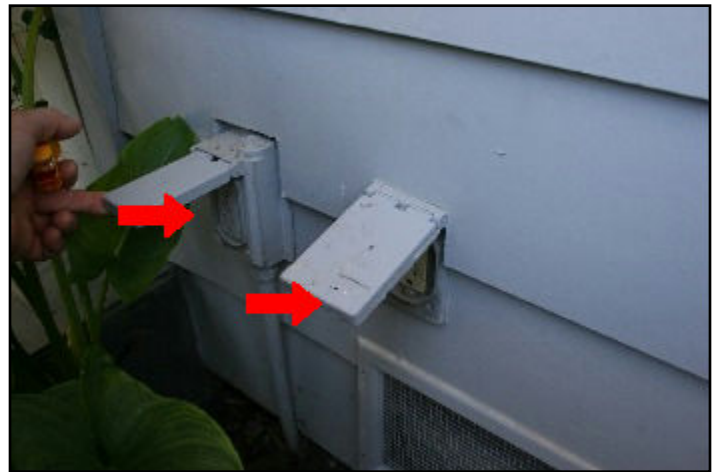
### **28. Condition:** • [Ground Fault Interrupter \(GFI\) needed](#)

78. No power at GFCI

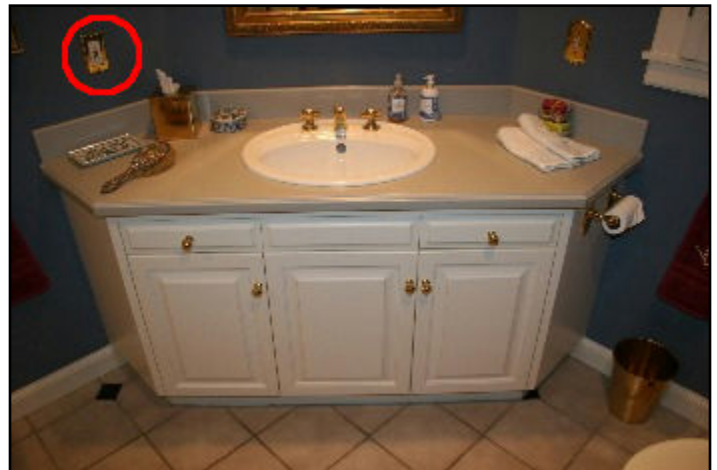
80. GFI test faulty

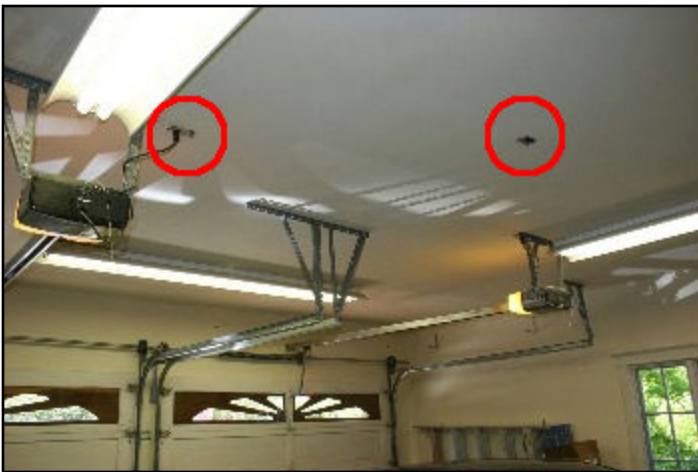
82. Missing

Task: Provide cover plates

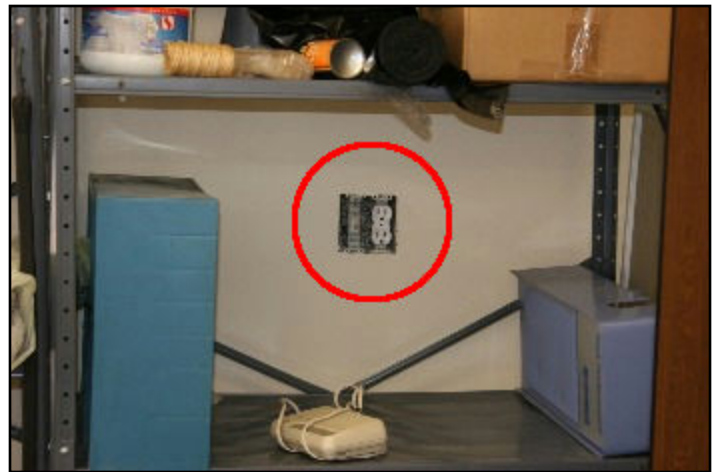
83. Missing

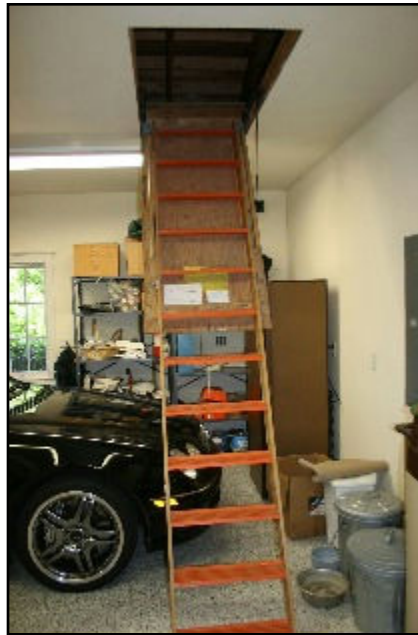
**96.** *Dangerous to lower or raise*

**Task:** Repair

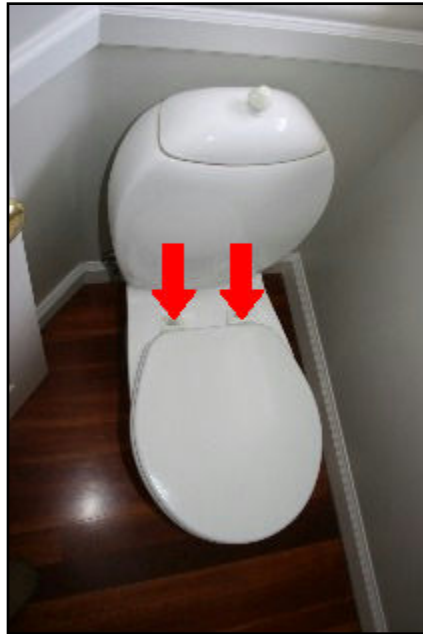
104. Loose

Task: Repair

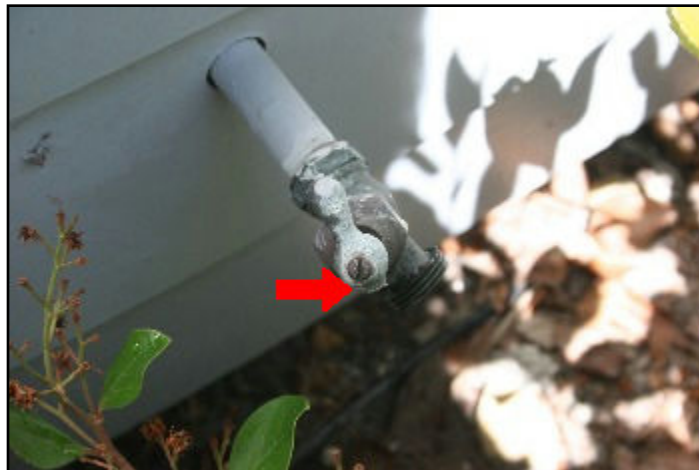
105. Damage

Task: Repair or replace

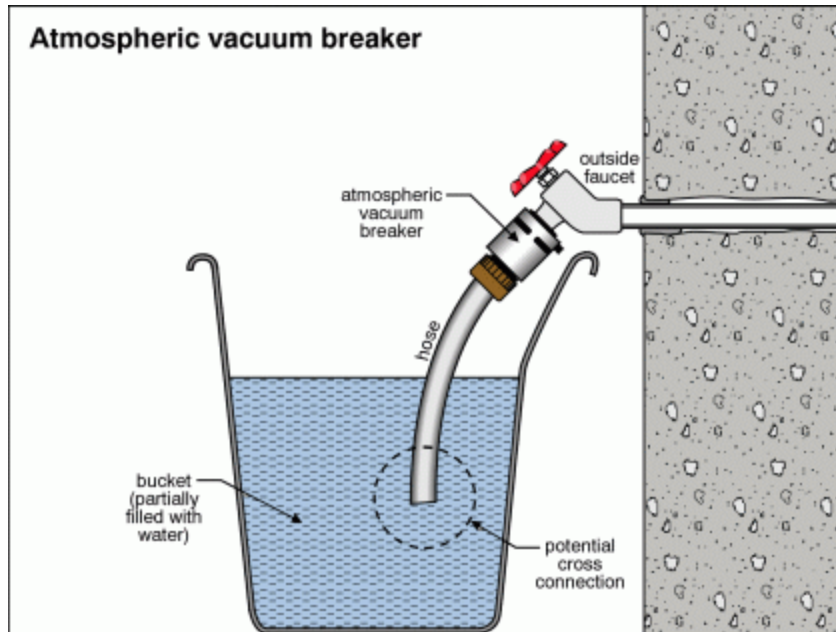
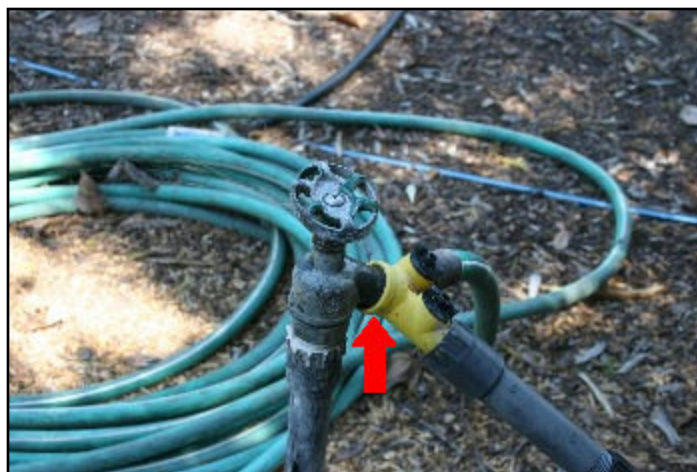
**39. Condition:** • [Backflow prevention missing](#)

**106.** Backflow prevention missing

**Task:** Provide

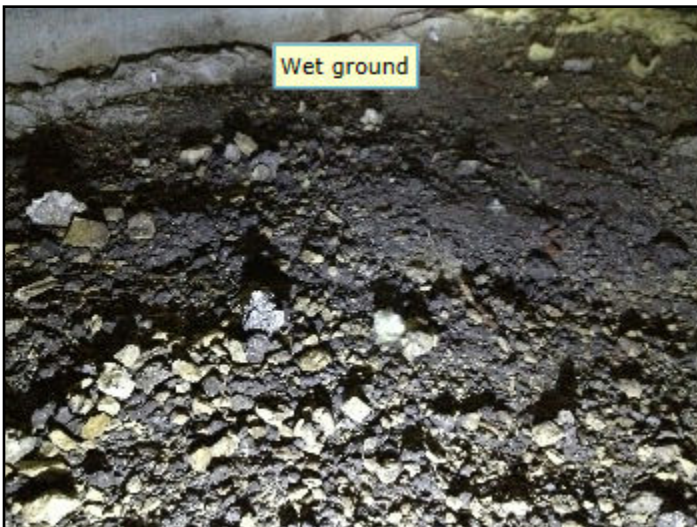
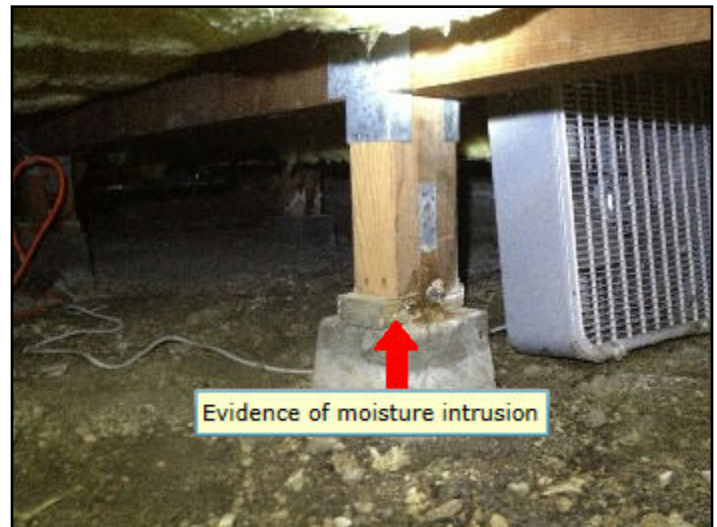
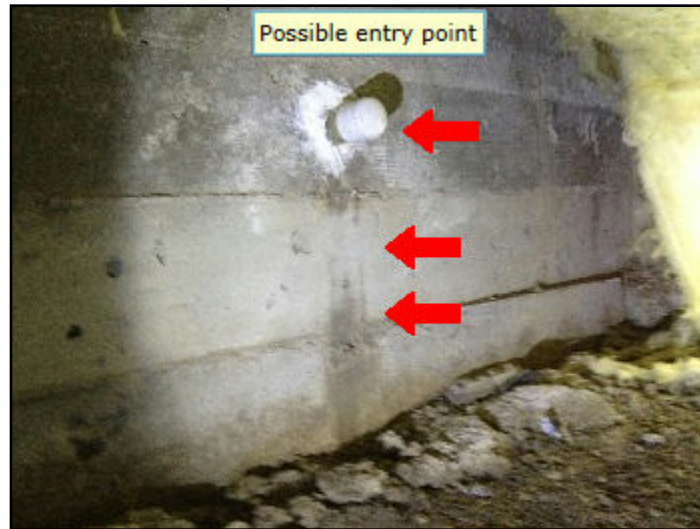
**Condition:** • One wet area was observed in the crawlspace on the southwest side of the home. The moisture appears to have come through the west side exterior wall beside which the patio slopes toward the house. Recommend further evaluation and repair by an appropriately licensed technician.

**Task:** Further evaluation

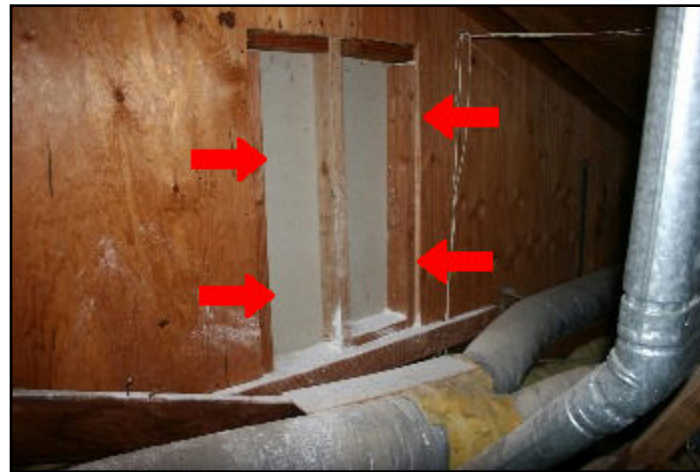
**Condition:** • The firewall was breached in the attic space. Recommend repair.

110. Firewall breach

**Task:** Repair

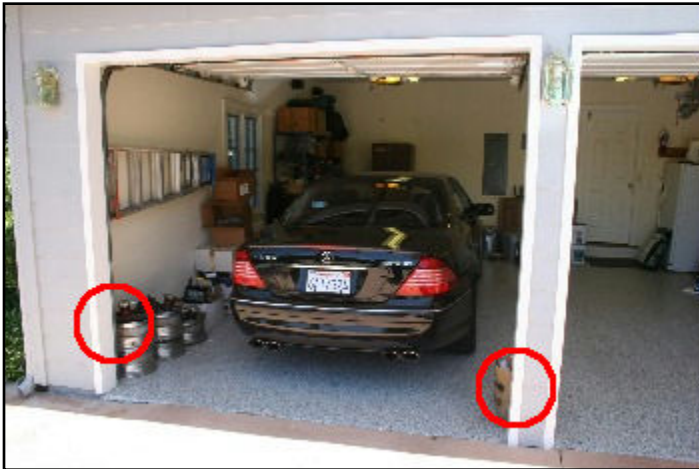
No sensors were observed at the time of this inspection.

112. Fails to auto reverse

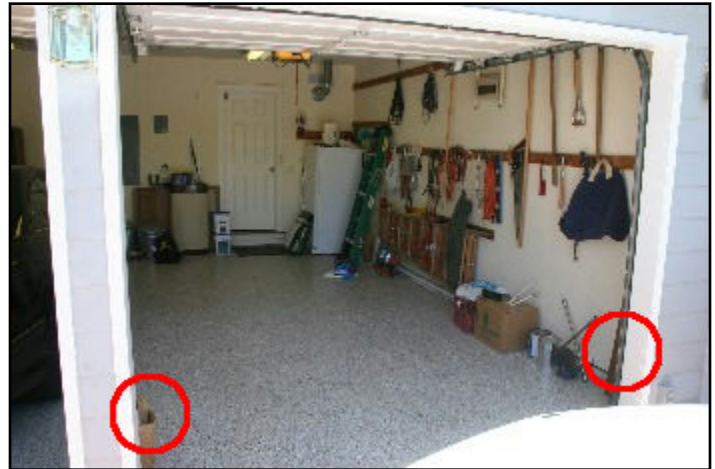
113. Fails to auto reverse

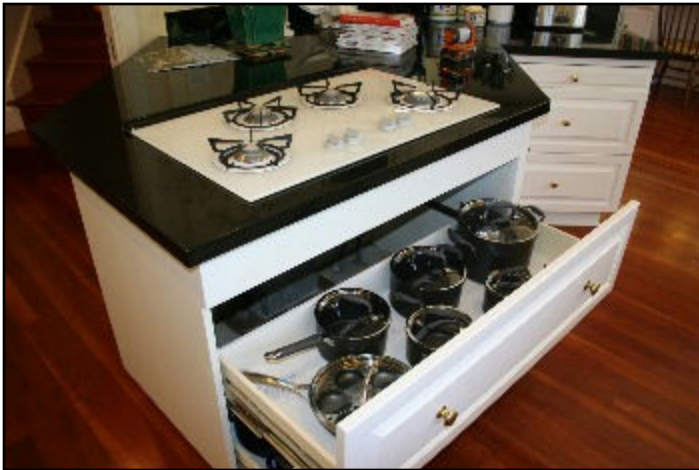
114. Blower inoperative

Task: Repair or replace

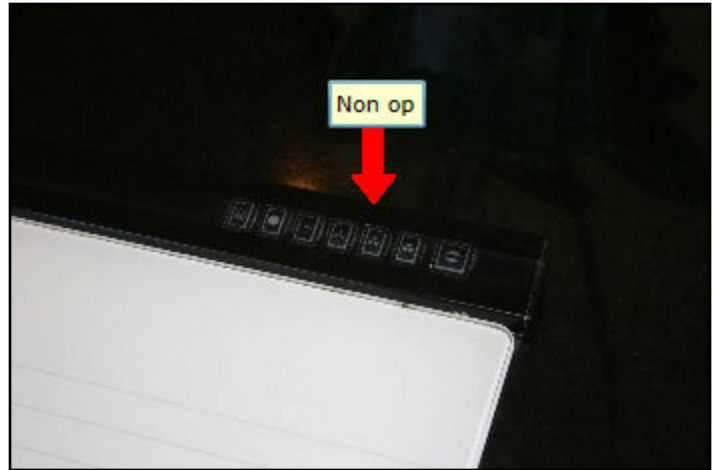
115. Blower inoperative
