YOUR INSPECTION REPORT

1111 Hodges Lane
Montecito, CA 93108

Monday, June 10, 2013

Report No. 1058

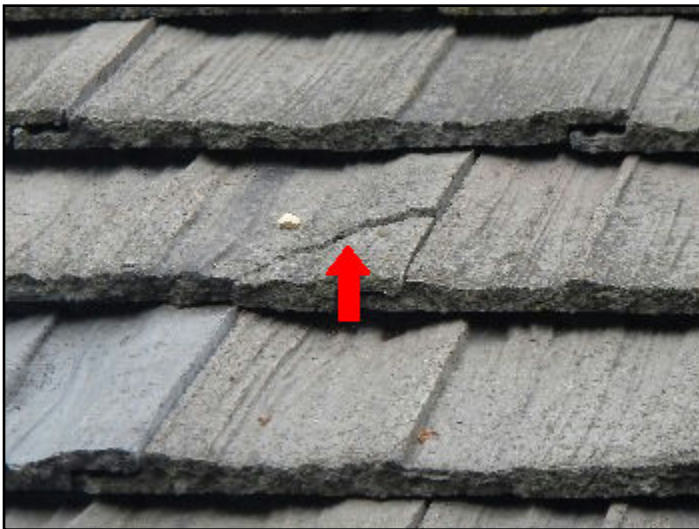
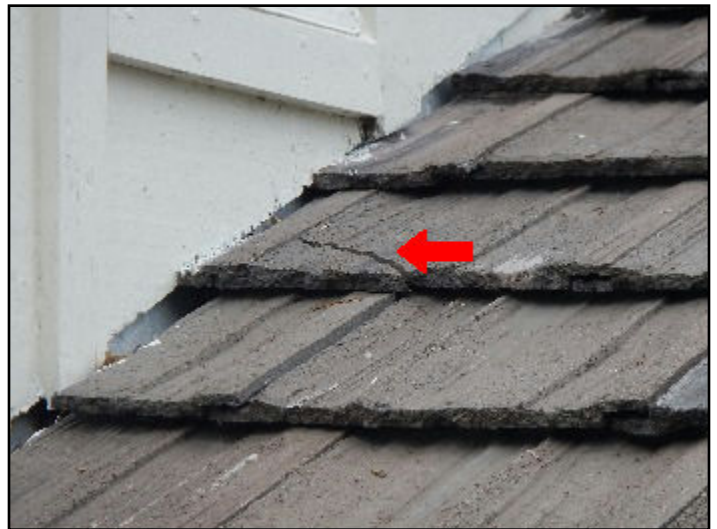
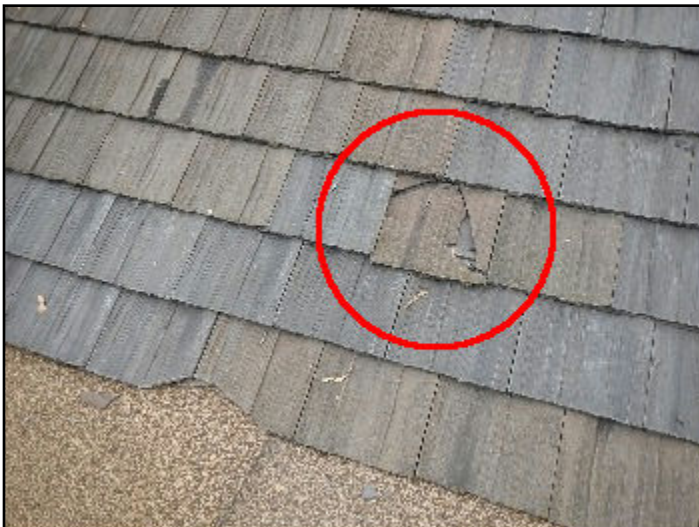
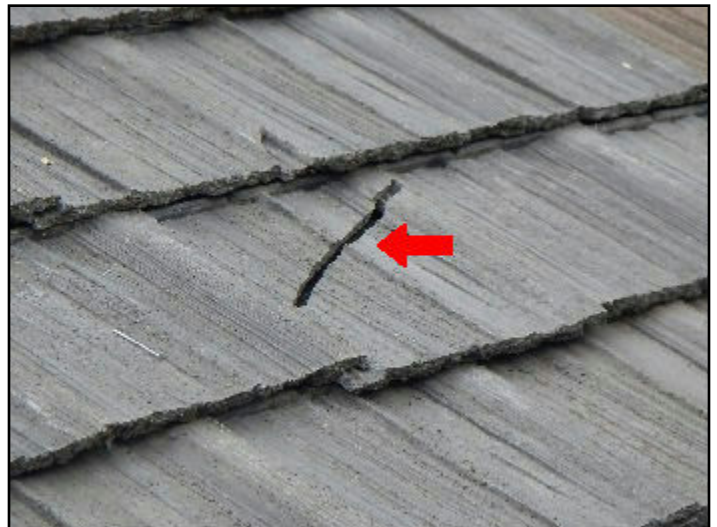
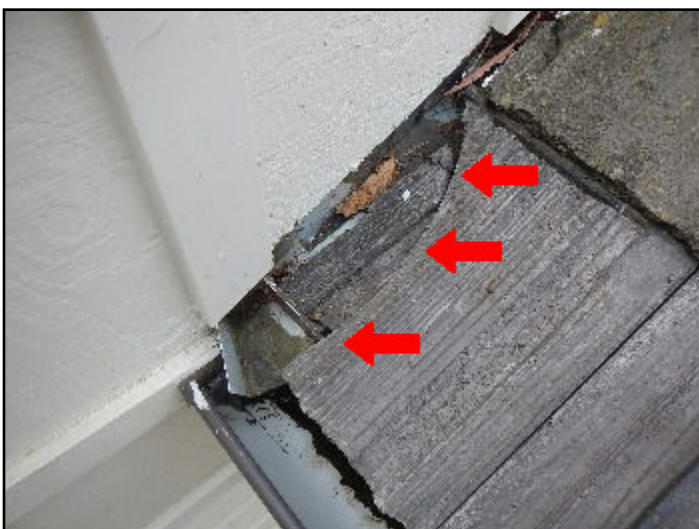
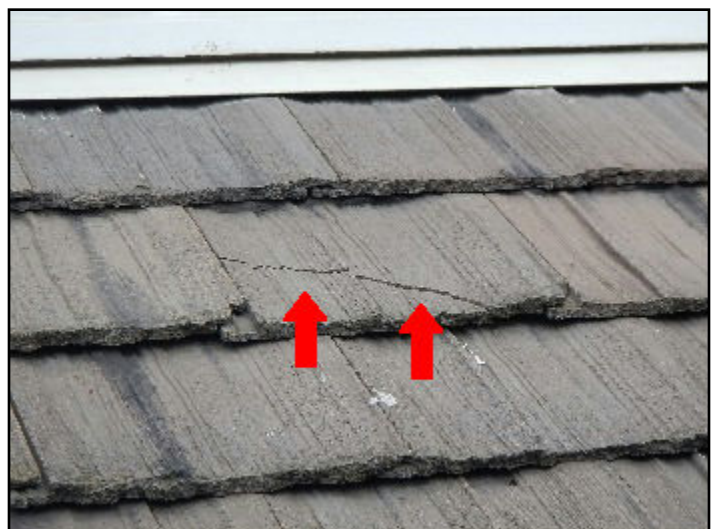
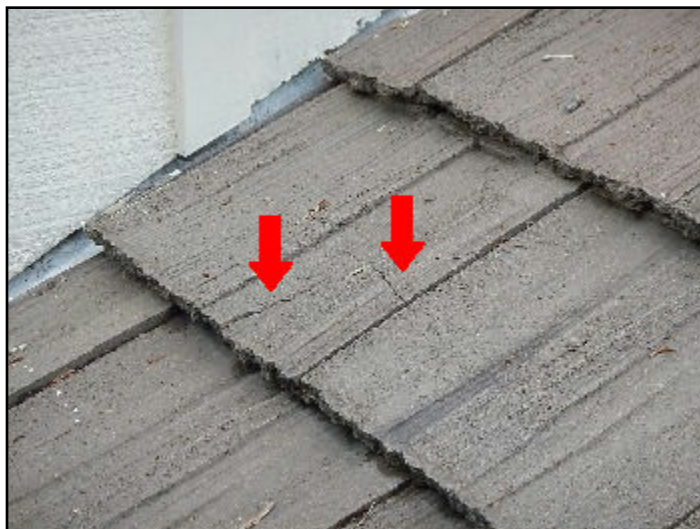
Several cracked roof tiles were observed.

Implication(s): Chance of water damage to contents, finishes and/or structure

Task: Repair or replace

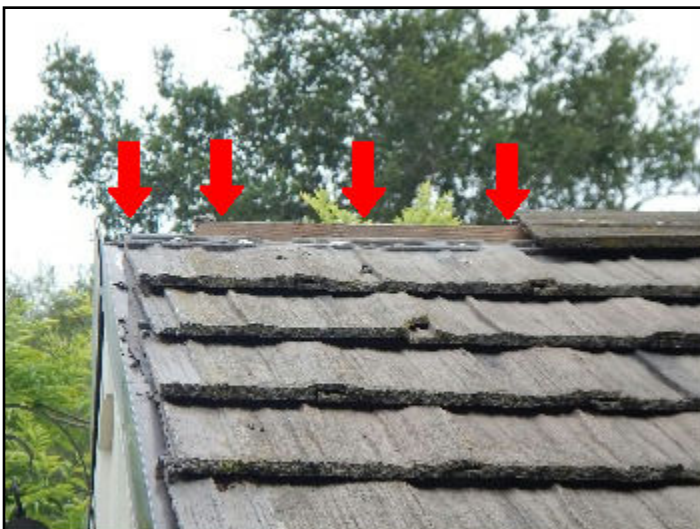
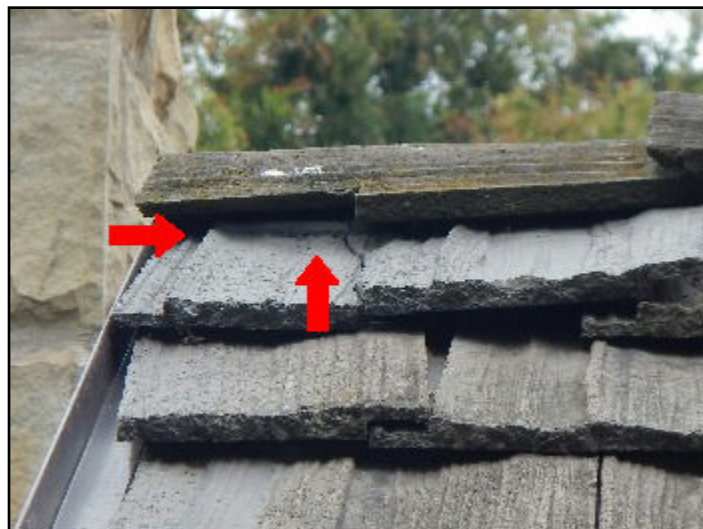
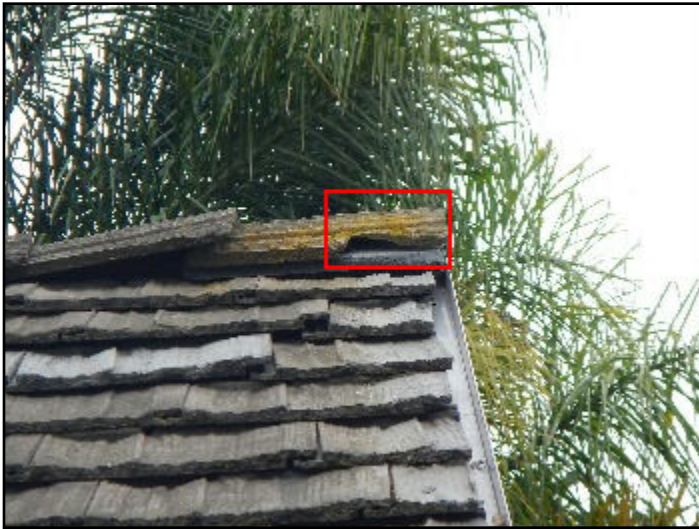
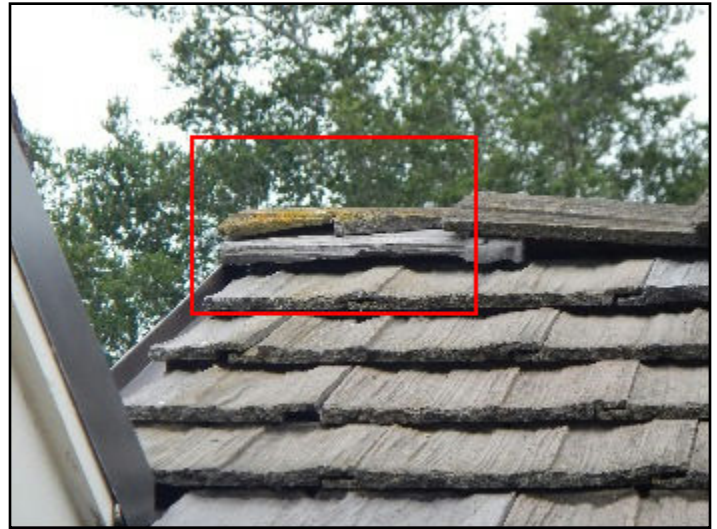
Missing and damaged ridge cap shingles were noted on the south ridges of the garage and main house as well as other areas.

Implication(s): Chance of water damage to contents, finishes and/or structure | Damage or physical injury due to falling materials

Task: Replace

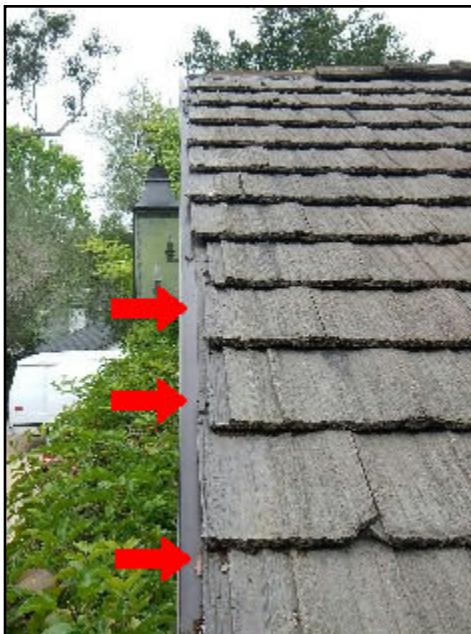
14. Vulnerable areas

4. Condition: • [Vulnerable areas](#)

Implication(s): Chance of water damage to contents, finishes and/or structure

Task: Repair

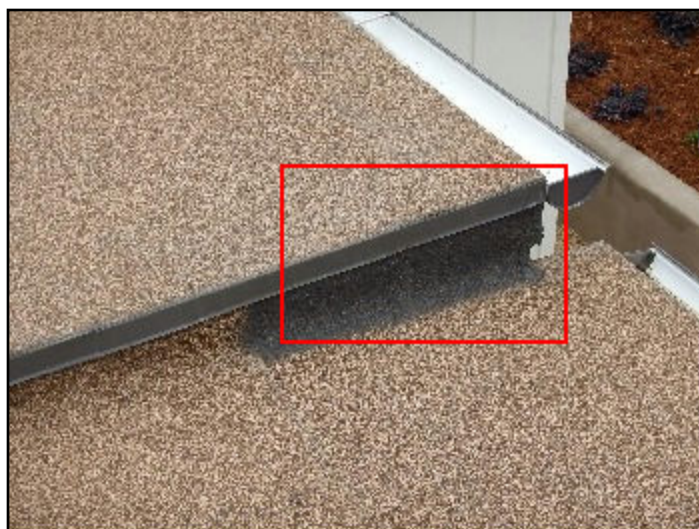
15. Patched

Evidence of patching was observed on the northeast flat roof where it meets the lower flat roof. After speaking with the owner it appears the area was not patched but colored for cosmetic reasons.

Implication(s): Chance of water damage to contents, finishes and/or structure

Task: Request disclosure

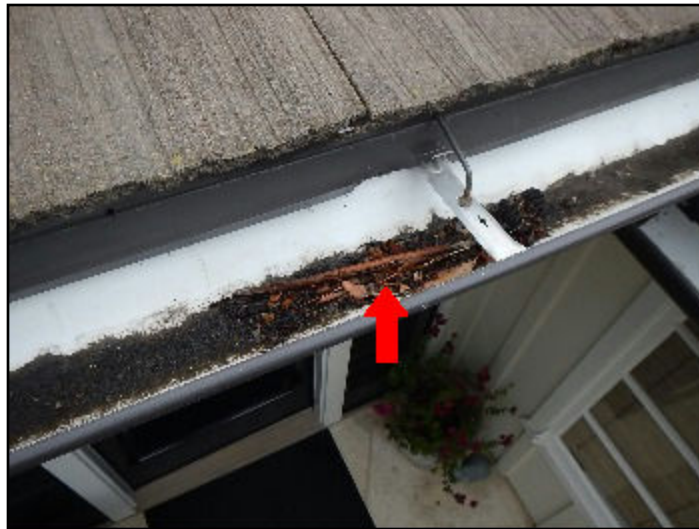
17. Clogged

Some areas of gutter had a layer of seasonal debris clogging flow. Recommend cleaning to ensure proper flow.

Implication(s): Chance of water damage to contents, finishes and/or structure

Task: Clean

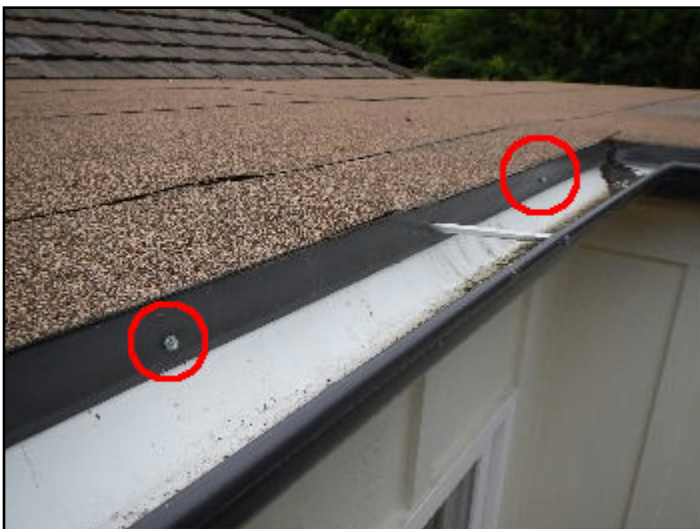
18. Exposed fasteners

Exposed fasteners were observed.

Implication(s): Chance of water damage to contents, finishes and/or structure

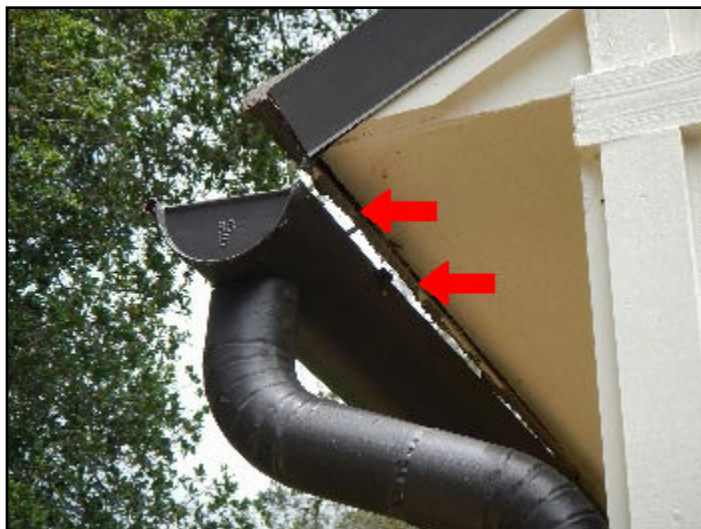
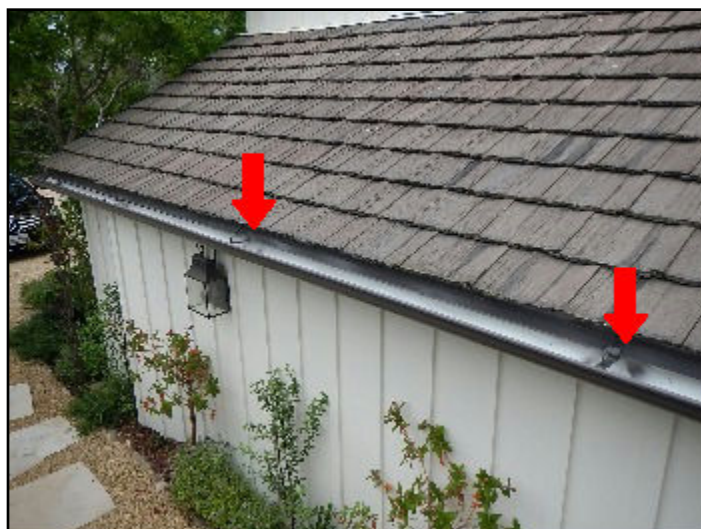
Improper installation noted. Gutters should be fastened every 2-3 feet. Any exposed fasteners should be sealed with appropriate caulking. Drip edge should flow into gutters not behind.

Implication(s): Chance of water damage to contents, finishes and/or structure

Task: Repair

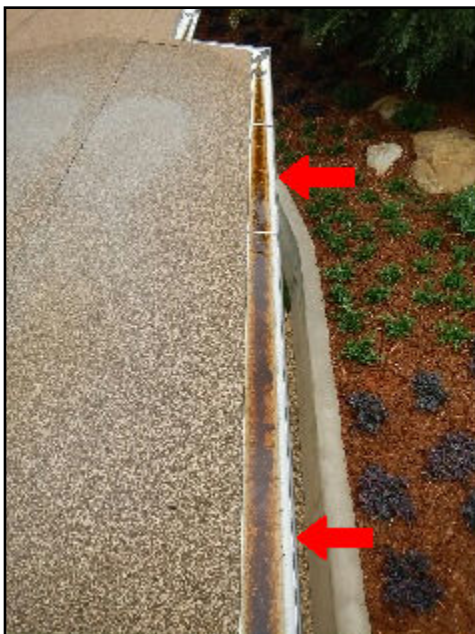
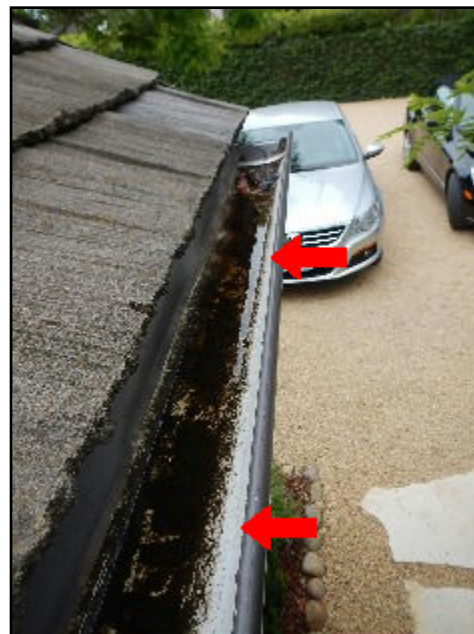
Standing water was observed in gutter due to improper slope.

Implication(s): Chance of water damage to contents, finishes and/or structure

Task: Repair

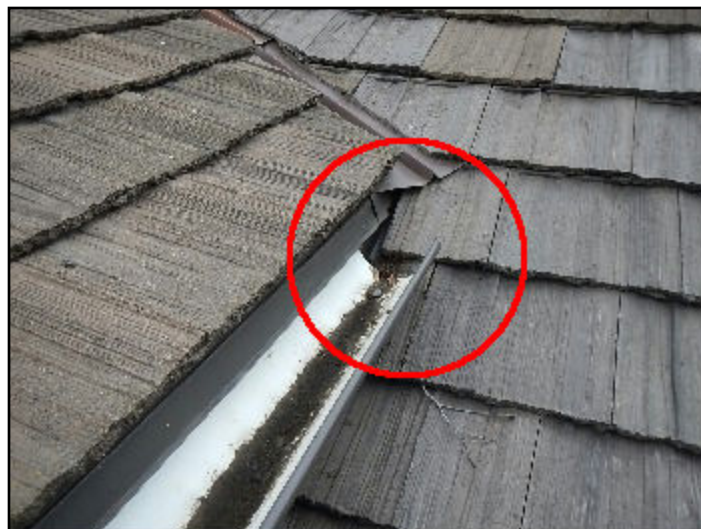
24. Discharging onto roof

The gutter above the entryway was discharging toward the slope of the roof. Recommend capping the end and making a drain into the gutter directly beneath it.

Implication(s): Material deterioration

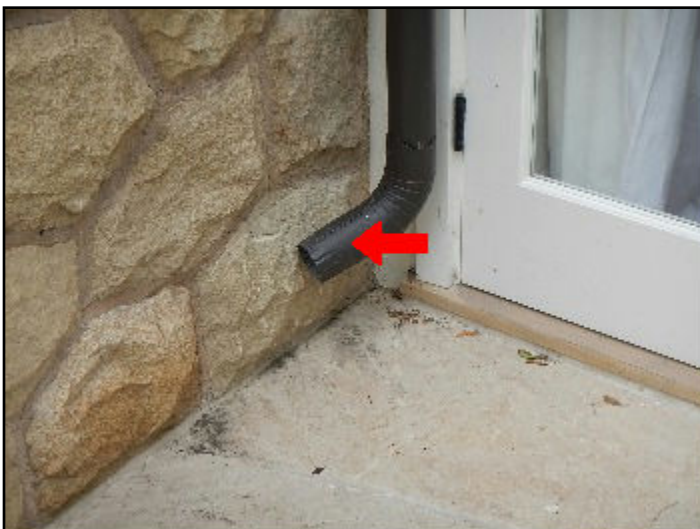
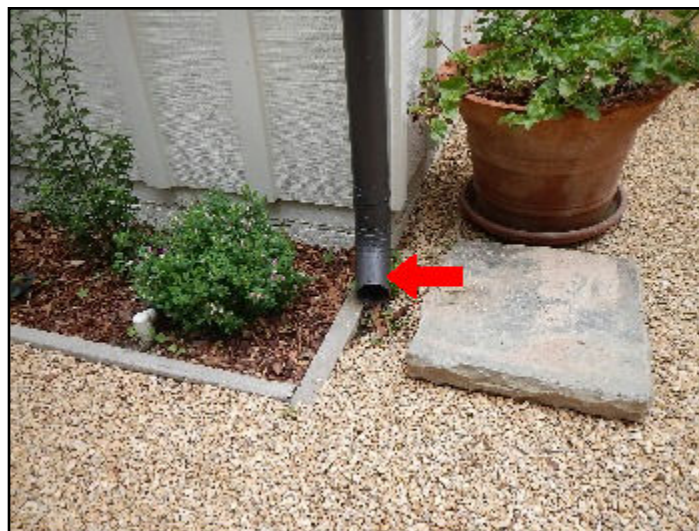
11. Condition: • [Downspouts end too close to building](#)

Implication(s): Chance of water damage to contents, finishes and/or structure

Task: Extend

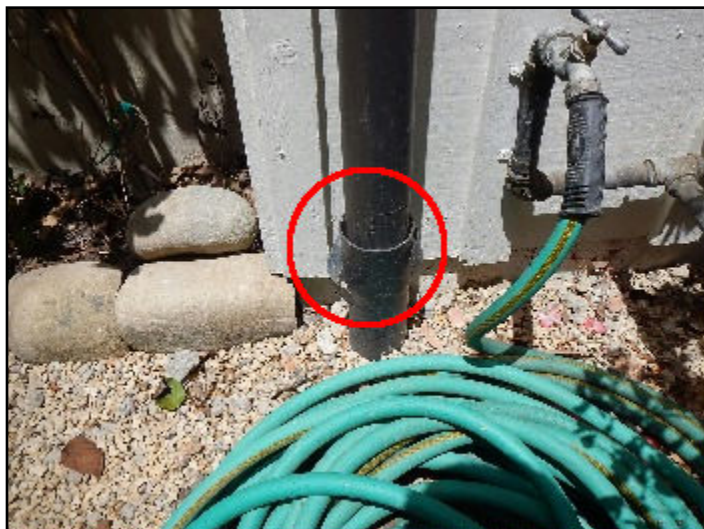
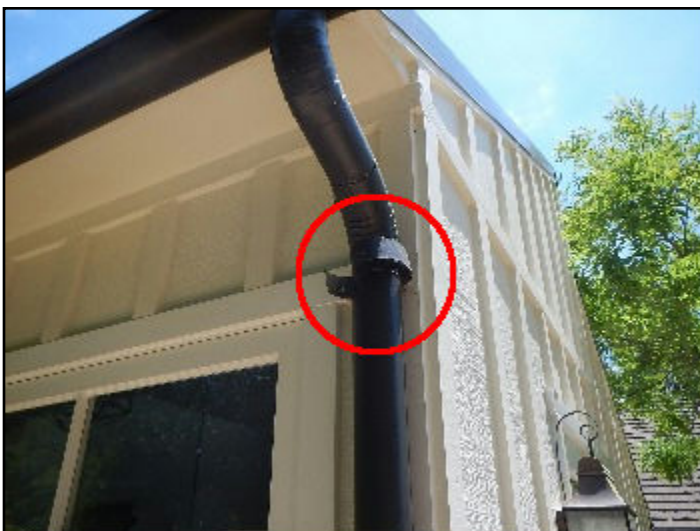
12. Condition: • [Not well secured](#)

Implication(s): Leakage

Task: Repair

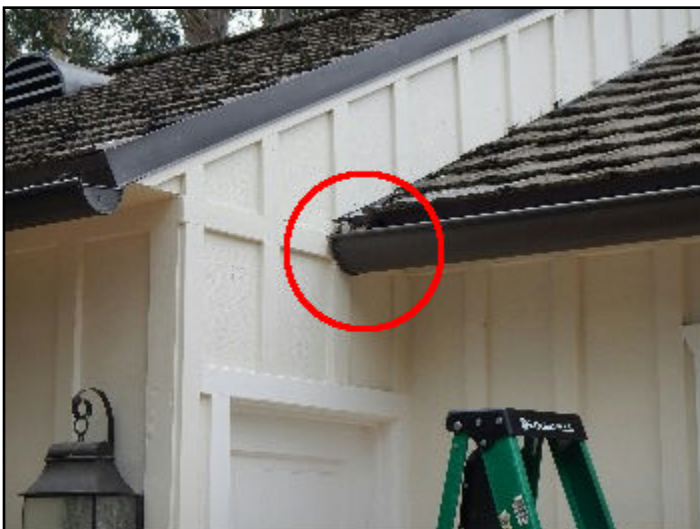
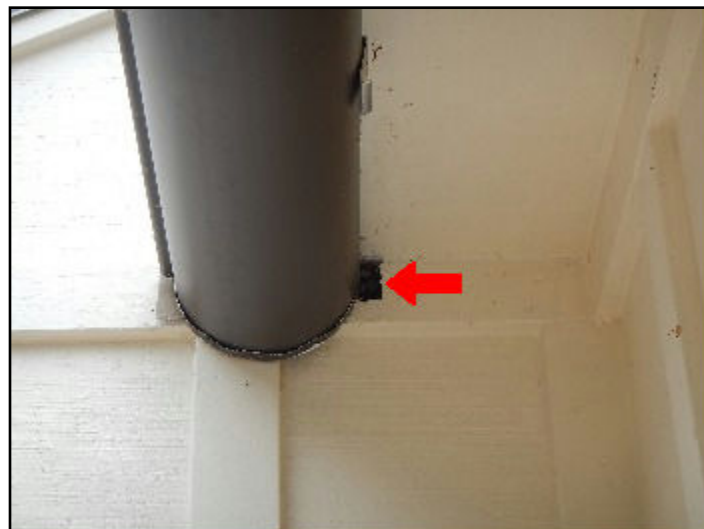
13. Condition: • A hole was noted in the trim next to the gutter and under the soffit.

Implication(s): Moisture and pest intrusion point

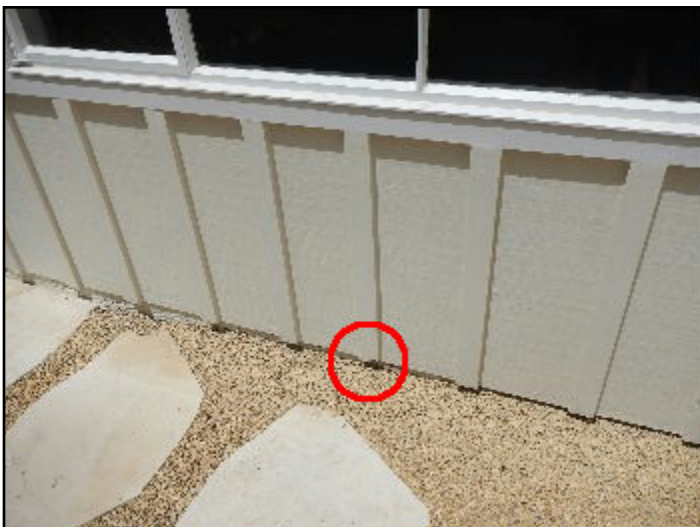
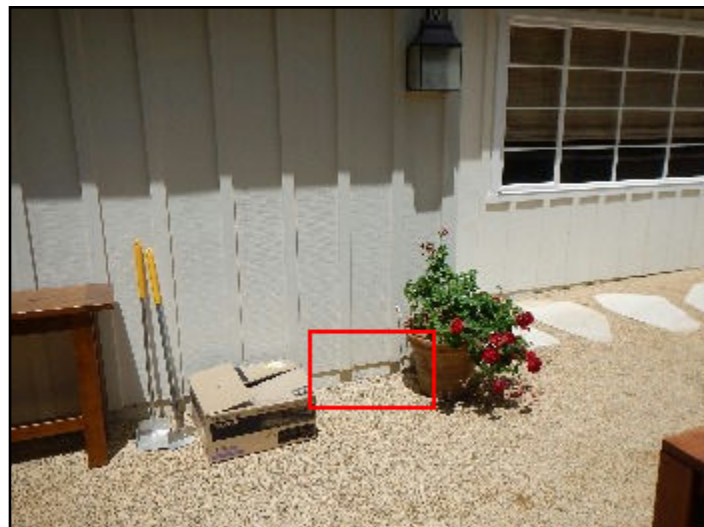
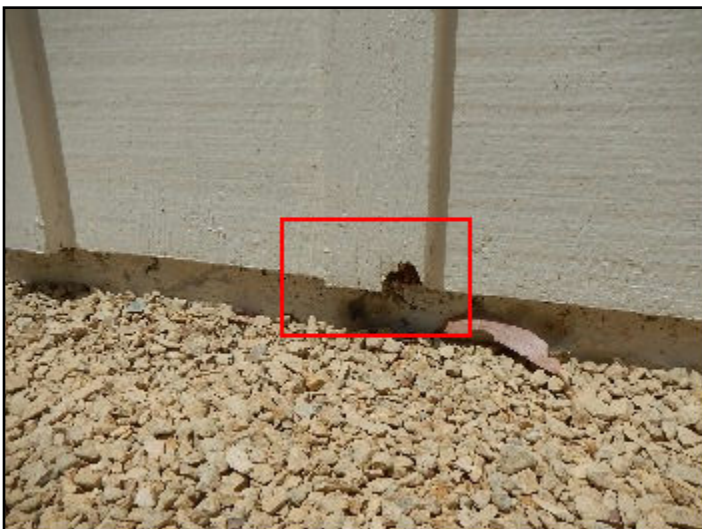
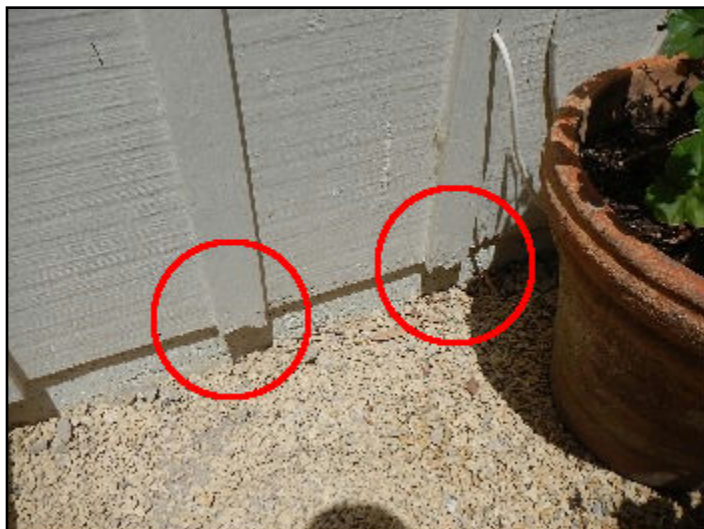
Rot or insect damage was observed on the bottoms of some trim pieces on the exterior siding. Recommend pest inspection and repair.

Implication(s): Chance of water damage to contents, finishes and/or structure | Material deterioration

Task: Repair

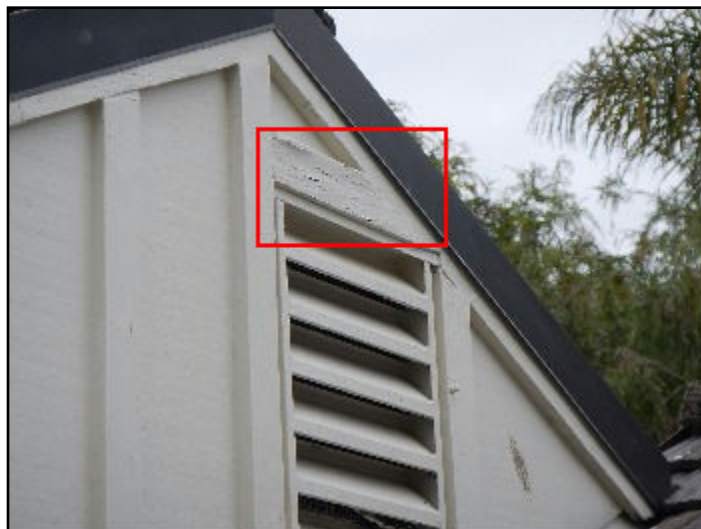
39. Rot

15. Condition: • Rot

Task: Repair

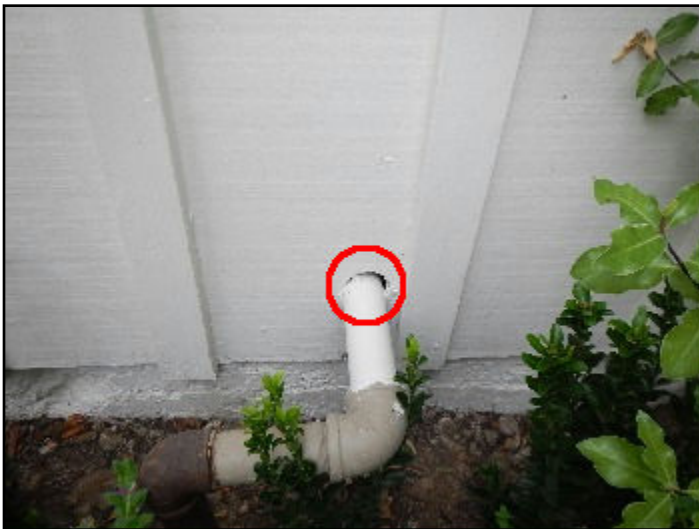
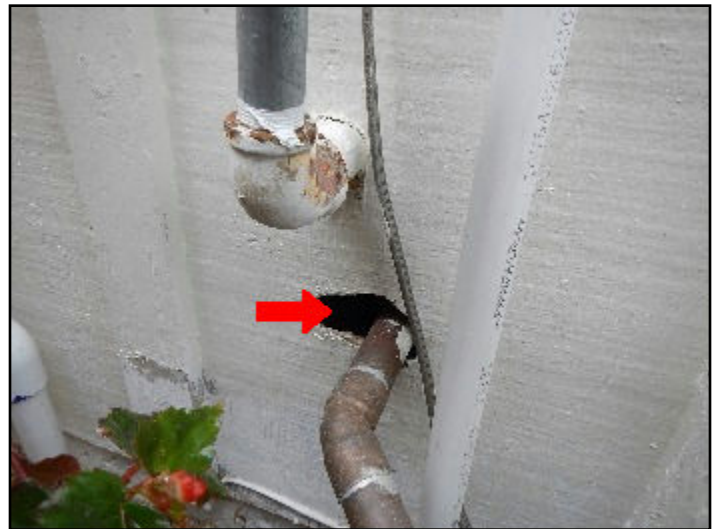
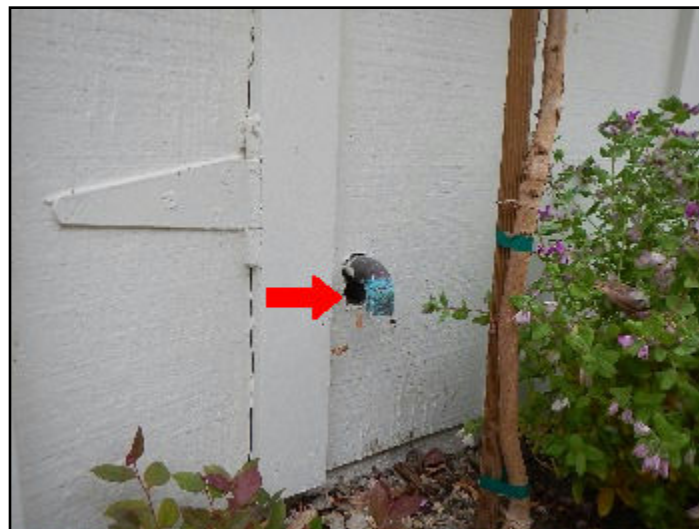
16. Condition: • Openings were noted where several pipes penetrate the walls.

Implication(s): Moisture and pest intrusion points

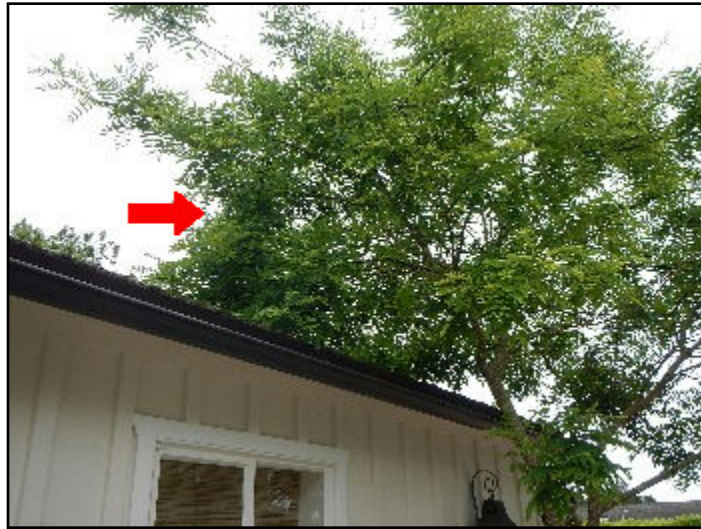
43. Trees or shrubs too close to house

17. Condition: • [Trees or shrubs too close to house](#)

Implication(s): Chance of water damage to contents, finishes and/or structure | Chance of pests entering house | Material deterioration

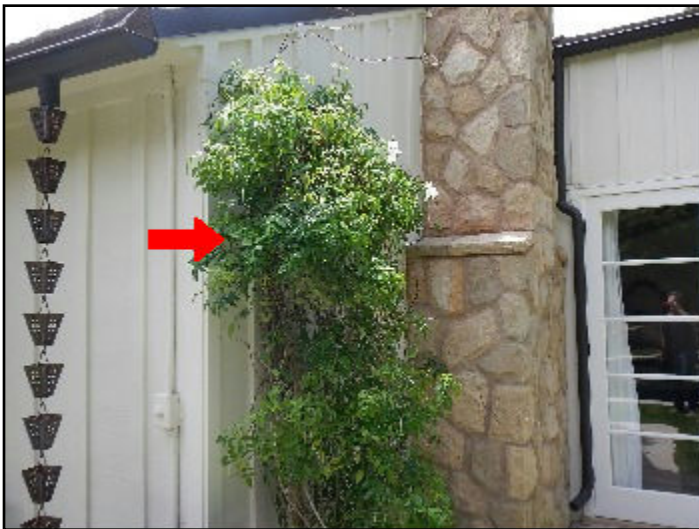
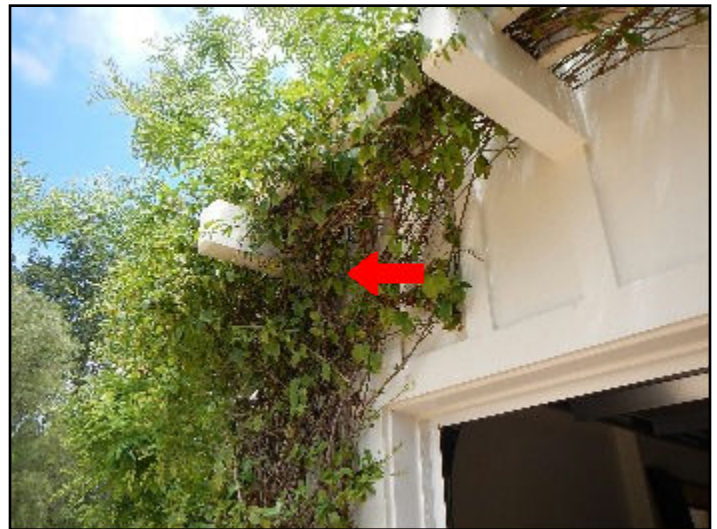
Vines were observed on the garage exterior and exterior wall by the chimney.

Task: Remove

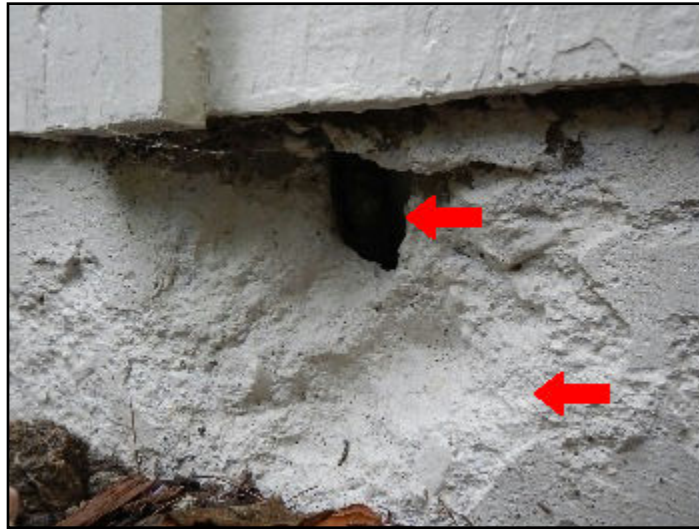
47. Spalling, crumbling or broken material

A hole was noted in the concrete possibly from an old utility line entry point. Recommend filling and sealing to prevent moisture or pest intrusion.

Task: Repair

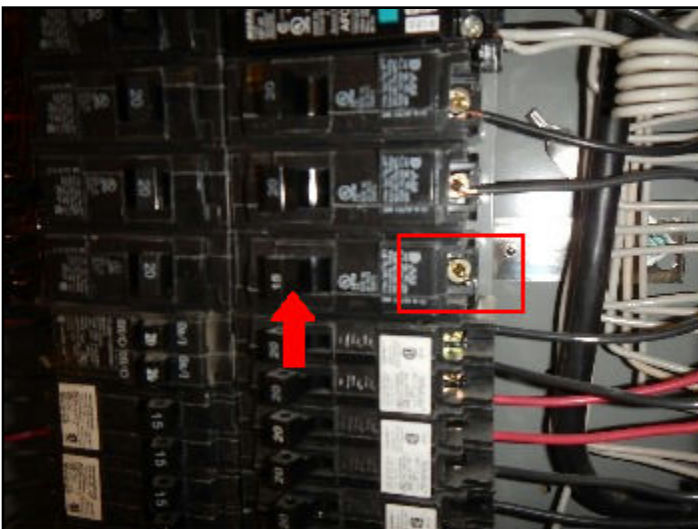
53. On- not in use

21. Condition: • A breaker was in the "on" position but not connected to any branch circuit conductor.

Task: Turn off if unused

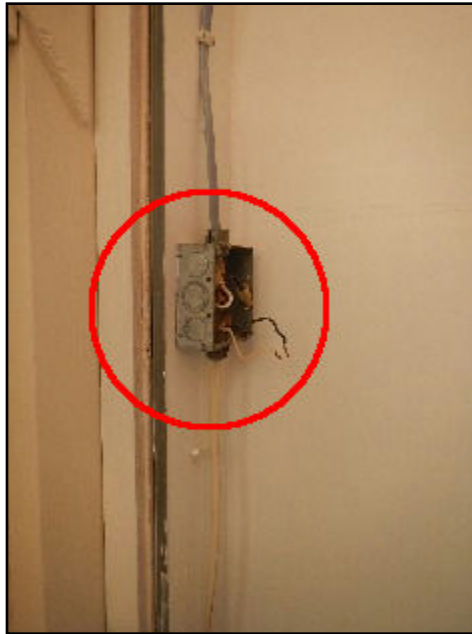
55. Cover loose or missing

At the junction box in the hot water heater closet, exposed wires and a missing cover were observed.

Implication(s): Electric shock | Fire hazard

Task: Repair

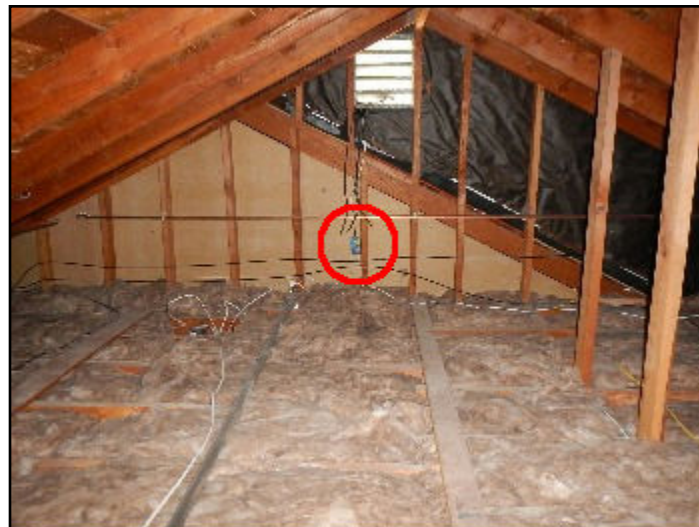
56. Cover loose or missing

23. Condition: • [Cover loose or missing](#)

Implication(s): Electric shock | Fire hazard

Task: Provide cover

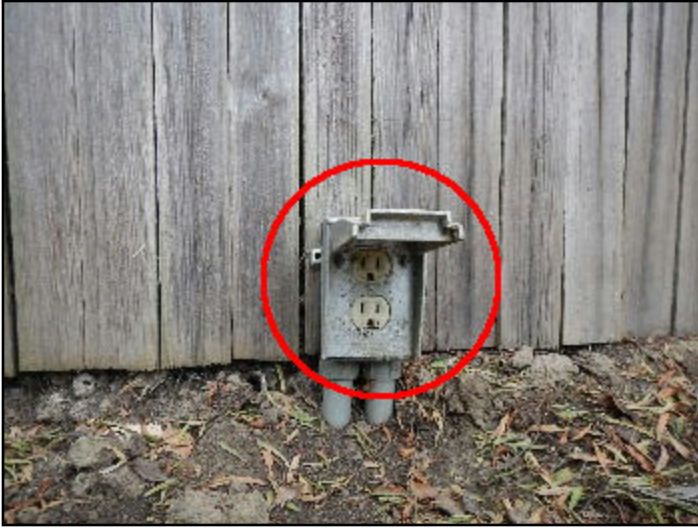
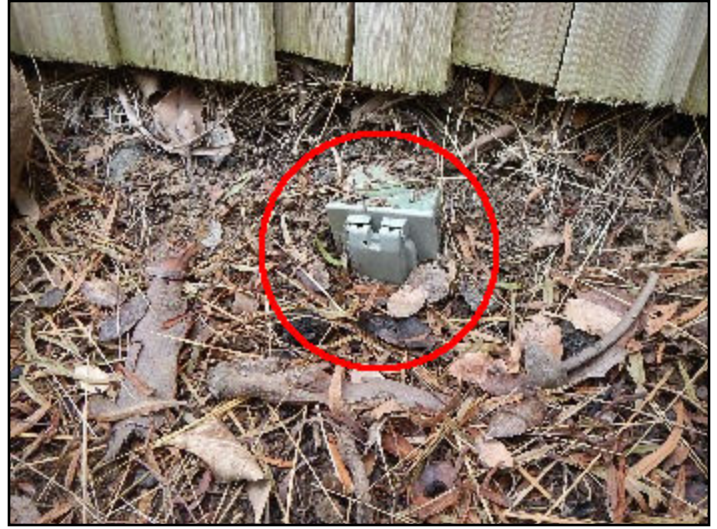
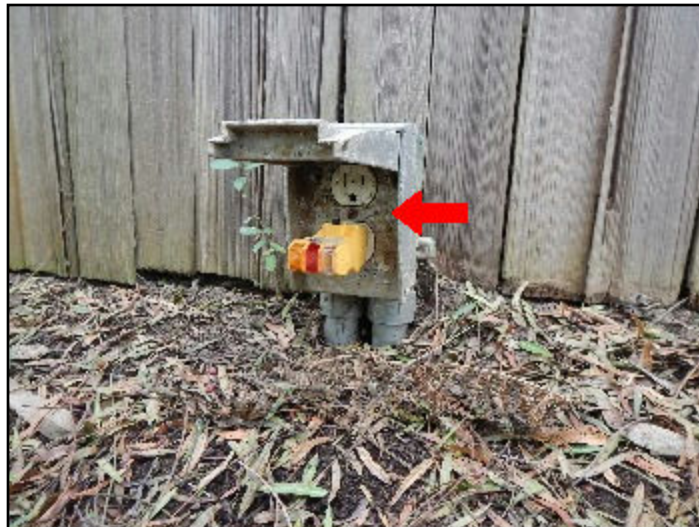
3 receptacles were noted along the driveway wooden fence. They were non GFCI and non operative at the time of this inspection. One was partially buried.

Task: Repair as needed

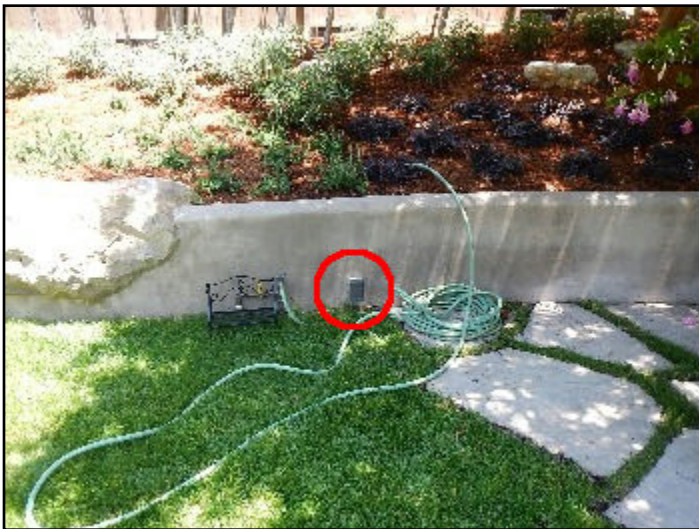
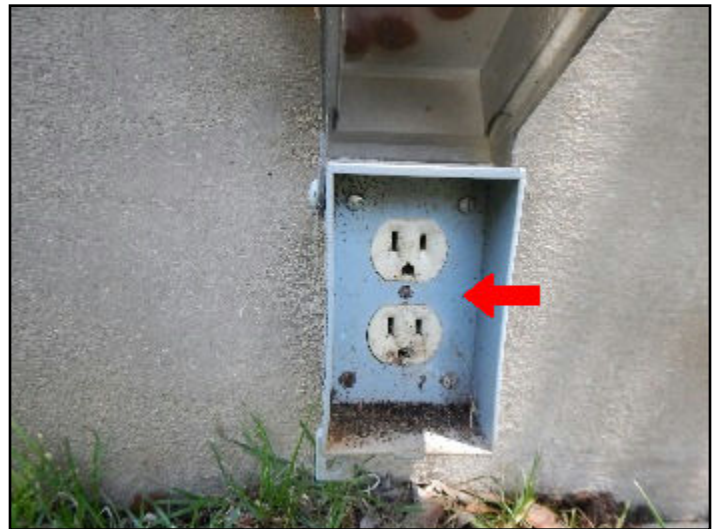
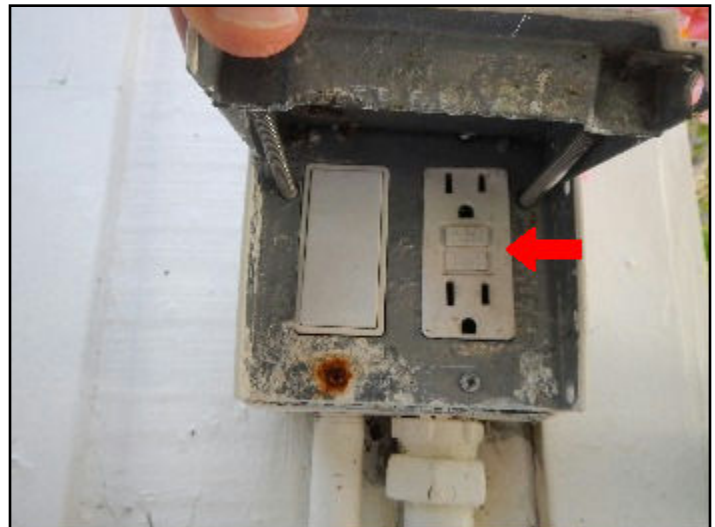
25. Condition: • [Inoperative](#)

Task: Repair or replace

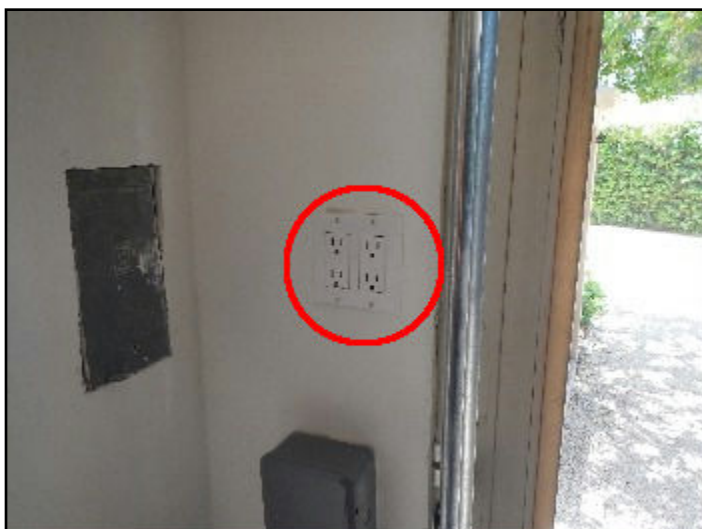
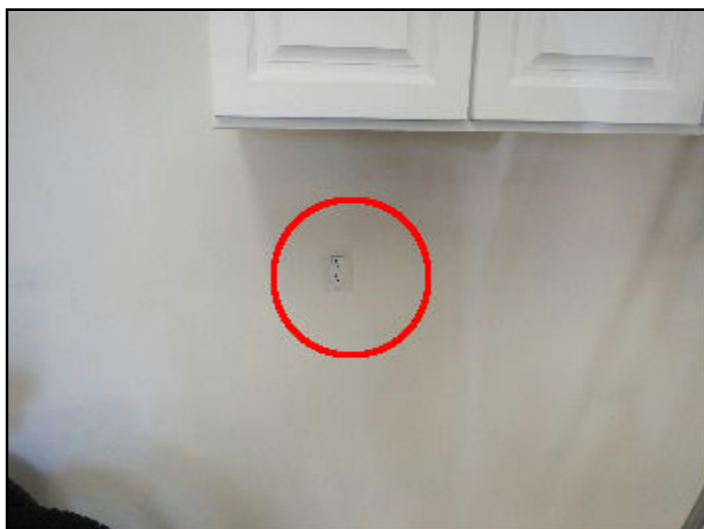
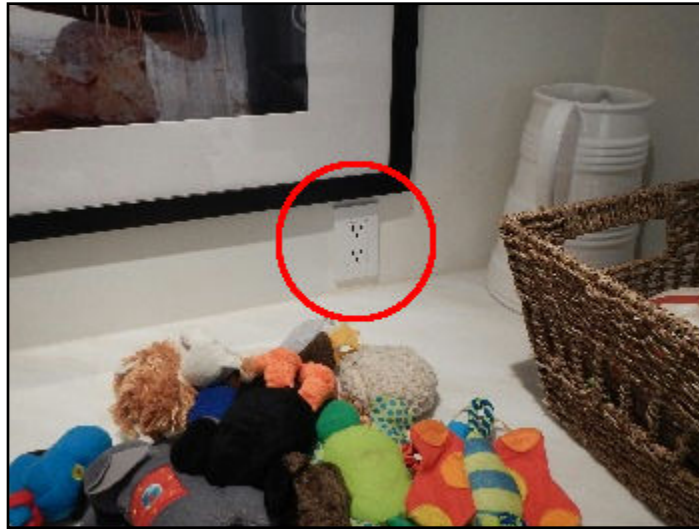
GFCI receptacles are required by the US National Electrical Code in locations where water and electricity are likely to come into contact, such as in kitchens, bathrooms, garages, and outdoors. Recommend having a licensed electrician install GFCI receptacles as needed.

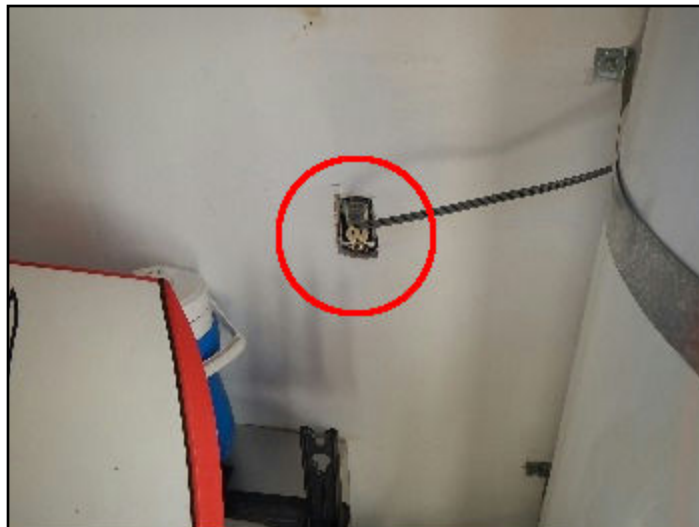
67. Missing

27. Condition: • [Missing](#)

Task: Replace cover

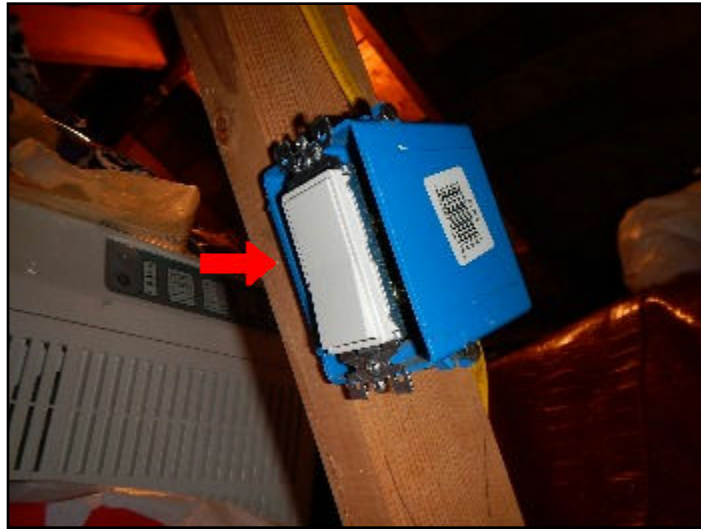
68. *Missing*

28. Condition: • [Missing](#)

Task: Provide cover

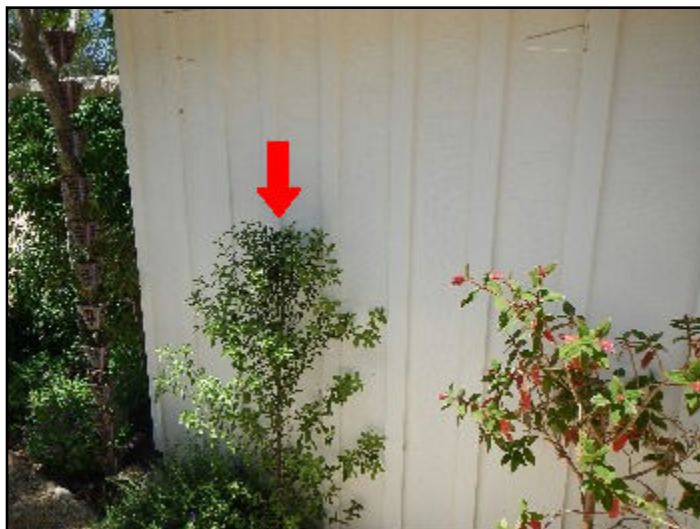
79. Shrub blocking door

31. Condition: • A shrub was planted in front of the water heater closet doors making accessibility difficult.

Task: Remove shrub

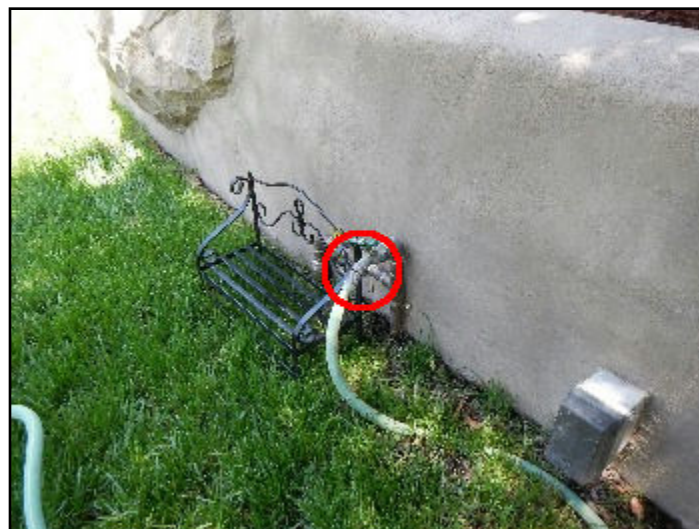
80. Backflow prevention missing

No backflow prevention devices were observed on any of the exterior hose bibs. Recommend installing.

Task: Provide
