YOUR INSPECTION REPORT

2817 Samarkand Drive
Santa Barbara, CA 93105

Wednesday, May 22, 2013

Report No. 1050

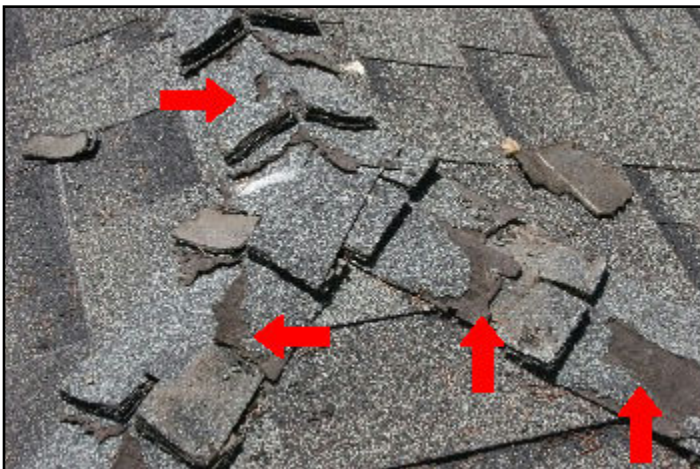
Almost all of the ridge cap shingles were worn out and deteriorated. The rest of the shingles appeared to be old but still had some life in them. Recommend replacing ridge cap shingles for certain.

2. Old, worn out

Task: Replace ridge cap shingles

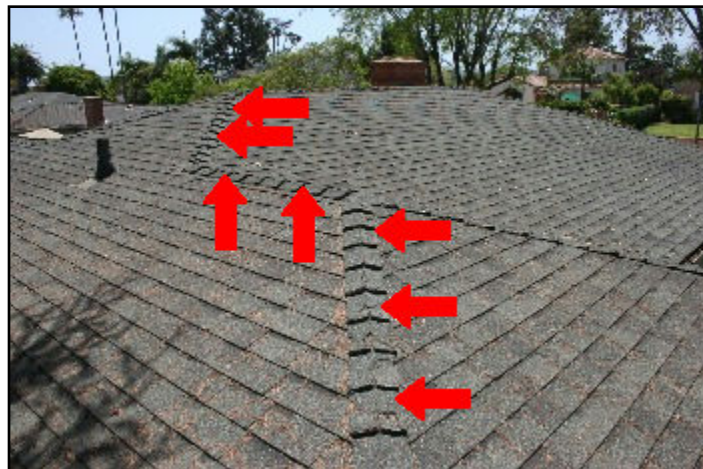
3. Old, worn out

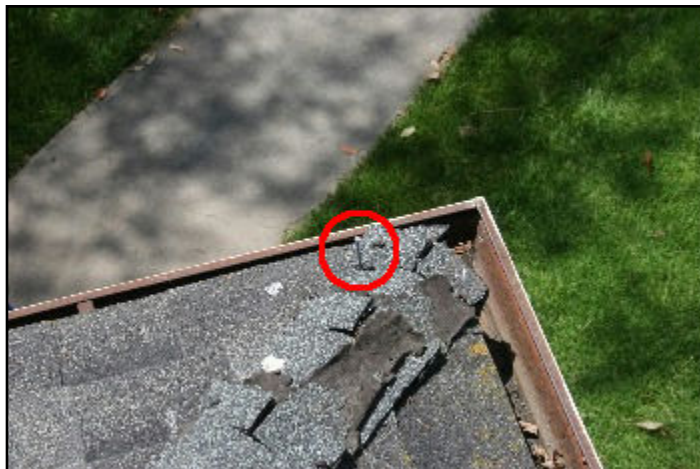
Exposed fasteners were observed. Recommend removing and/or sealing as needed.

4. Exposed fasteners

Task: Repair as needed

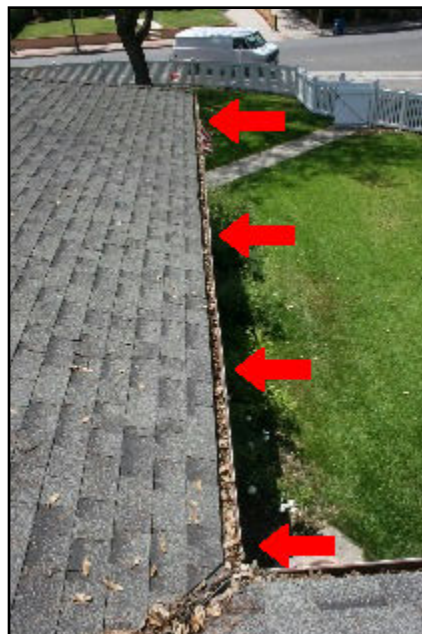
The gutters were full of dirt and debris as well as vegetation. Recommend cleaning.

8. Clogged

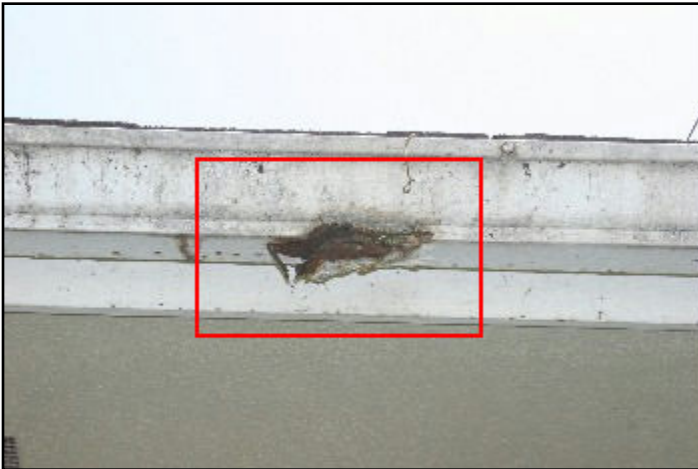
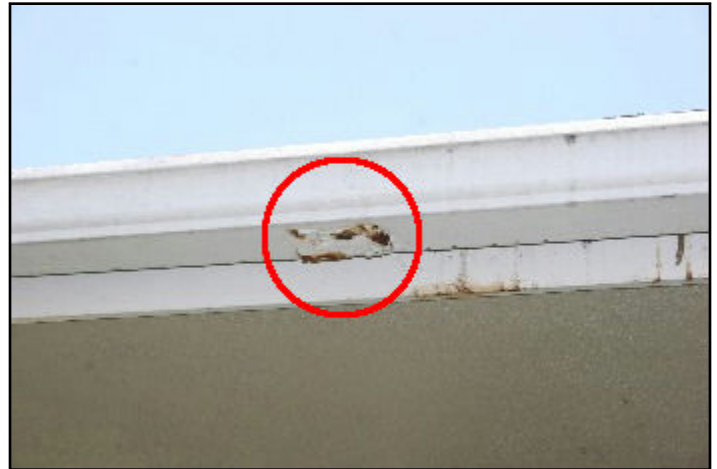
Some sections of gutter were rusted through and need to be replaced.

9. Rust

10. Rust

Task: Replace

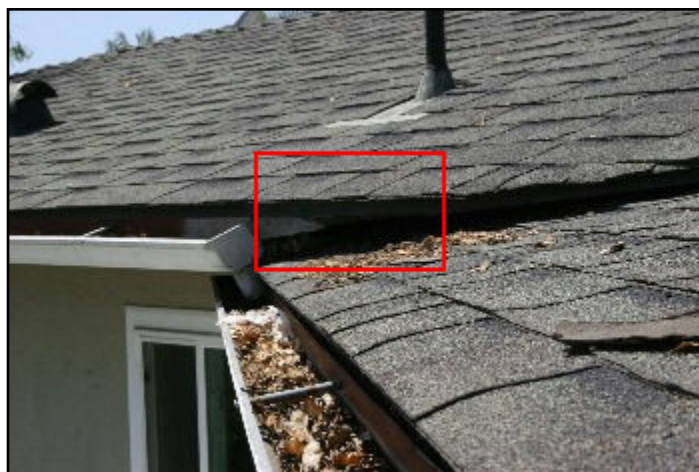
13. Rot or insect damage

Task: Repair

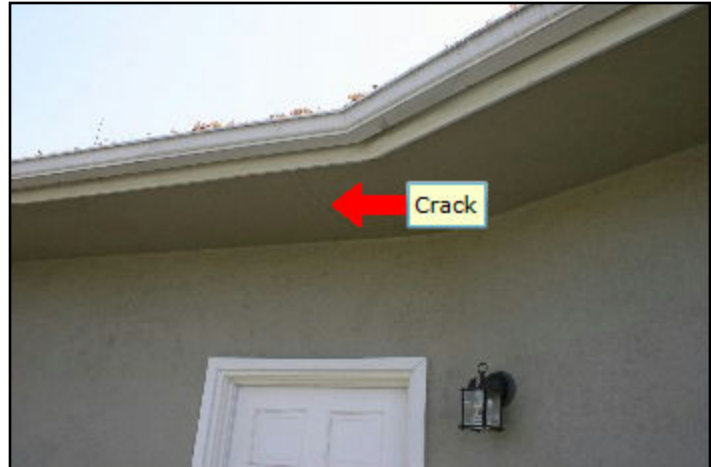
14. Crack

Task: Repair and seal

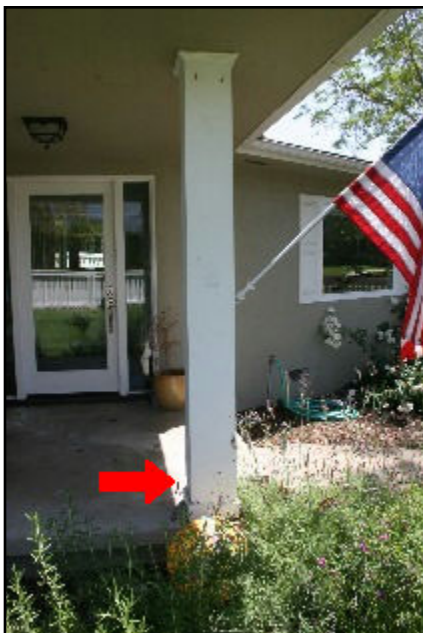
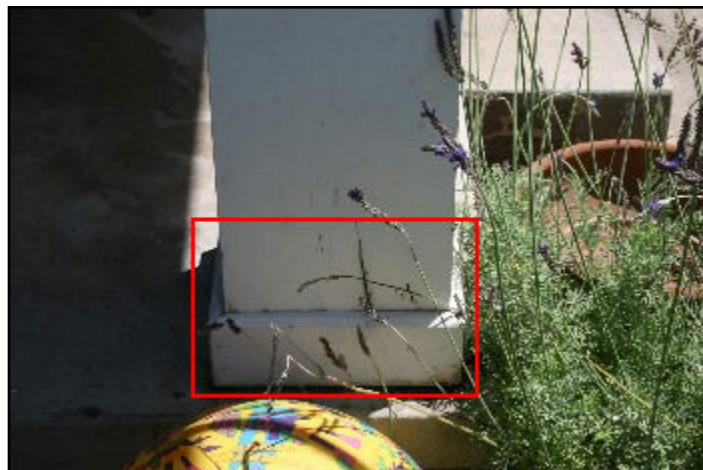
Dry rot or insect damage was observed on the column on the front patio. Recommend pest inspection and repair.

16. Rot or insect damage

17. Rot or insect damage

Task: Pest inspection and repair

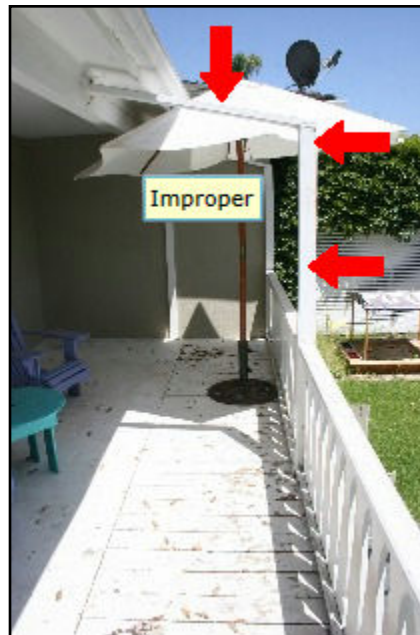
Condition: • **Unconventional or improper construction methods were used to stabilize the back railing.** Recommend replacement by a licensed contractor.

18. Improper

Task: Replace

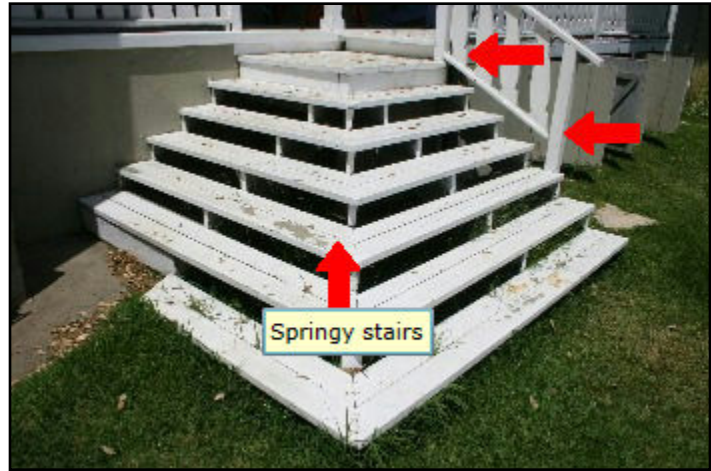
19. Improper

Task: Provide

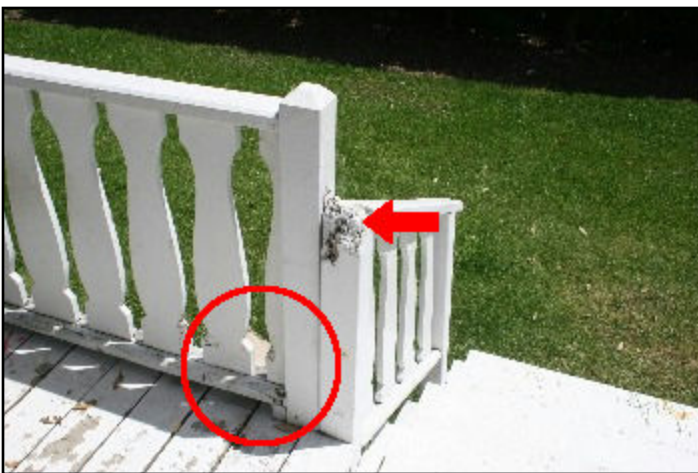
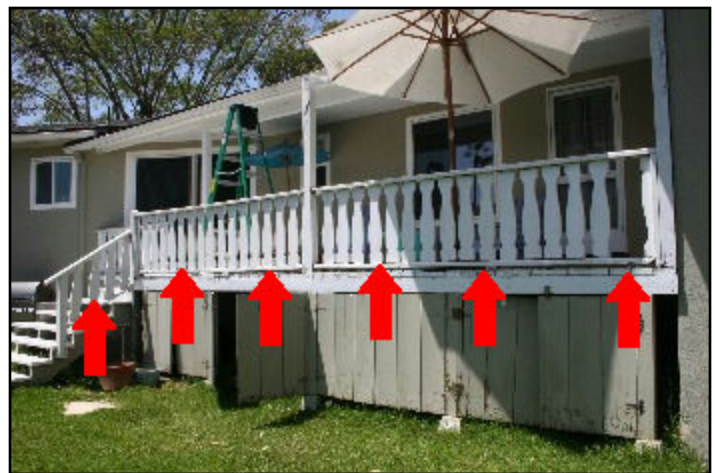
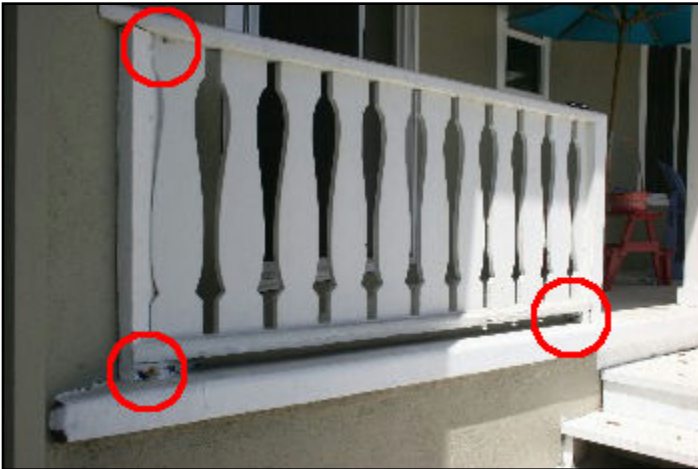
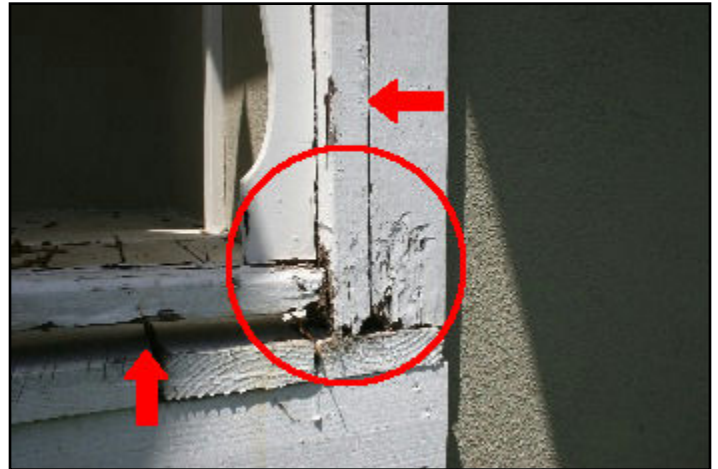
Rot and insect damage was observed throughout the back deck railing. Recommend replacing.

20. Rot or insect damage

21. Rot or insect damage

22. Rot or insect damage

23. Rot or insect damage

Task: Repair or replace

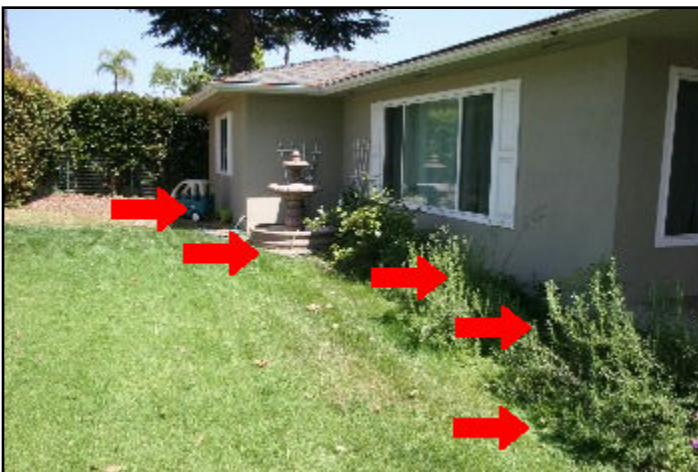
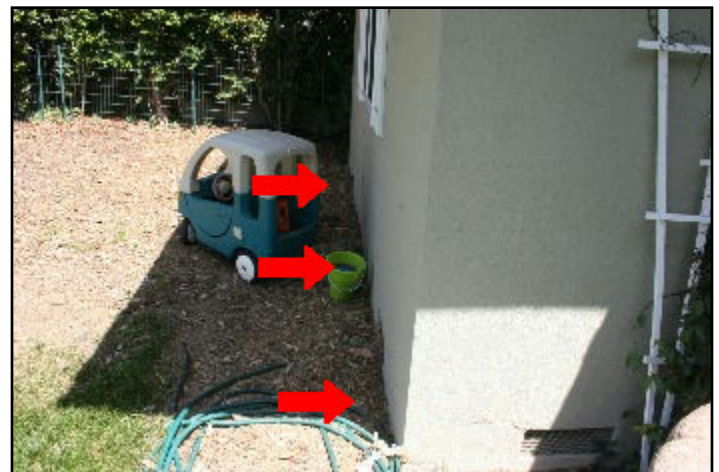
The front of the yard slopes toward the house meaning seasonal run off and/or irrigation may undermine the foundation or cause moisture in the crawl space. Recommend installing catch basins and directing water around perimeter and downhill.

24. Improper slope

25. Improper slope

Task: Provide catch basins and drains

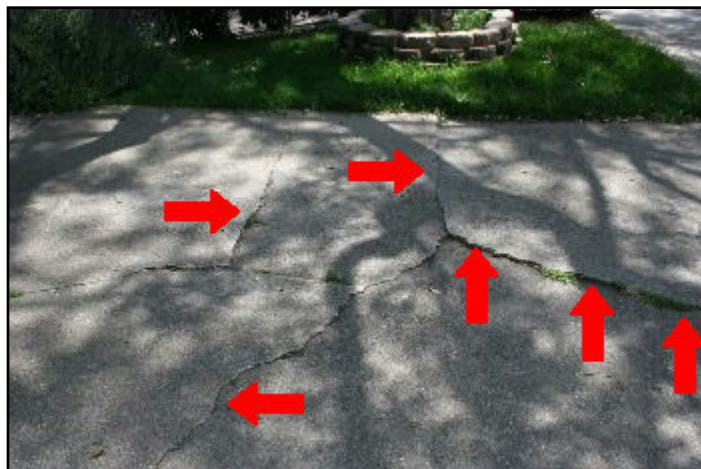
The concrete driveway may have been poured at a time when re-enforcement steel bar was not required. Recommend improving when able.

26. Uneven (trip hazard)

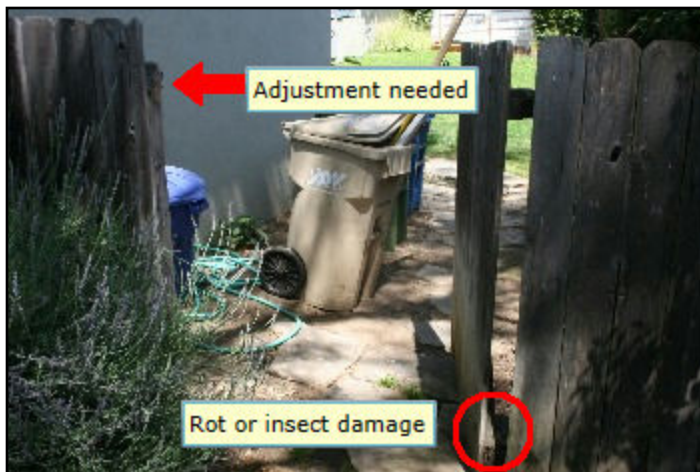
28. Rot or insect damage

Task: Repair as needed

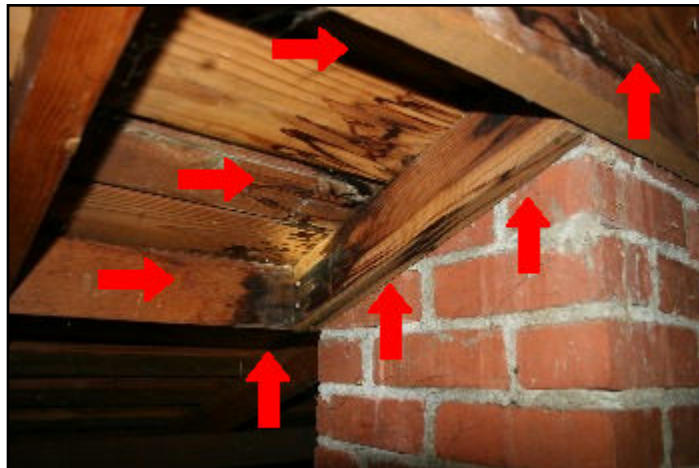
Water stains were noted in the attic around the chimney. Recommend requesting disclosure to see if the issue was resolved prior to the remodel of the interior. Otherwise further evaluation will be required to ensure it is not an active problem.

31. *Water stains*

Task: Request disclosure

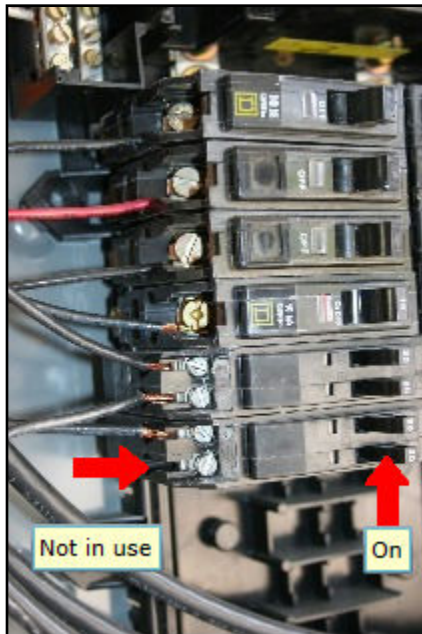
35. Breaker 'On' not in use

Task: Turn off

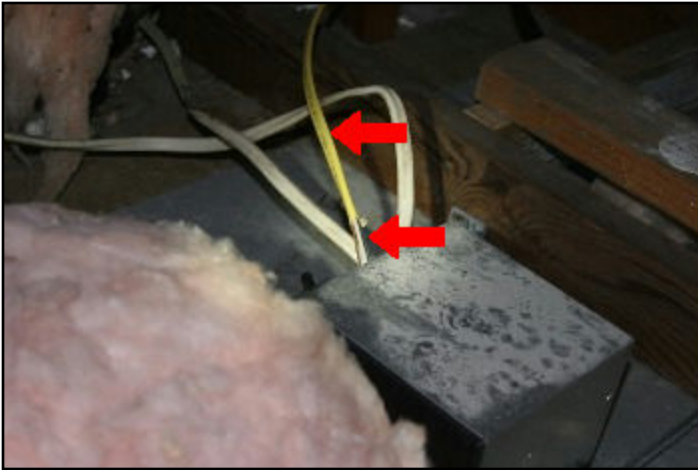
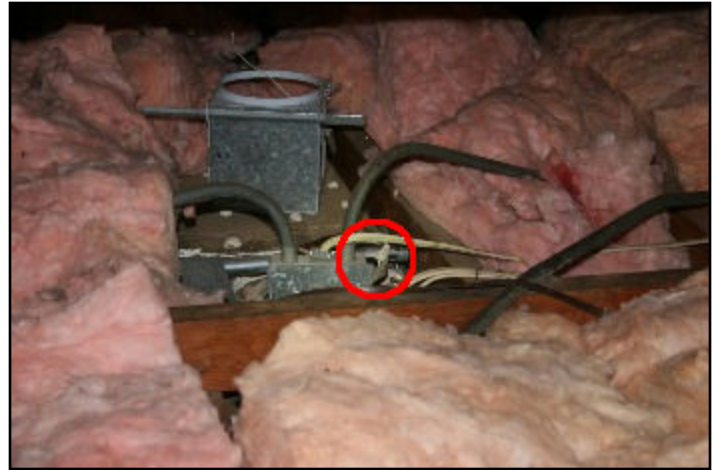
Exposed and improper wiring observed in multiple locations in attic. Risk of fire and electric shock. Recommend repair by a licensed electrician.

36. Exposed in attics

37. Exposed in attics

Task: Repair

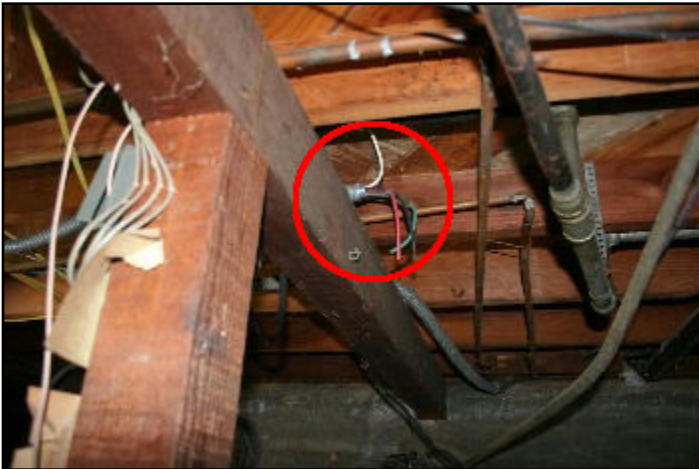
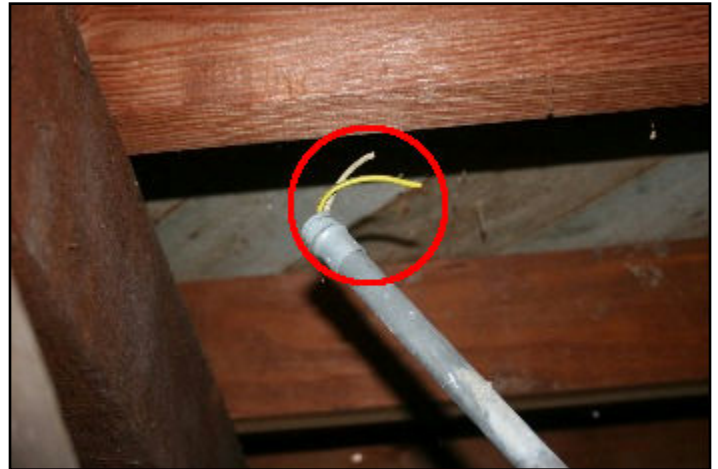
Abandoned electrical wiring was observed in the crawlspace. Recommend further evaluation and repair by a licensed electrician.

39. Abandoned wire

40. Abandoned wire

Task: Further evaluation and repair

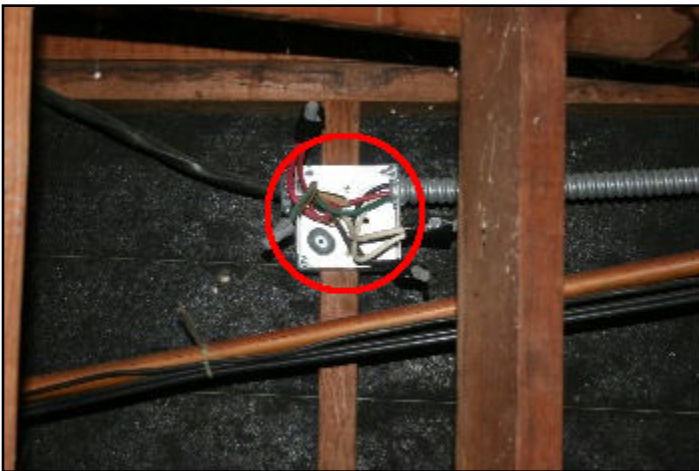
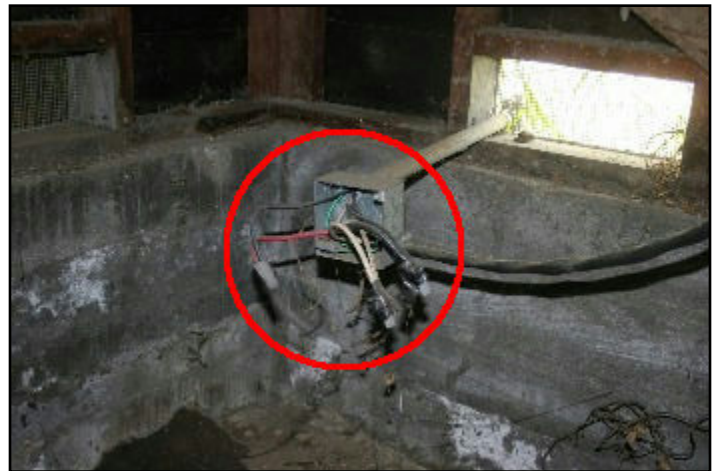
Several junction boxes were observed with missing covers and exposed wiring. Recommend repair by a licensed electrical contractor.

41. Missing, loose

42. Missing, loose

Task: Provide

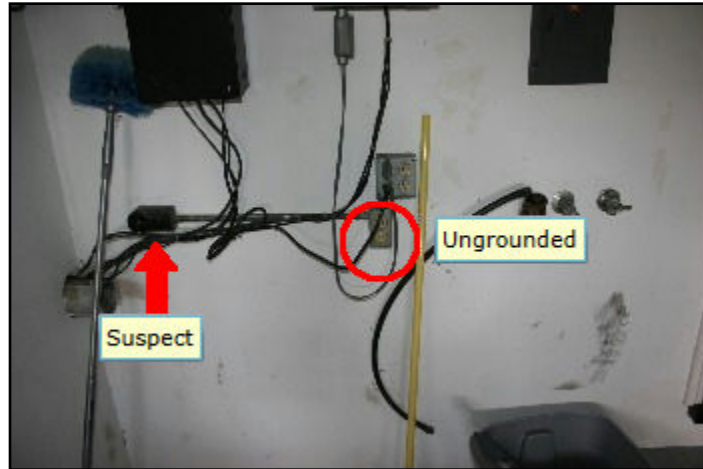
A receptacle at the laundry area in the garage is ungrounded and the connecting dryer receptacle is suspect. Recommend further evaluation by a licensed electrician.

43. Ungrounded

Task: Further evaluation

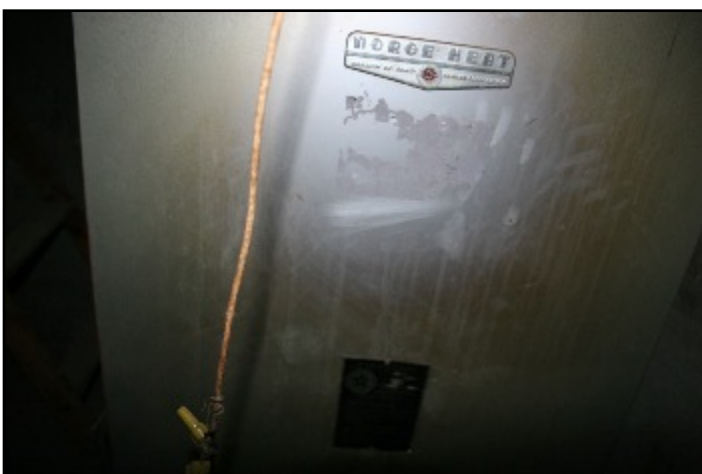
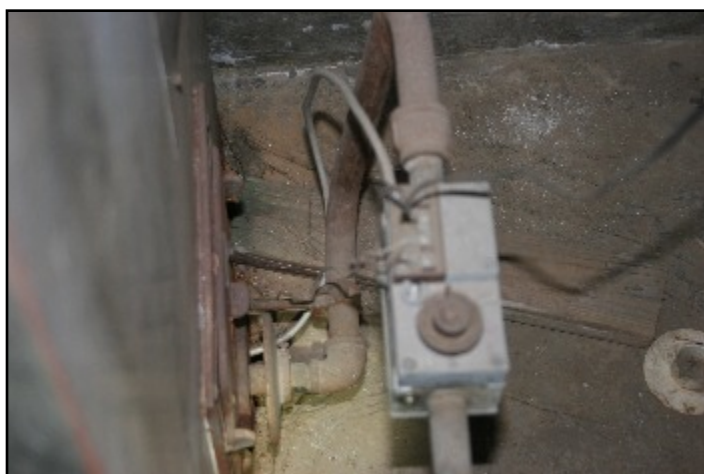
The gravity heater was inoperative at the time of this inspection. Recommend further evaluation by a licensed heating contractor.

47. Inoperative

48. Inoperative

Task: Repair or replace

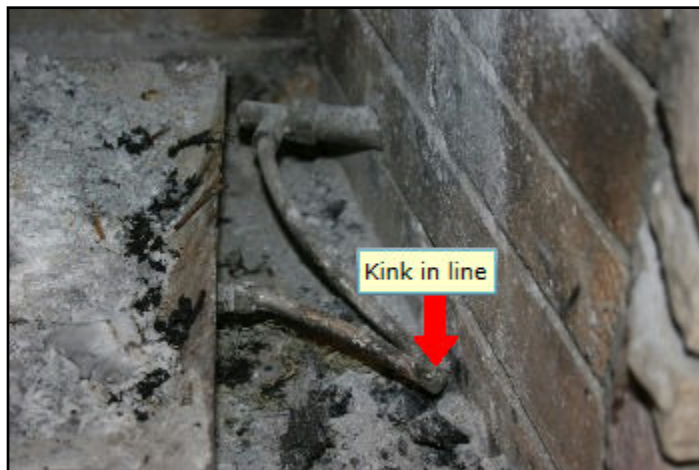
A kink in the gas line was observed in the fireplace. Recommend repair by a licensed professional.

50. Pipe obstructed

Task: Repair or replace

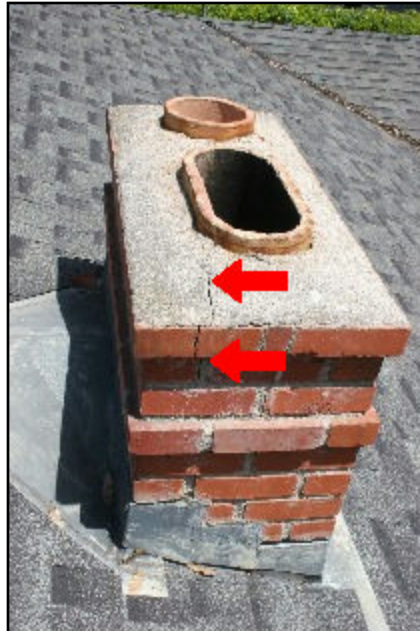
52. Cracked

Task: Repair crack

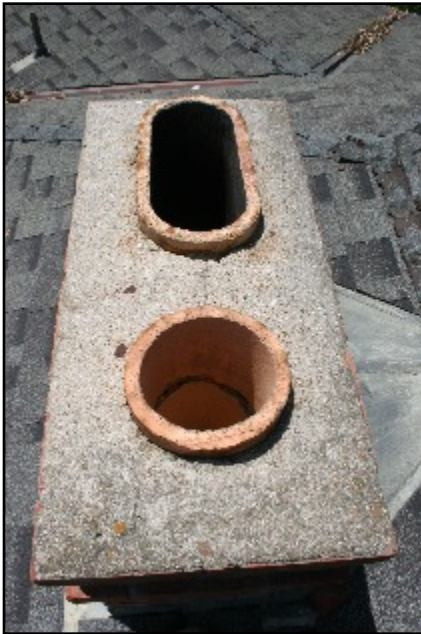
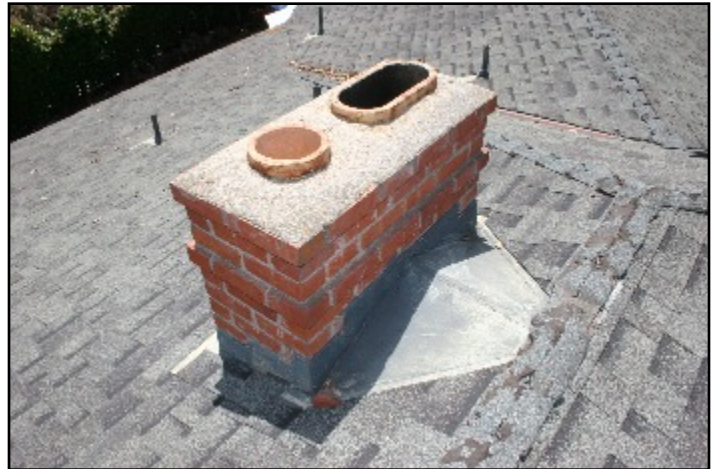
53. Missing

54. Missing

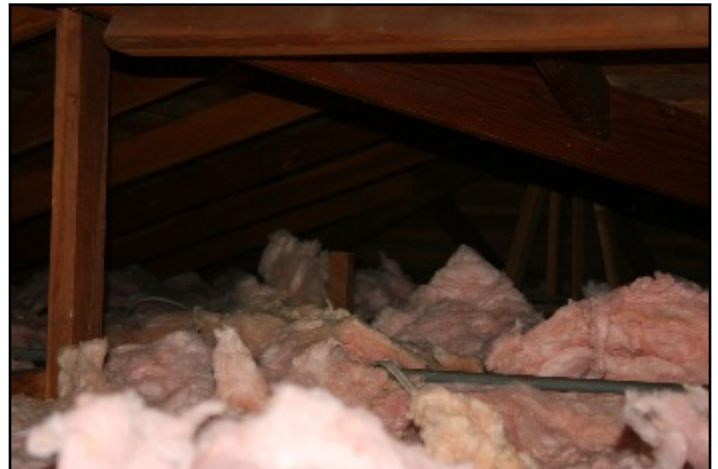
The roof was ventilated by soffit vents which appeared to be obstructed by the mounds of excess insulation in the attic. Recommend removing excess insulation and exposing soffit vents to attain proper air flow. Attic was extremely hot at the time of this inspection.

58. Obstructed

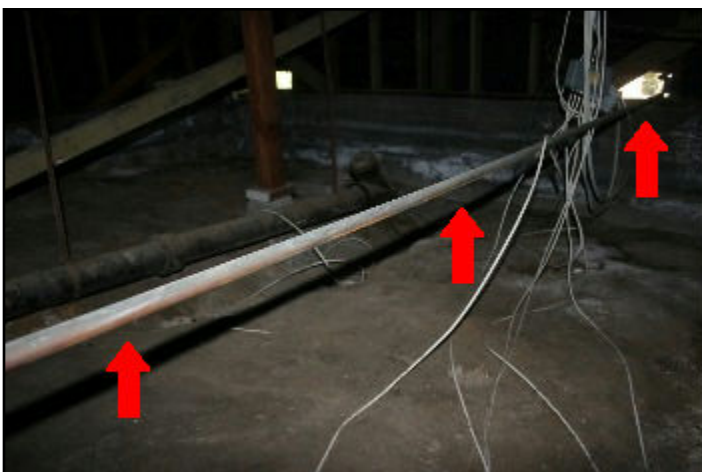
Long runs of unsupported water supply line observed in crawlspace. Recommend repair by a licensed plumber.

64. Poor support

Task: Repair

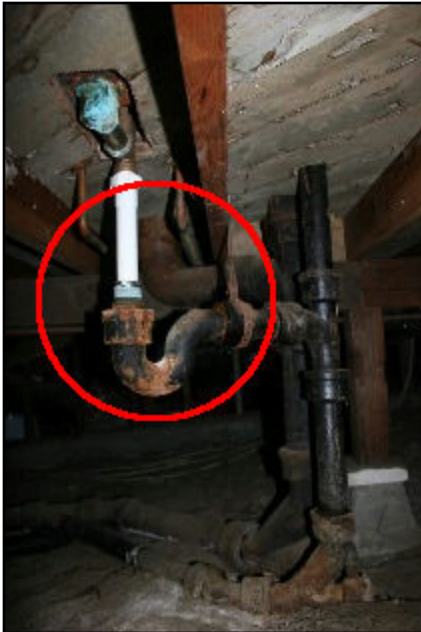
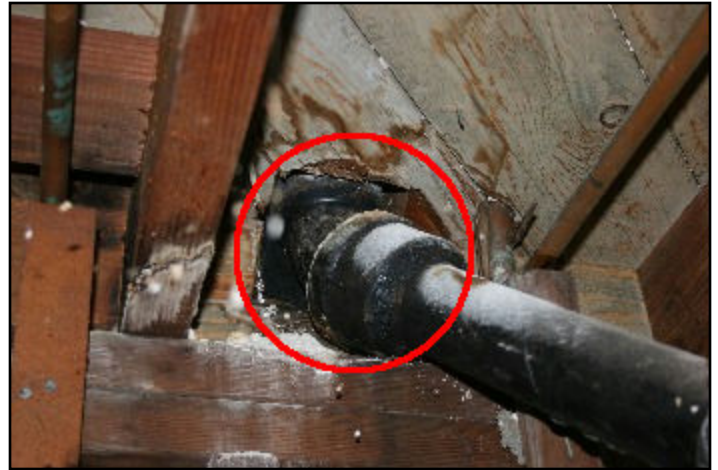
Evidence of leaking and improper drain connections noted. Recommend further evaluation and repair by a licensed plumbing contractor.

66. Leak

67. Leak

Task: Further evaluation and repair

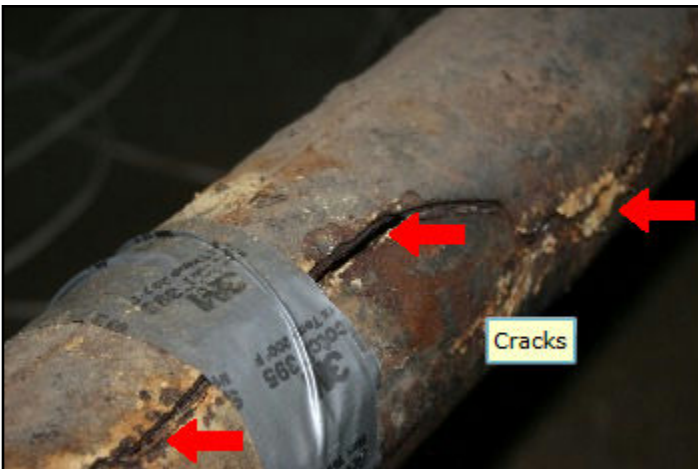
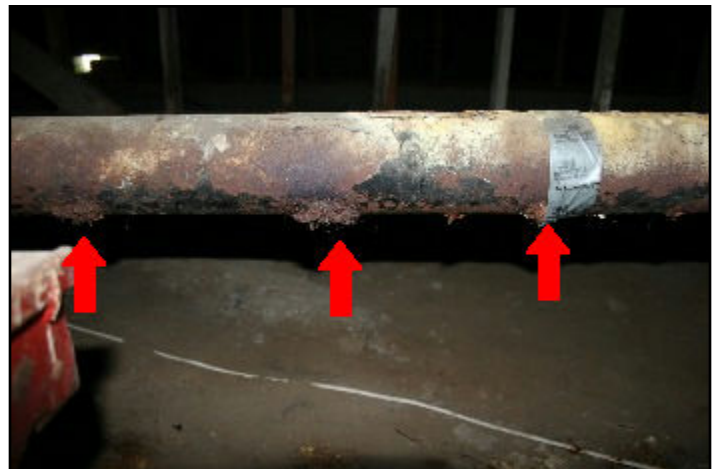
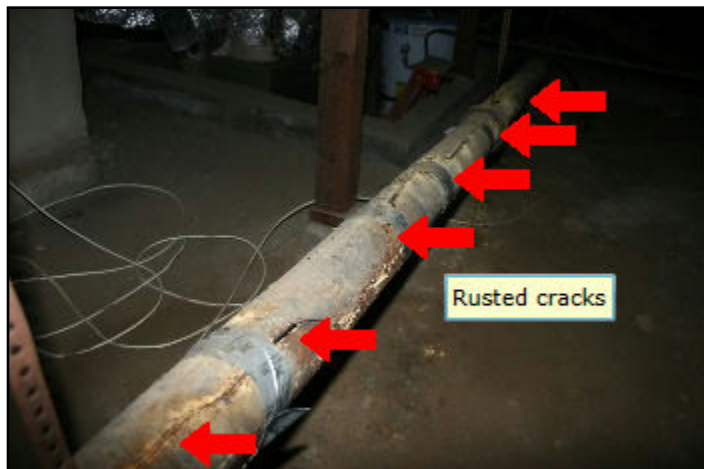
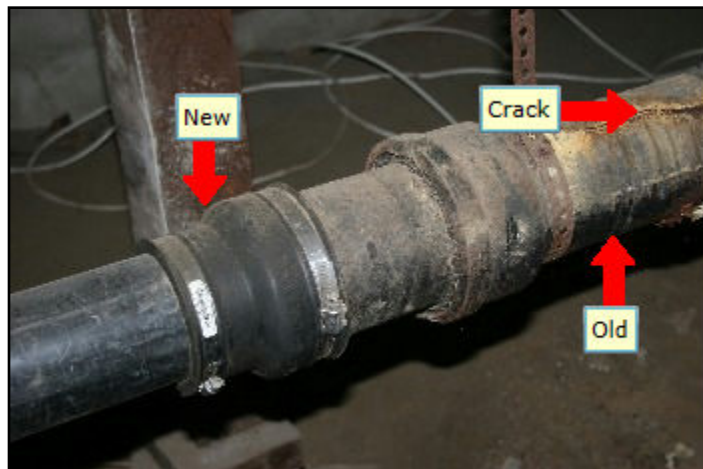
A large portion of the cast iron drains in the crawlspace appeared split, rusted, damaged and oozing. Recommend further evaluation and repair of entire waste system by a licensed plumbing contractor.

68. Split and damaged

69. Split and damaged

70. Split and damaged

71. Split and damaged

Task: Further evaluation and repair

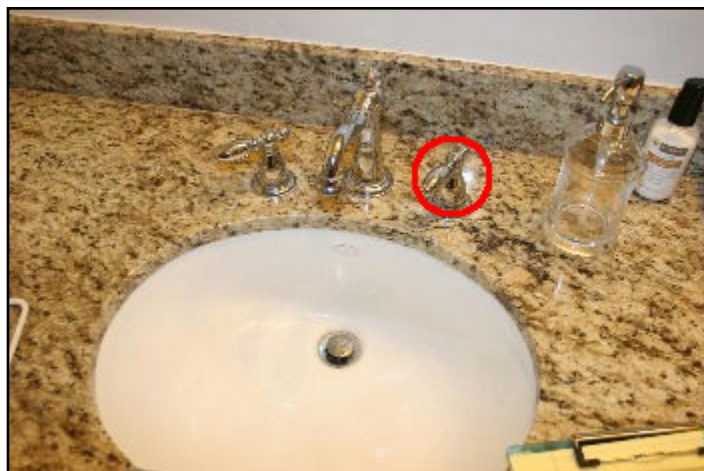
72. Inoperative

Task: Repair

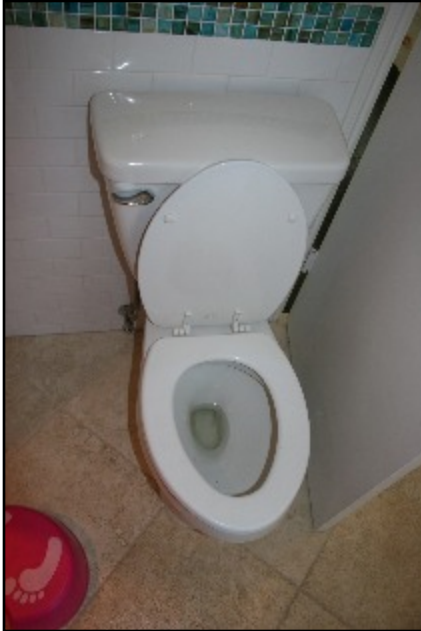
Both toilets exhibited poor flushing mechanics at the time of this inspection. Recommend further evaluation and repair by a licensed plumber.

74. Obstructed or weak flush

Task: Repair or replace

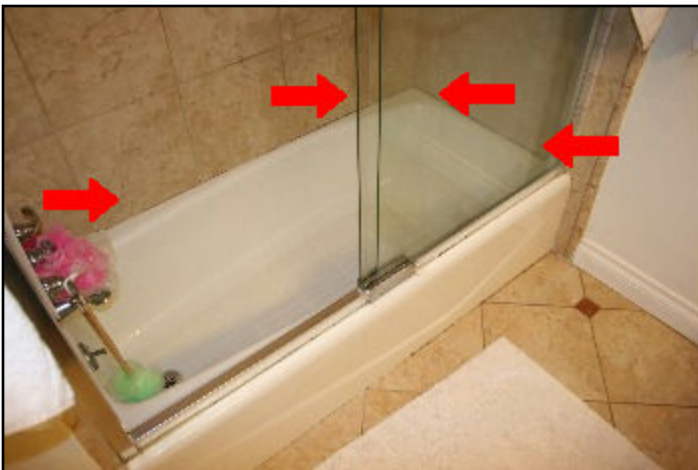
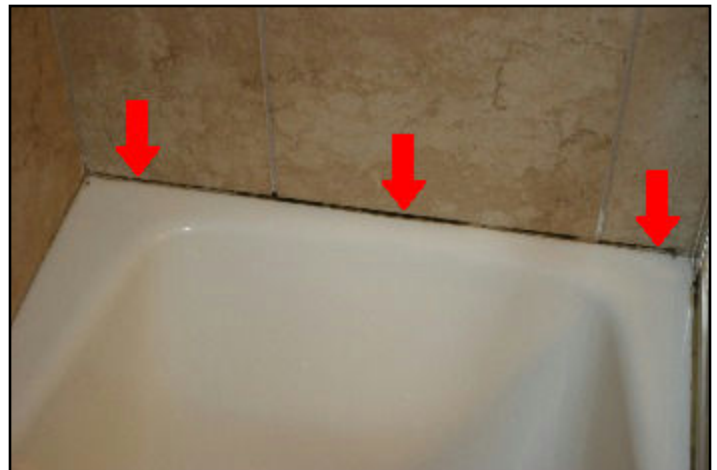
76. Caulking loose, missing or deteriorated

77. Caulking loose, missing or deteriorated

Task: Repair

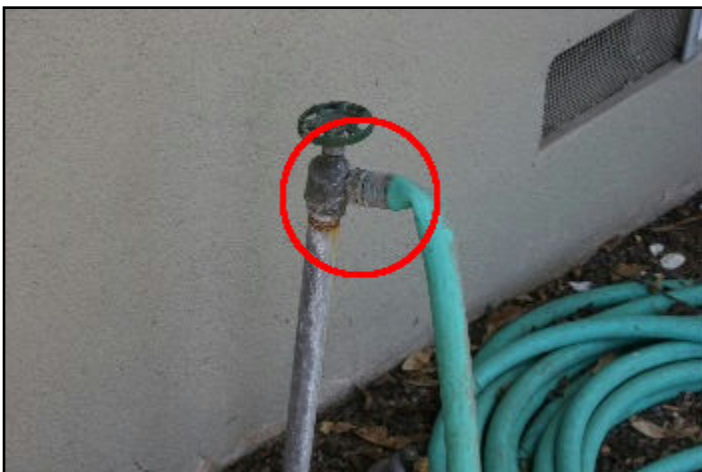
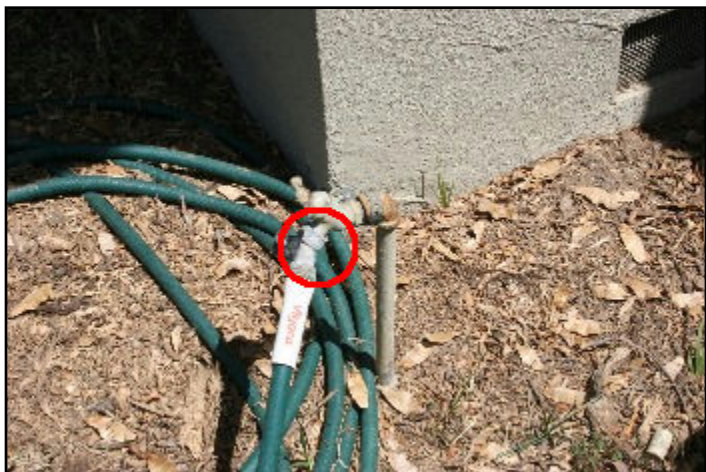
78. Backflow prevention missing

79. Backflow prevention missing

Task: Provide

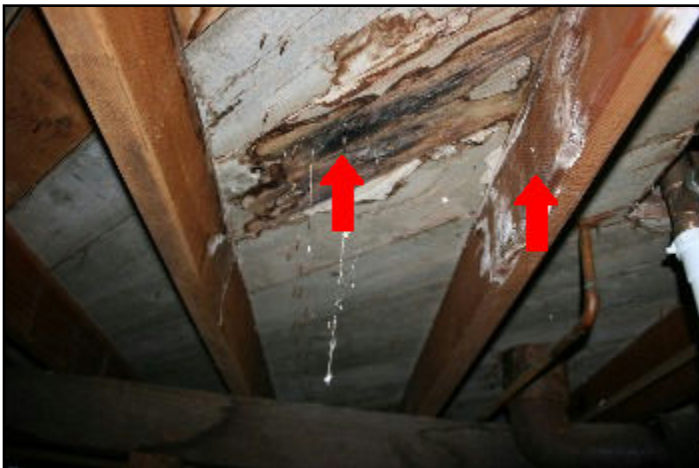
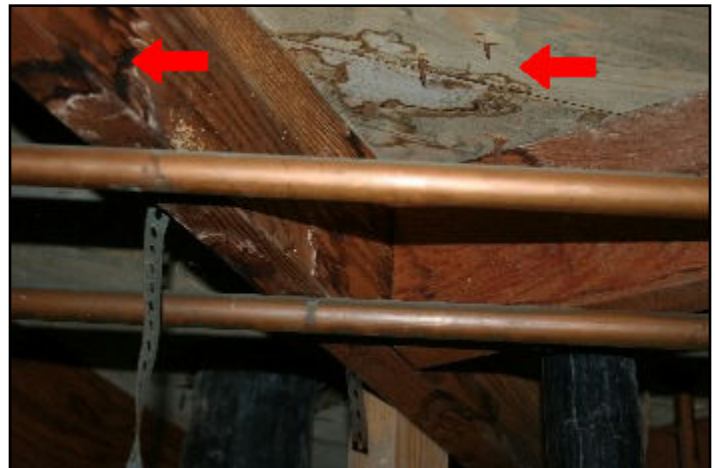
Signs of moisture damage including rot were observed on the subfloor in the bathroom areas. Recommend requesting disclosure to determine if damage is from an old or existing issue.

80. Rot

81. Rot

Task: Request disclosure and repair

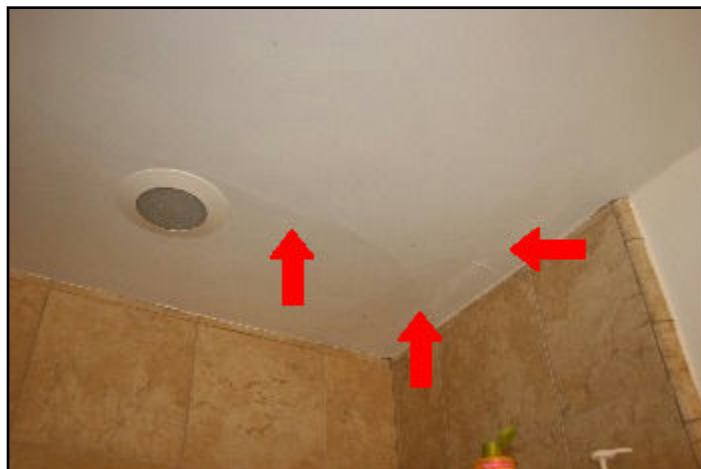
The walls throughout the home were covered in thin cracks from what appears to be the settling of a thin plaster top coat.

82. Cracked

Task: Repair as necessary

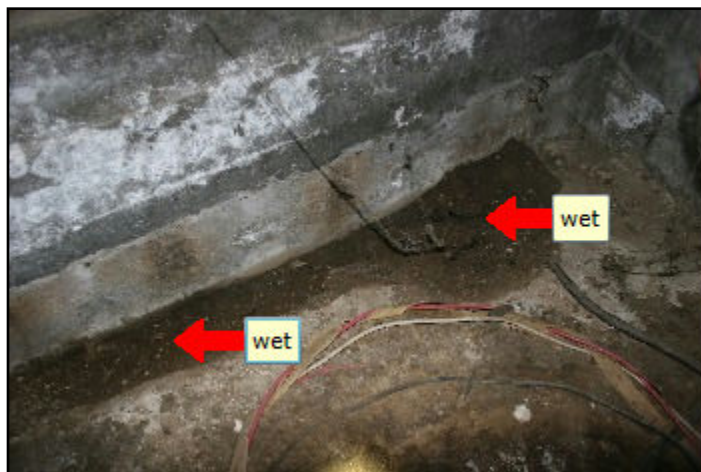
Moisture was observed along the east wall in the crawlspace. Recommend regrading east exterior away from home to control moisture intrusion. Seek assistance from a licensed drainage contractor.

83. Dampness on floor or walls

Task: Regrade exterior of east wall

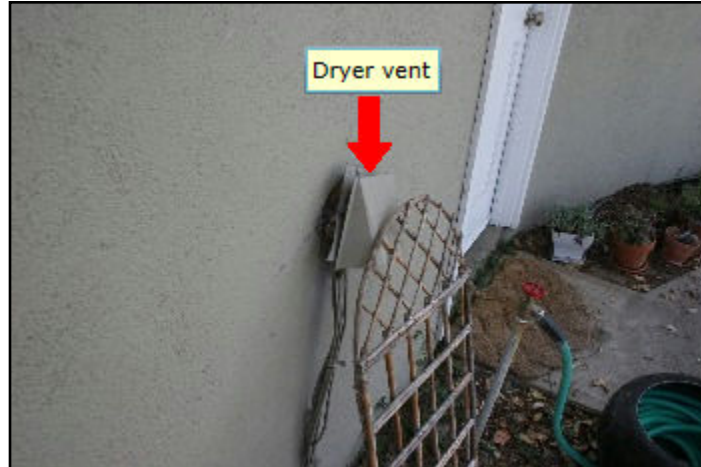
89. *Damaged*

Task: Repair

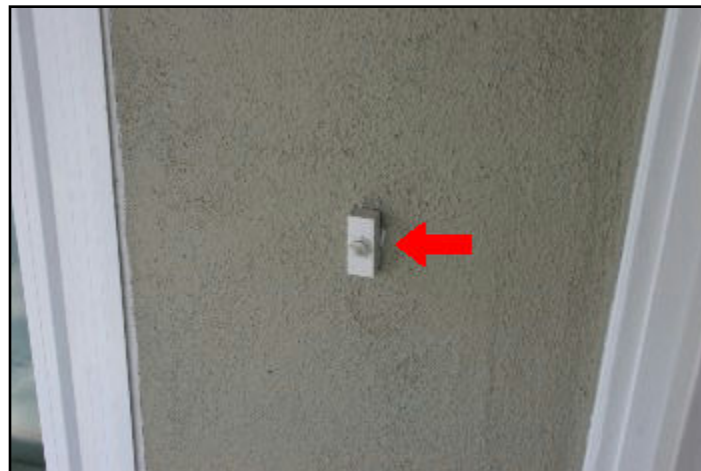
90. *Inoperative*

Task: Repair or replace
