YOUR INSPECTION REPORT

5025 Sungate Ranch Rd
Santa Barbara, CA 93111

Wednesday, July 17, 2013

Report No. 1078, v.0

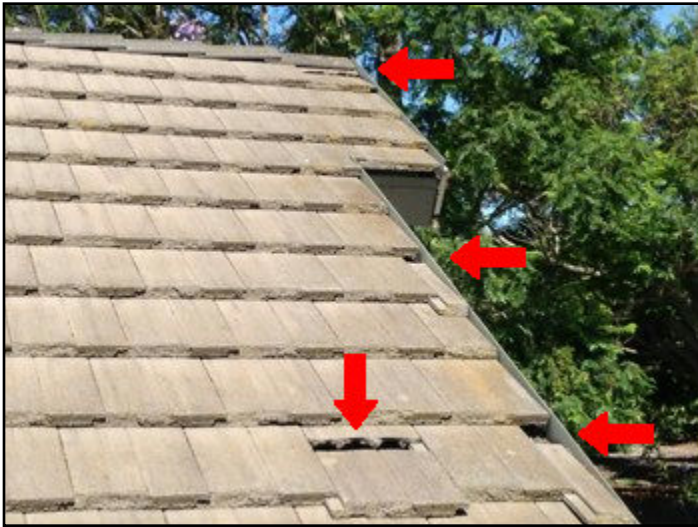
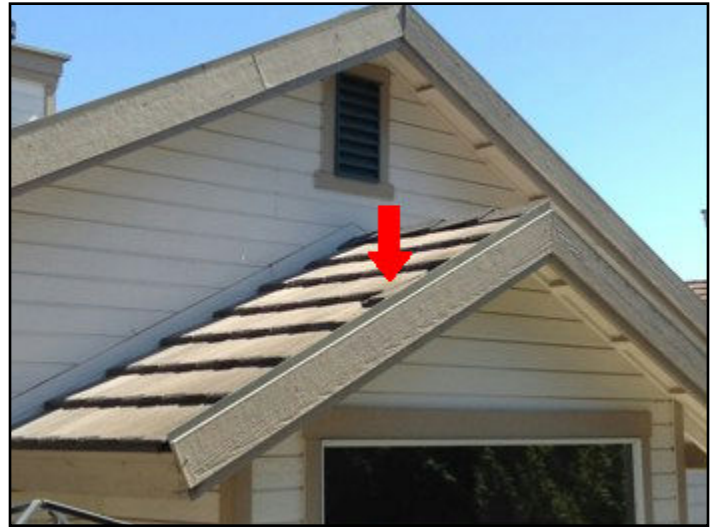
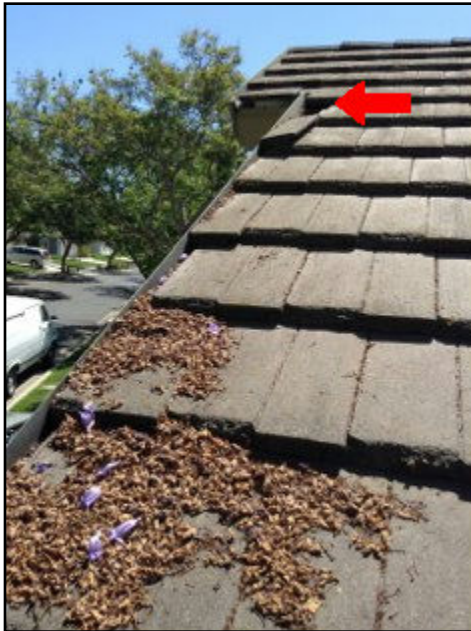
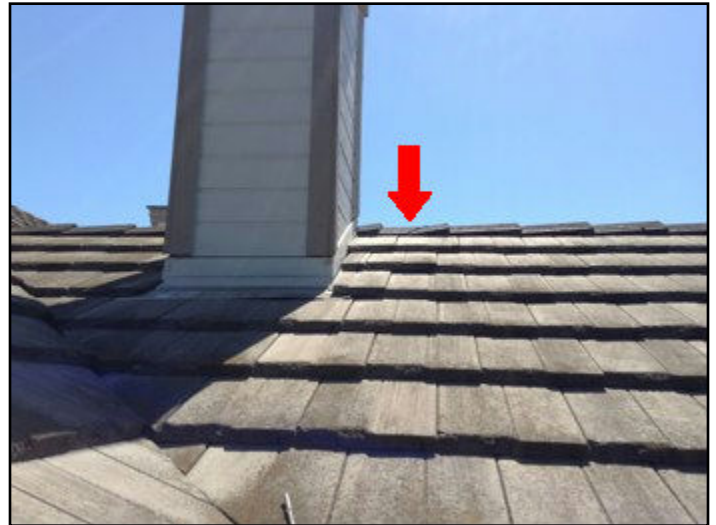
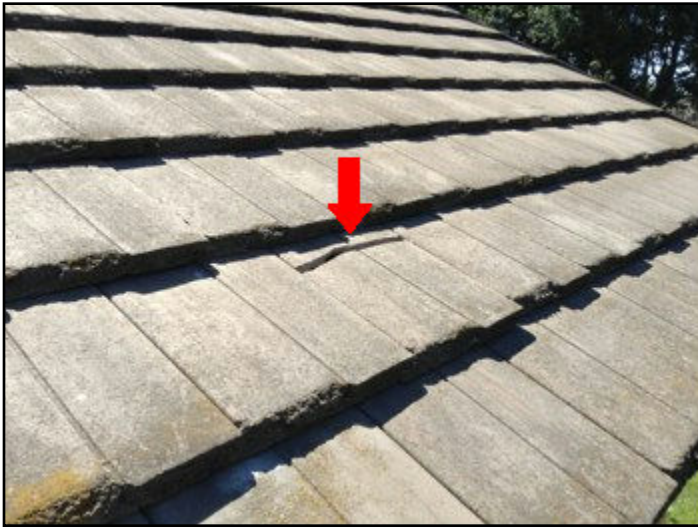
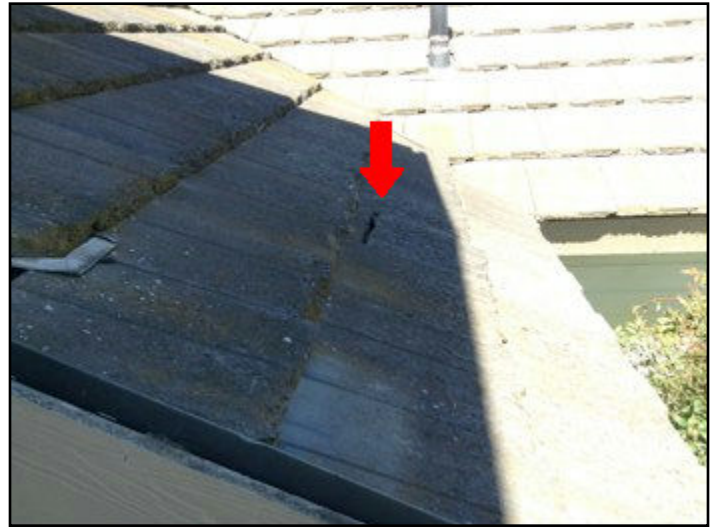
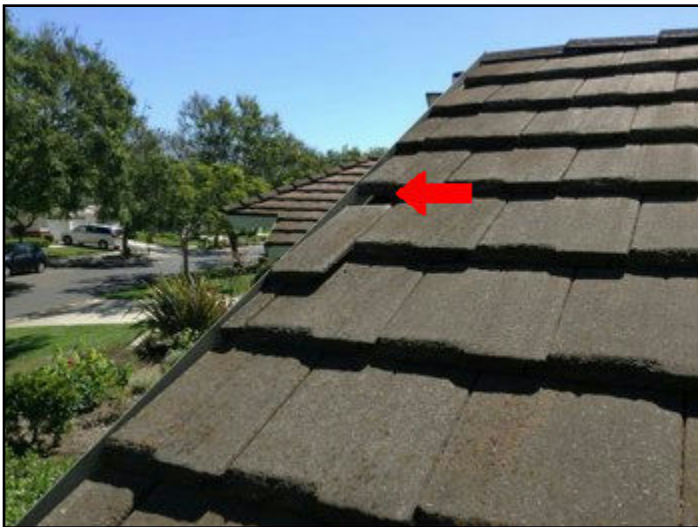
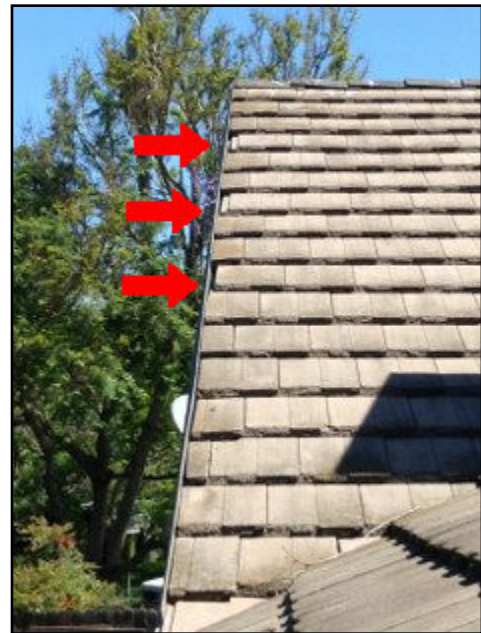
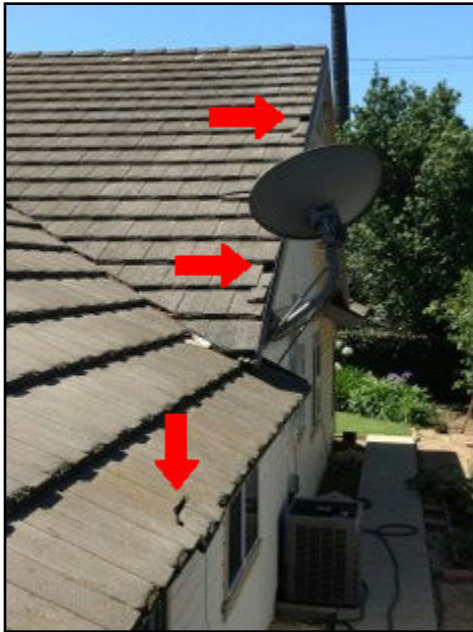
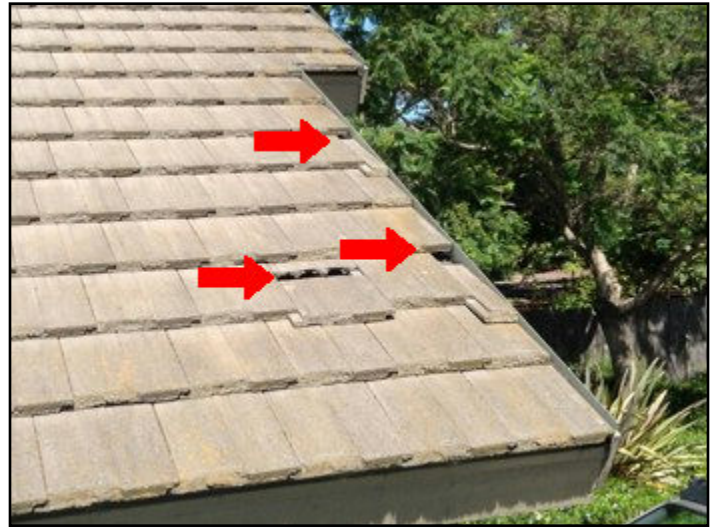
1. **Condition:** • [Missing, loose or broken pieces](#)

2. Missing, loose or broken pieces

Task: Repair or replace

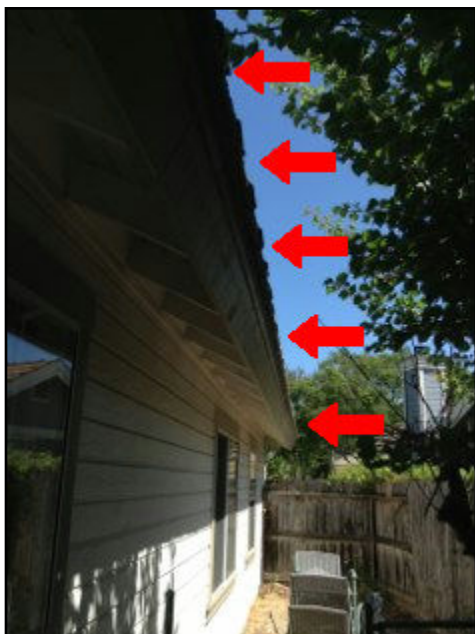
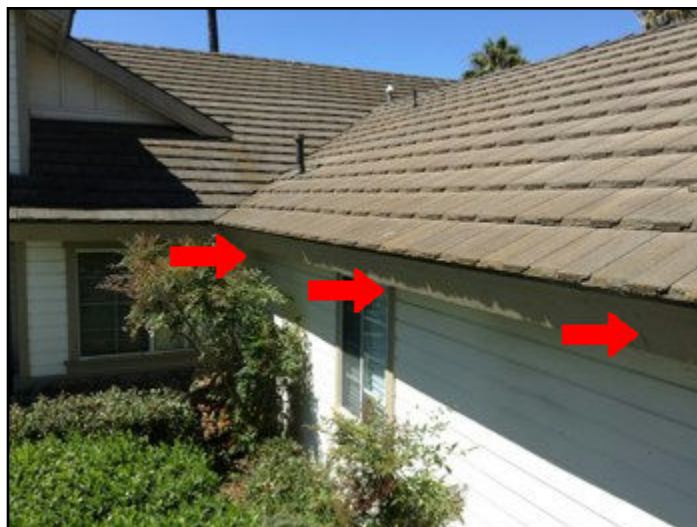
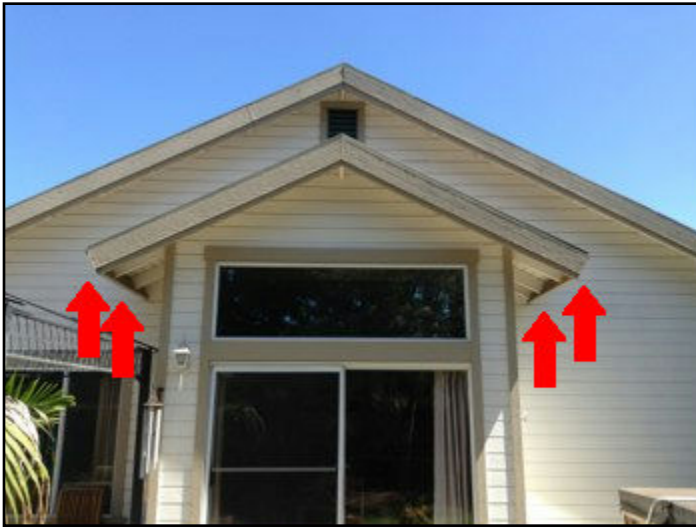
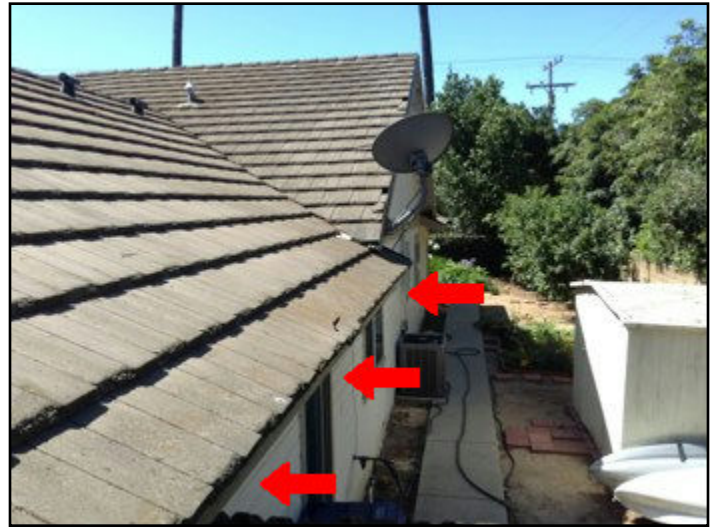
2. Condition: • [Missing](#)

There are gutters and downspouts in two areas of the home but many areas are without.

Task: Provide

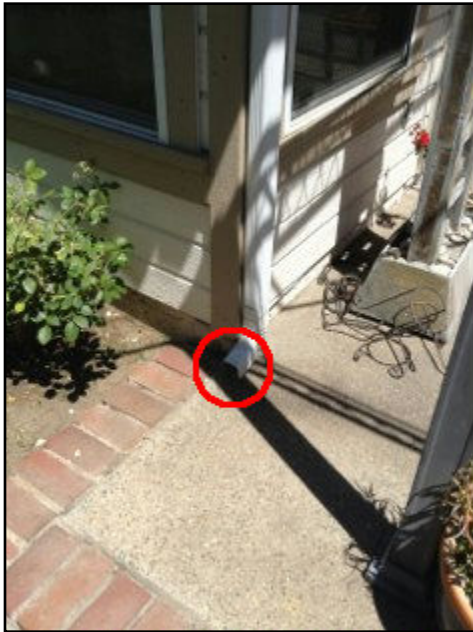
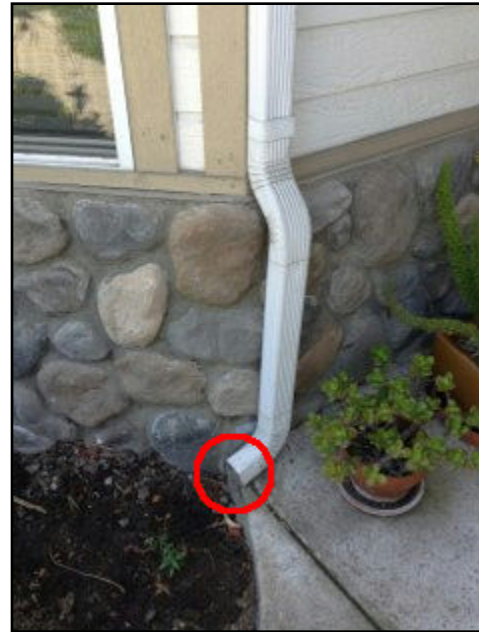
3. Condition: • [Downspouts end too close to building](#)

The downspouts were observed discharging too close to the structure. Recommend elongating end of downspout to direct run-off further away from structure.

Task: Extend as needed

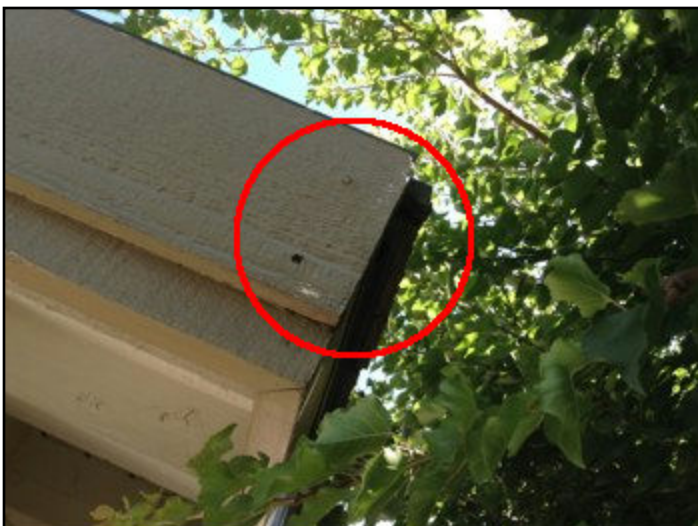
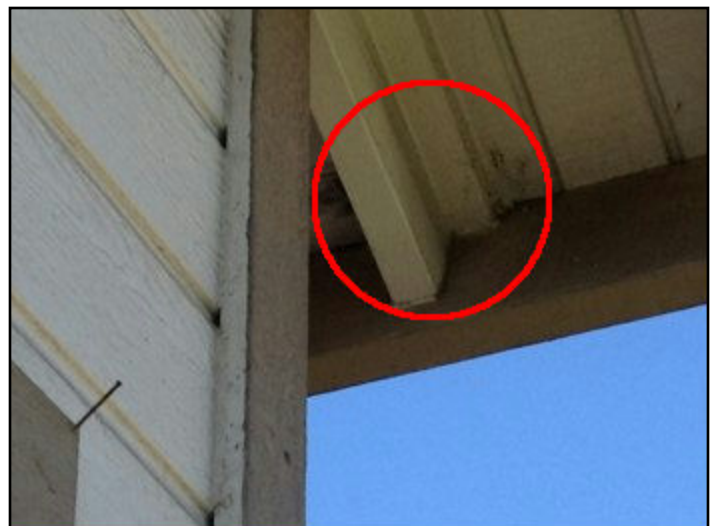
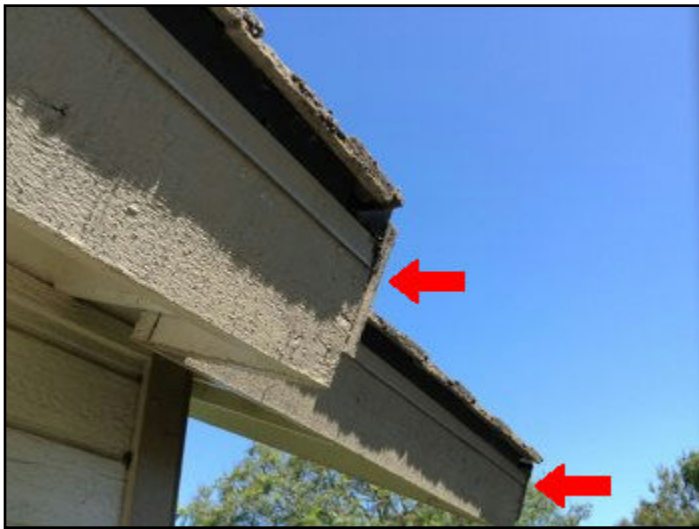
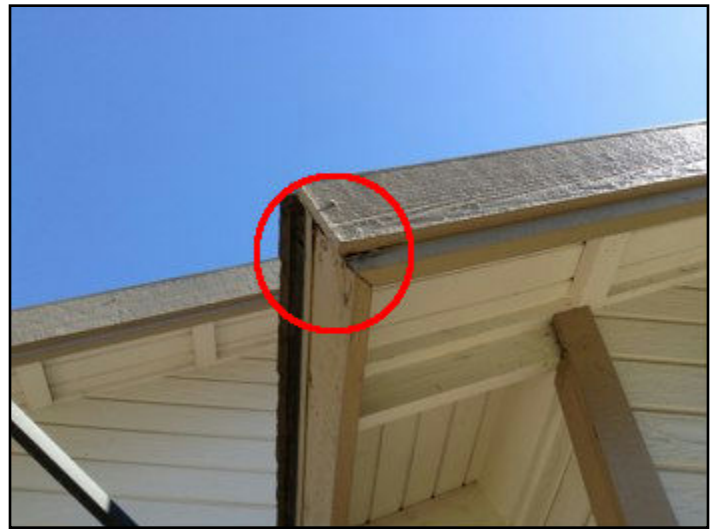
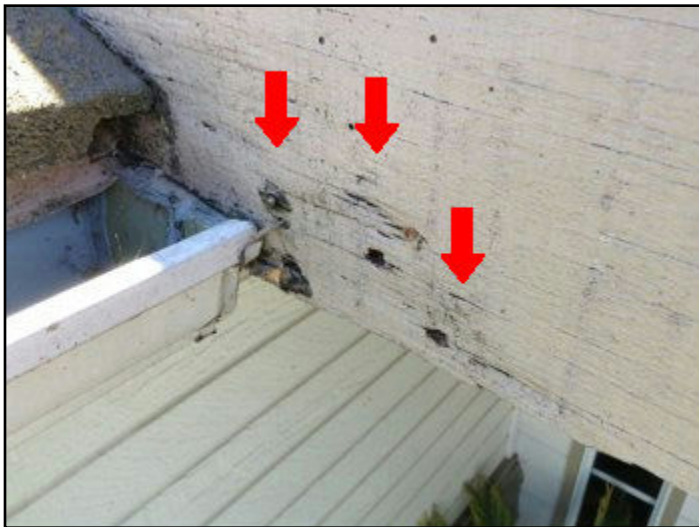
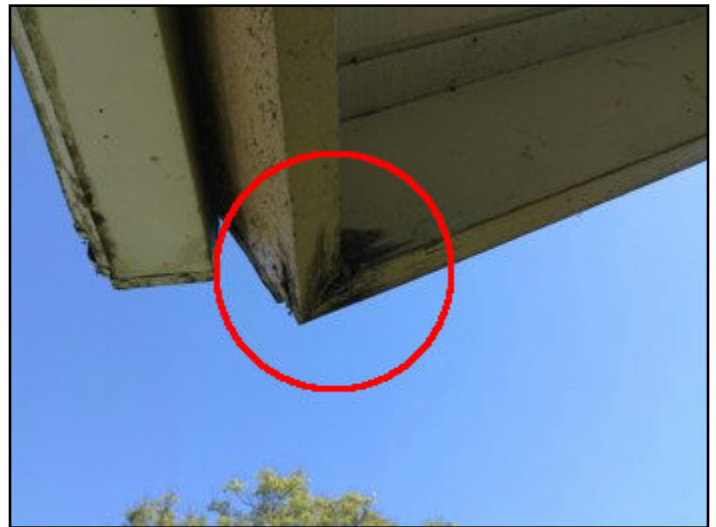
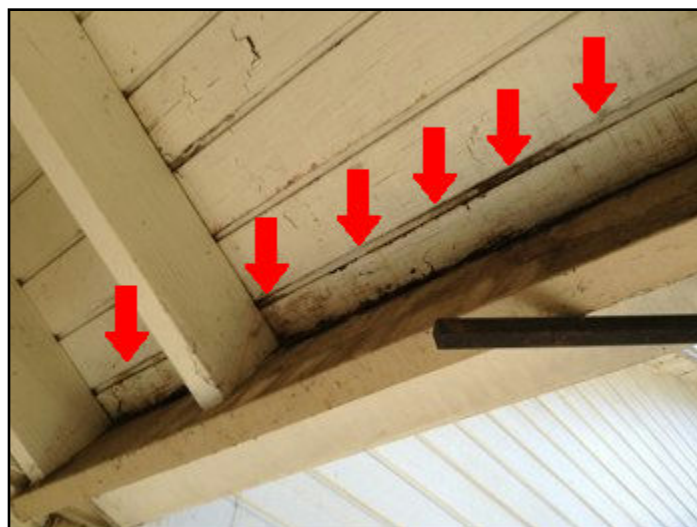
4. Condition: • [Rot or insect damage](#)

Several areas of dry rot and insect damage were observed on various parts of the fascia and soffit. Recommend pest inspection and repairing as needed.

Task: Pest inspection and repair

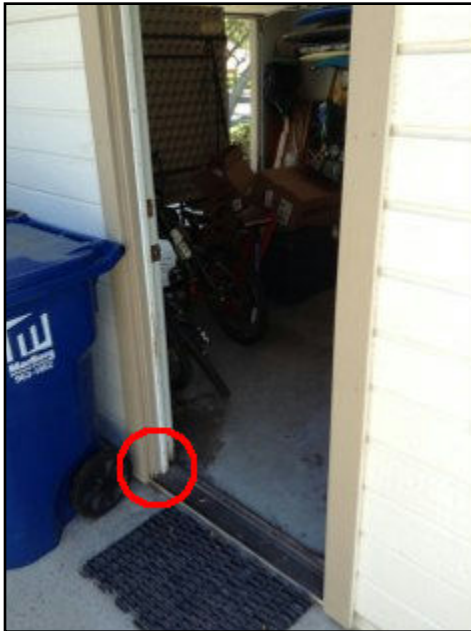
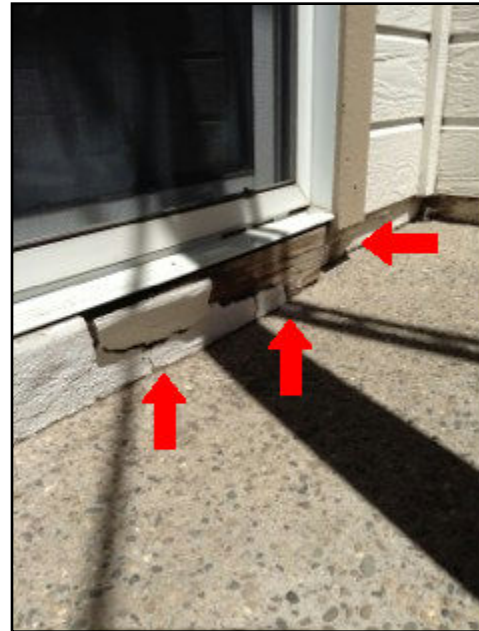
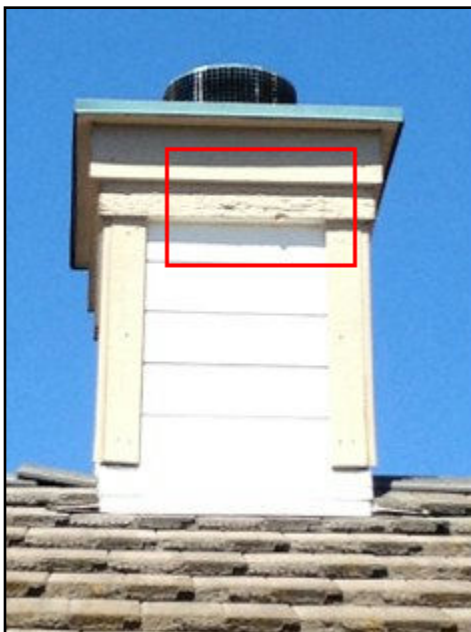
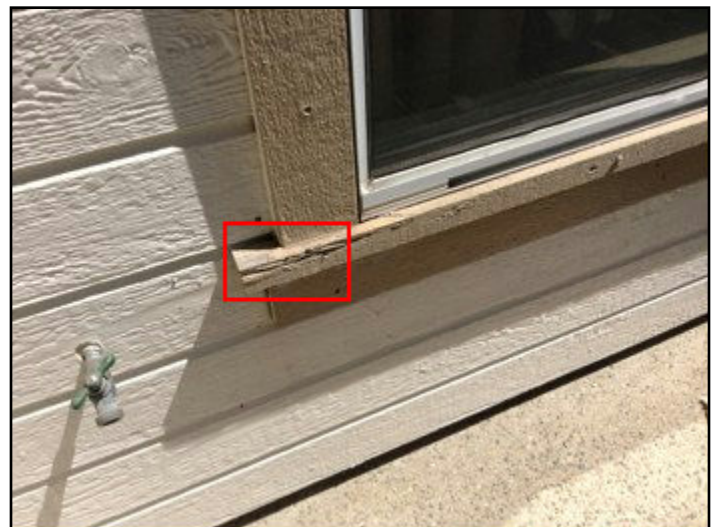
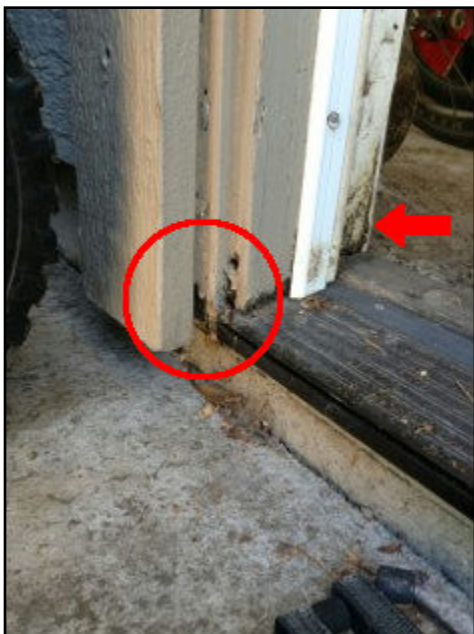
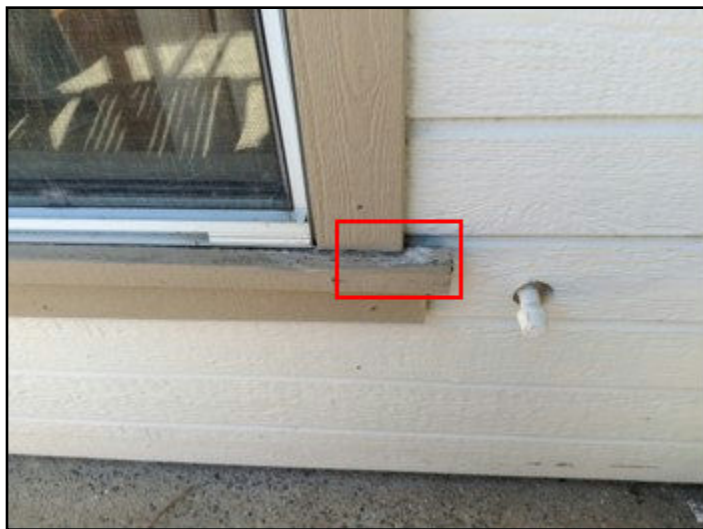
5. Condition: • [Rot or insect damage](#)

Task: Pest inspection and repair

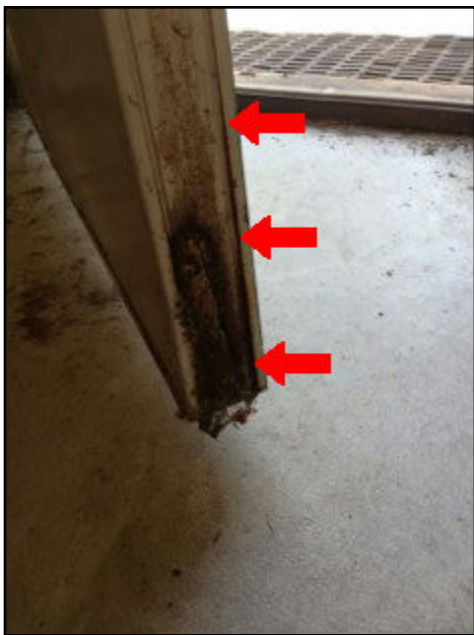
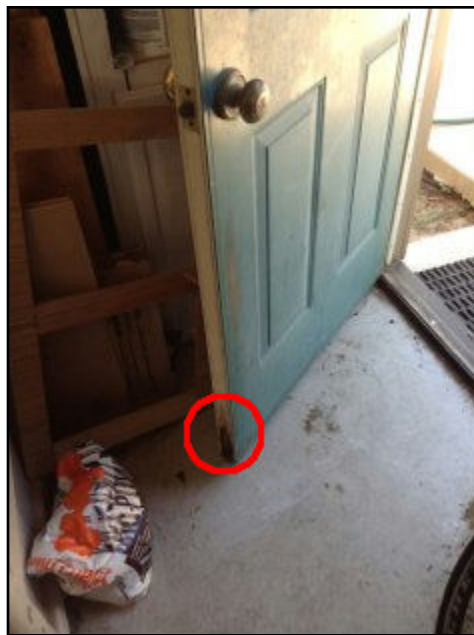
6. Condition: • [Rot or insect damage](#)

Task: Repair or replace

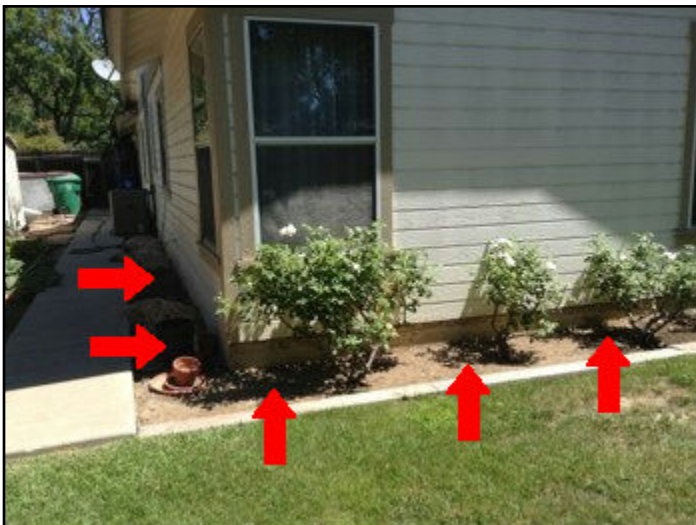
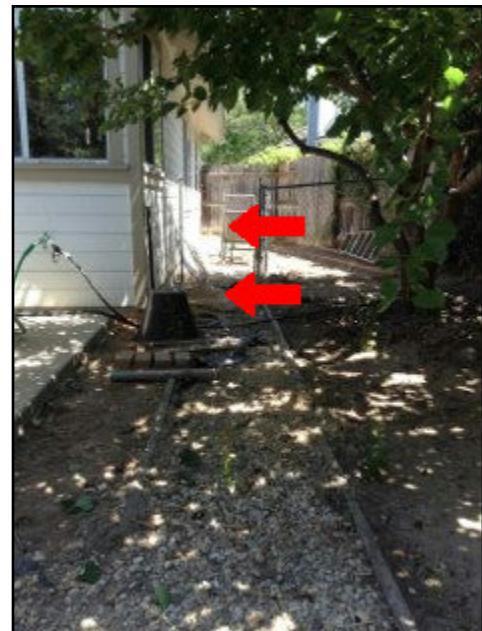
7. Condition: • [Improper slope](#)

Although the walkways are properly sloped away from the home, the planter areas on the west and south and the open area on the east are not. This is putting the foundation at risk of seasonal undermining from run off.

Task: Regrade and install drains

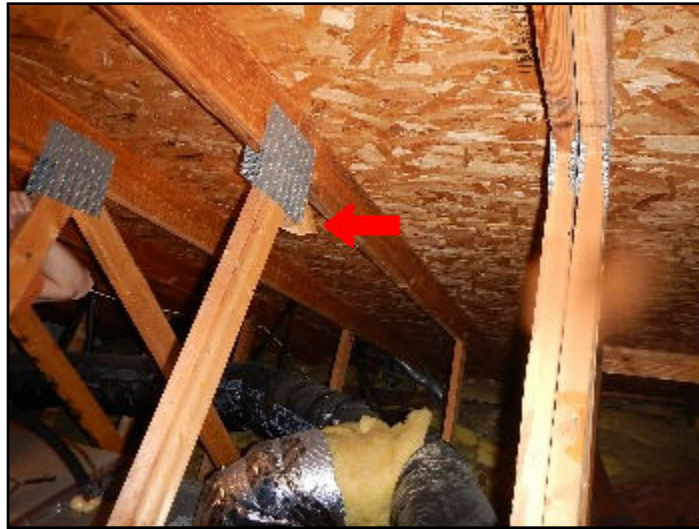
9. Condition: • [Mechanical damage](#)

A truss was cut to make room for the furnace. Recommend reinforcing the rafter portion of the truss with a sister 2x6 to spread the load to the other braces.

36. Mechanical damage

Task: Repair

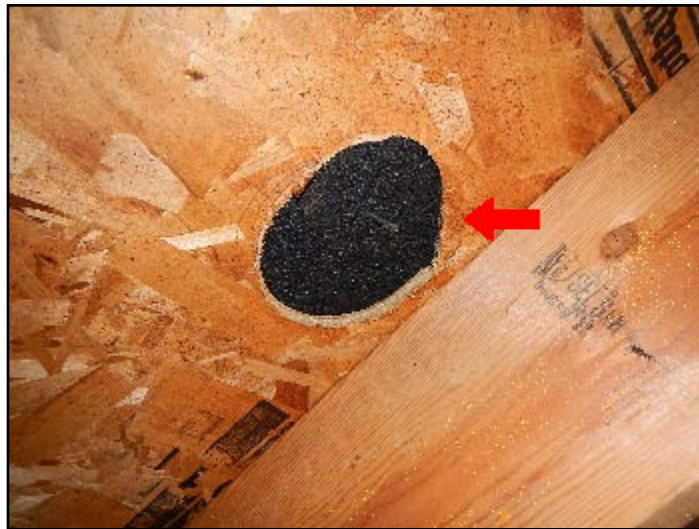
10. Condition: • A hole in the sheathing was noted and should be patched to prevent moisture intrusion.

37. Hole in sheathing

Task: Repair

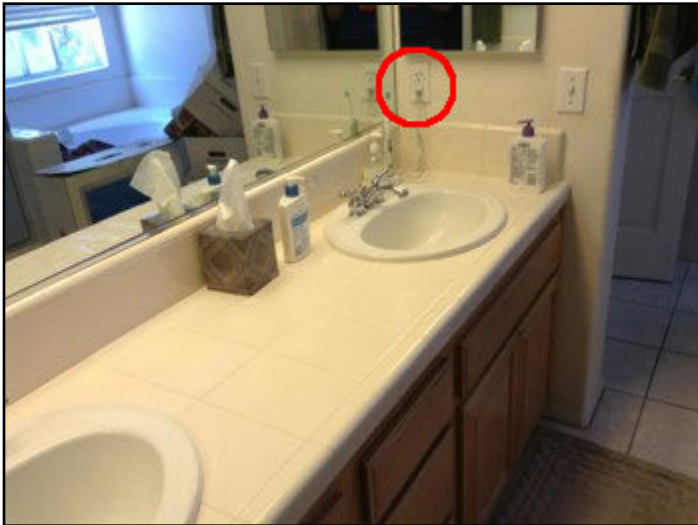
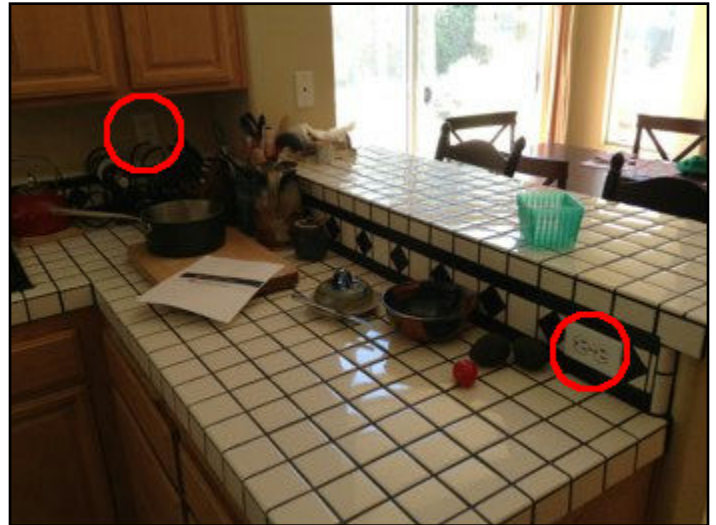
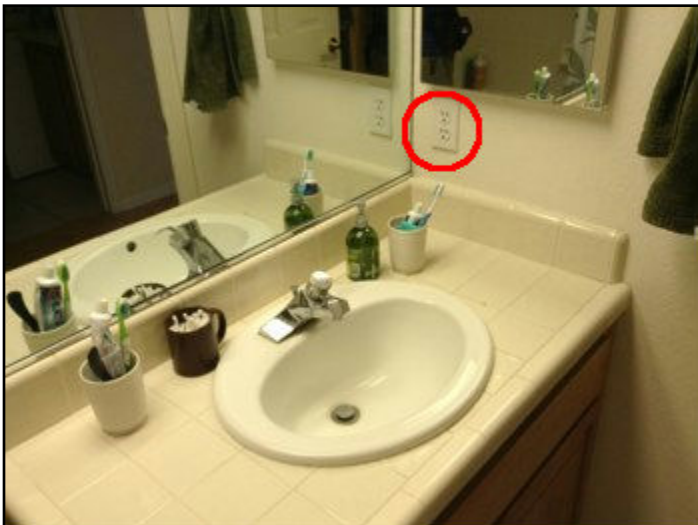
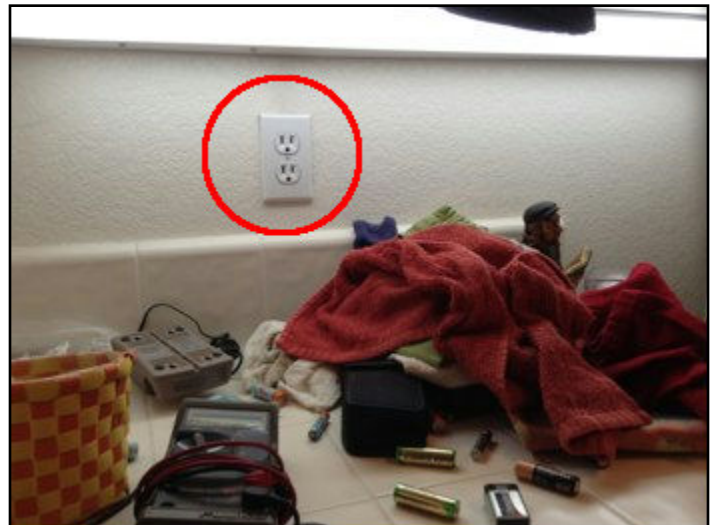
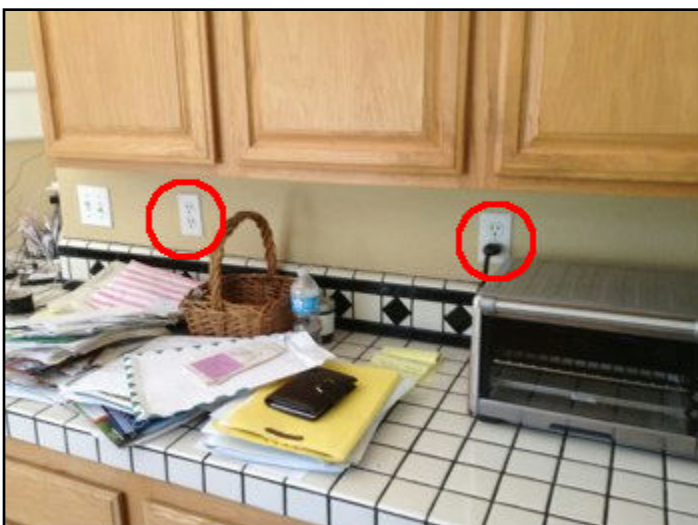
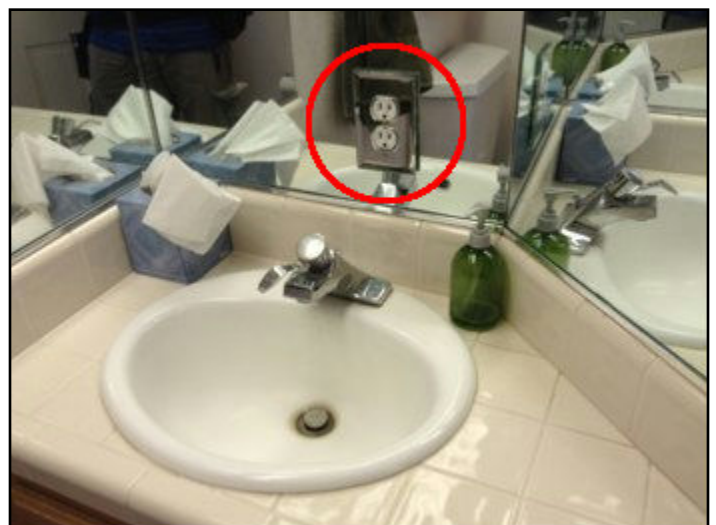
11. Condition: • [Ground Fault Interrupter \(GFI\) needed](#)

GFCI receptacles are required by the US National Electrical Code in locations where water and electricity are likely to come into contact, such as in kitchens, bathrooms, garages, and outdoors. Some areas had the required receptacles while others did not. Recommend having a licensed electrician install and replace GFCI receptacles as needed.

Task: Provide as needed

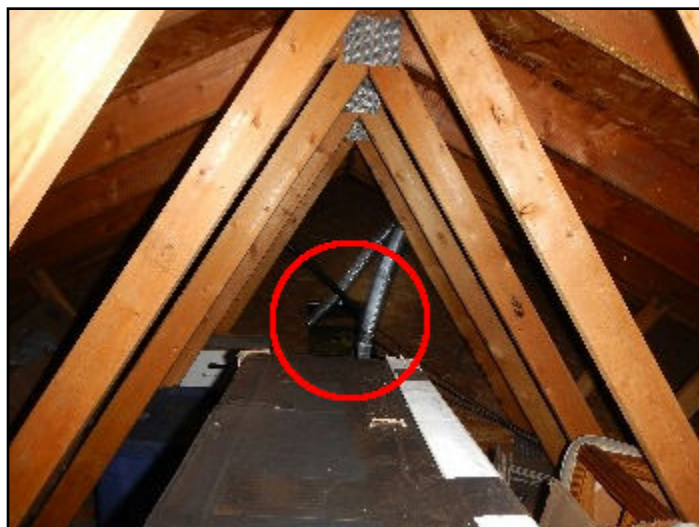
14. Condition: • [Penetrated](#)

56. Penetrated

Task: Repair

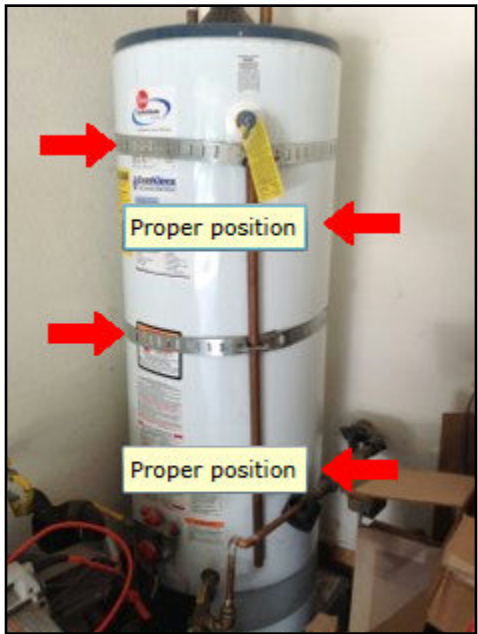
15. Condition: • Seismic Bracing Incorrect

61. Seismic Bracing Incorrect

Task: Correct

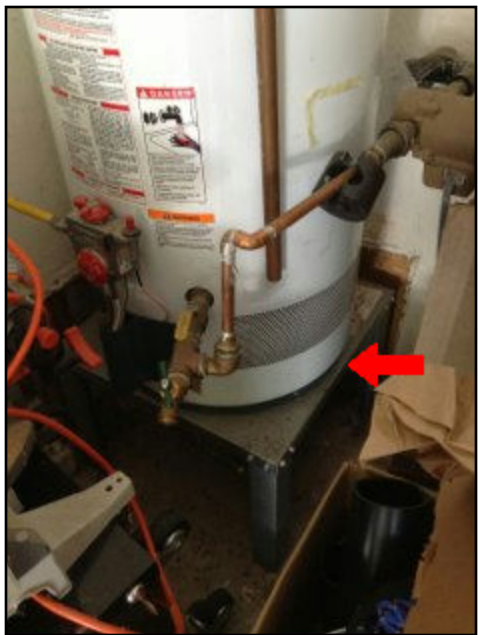
16. Condition: • Safety pan and drain missing

62. Safety pan and drain missing

Task: Provide

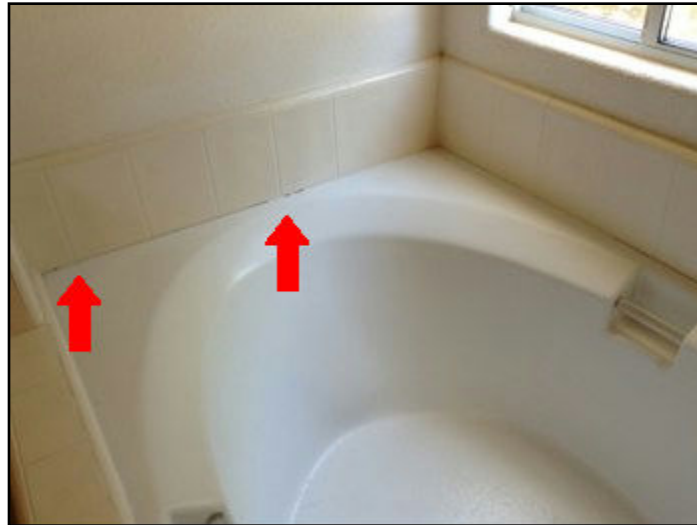
17. Condition: • [Grout loose, missing or deteriorated](#)

63. Grout loose, missing or deteriorated

Task: Repair

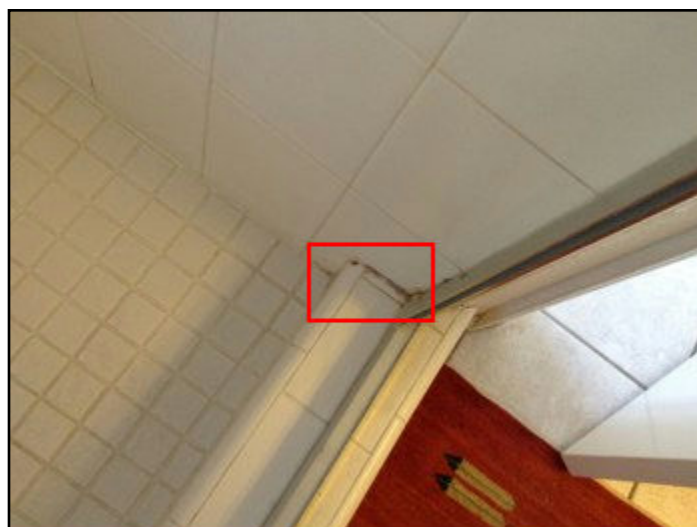
18. Condition: • [Caulking loose, missing or deteriorated](#)

64. Caulking loose, missing or deteriorated

Task: Seal with appropriate caulking

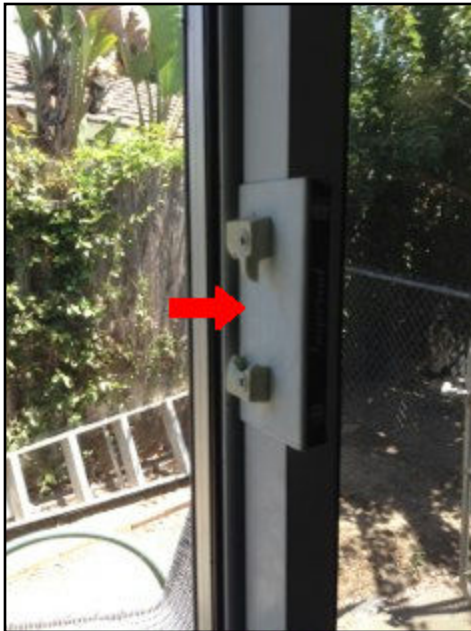
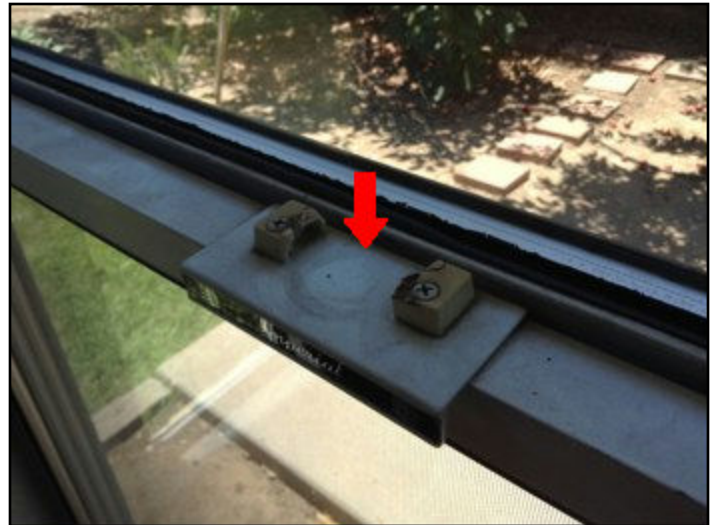
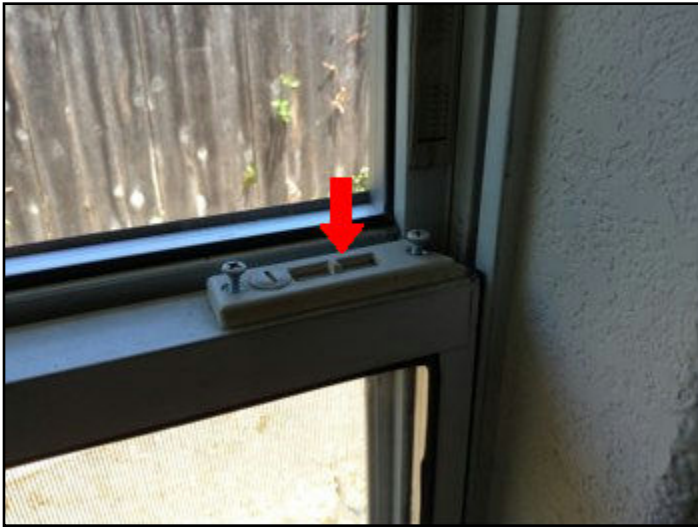
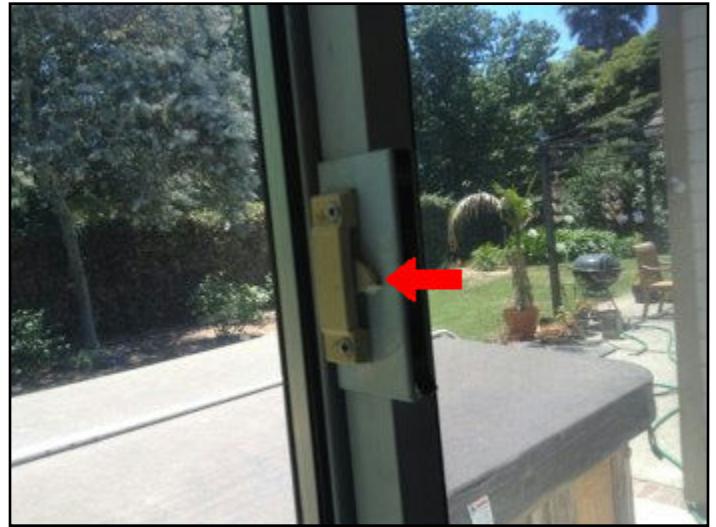
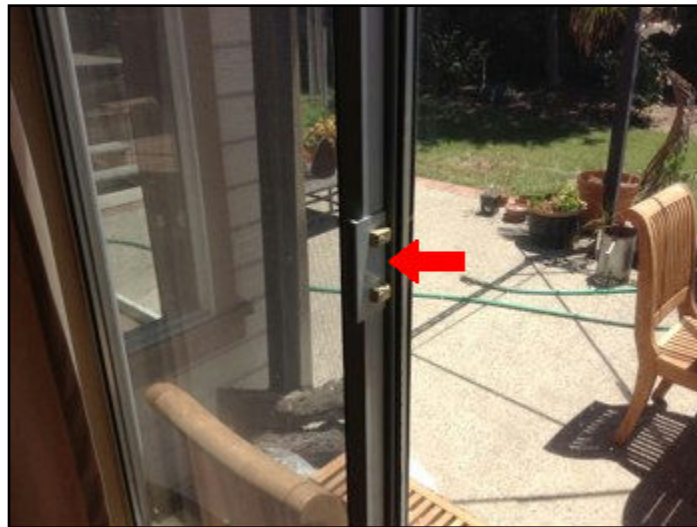
19. Condition: • [Broken](#)

Broken hardware was observed on several windows.

Task: Replace
