# YOUR INSPECTION REPORT

857 Cheltenham Rd  
Santa Barbara, CA 93105

Sunday, July 14, 2013

Report No. 1075, v.0

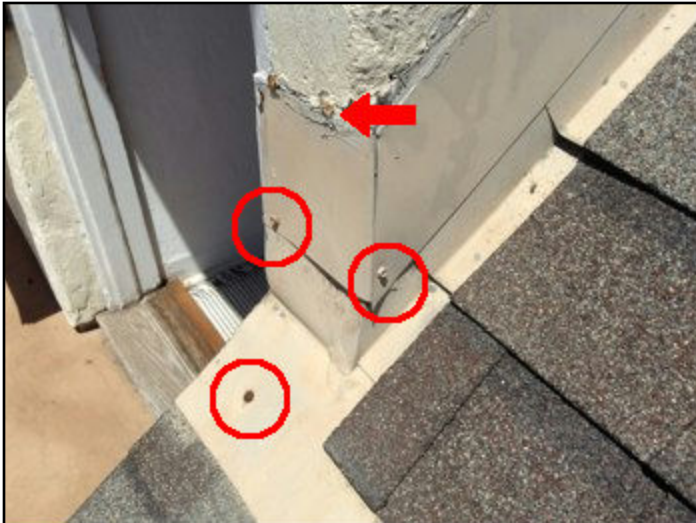
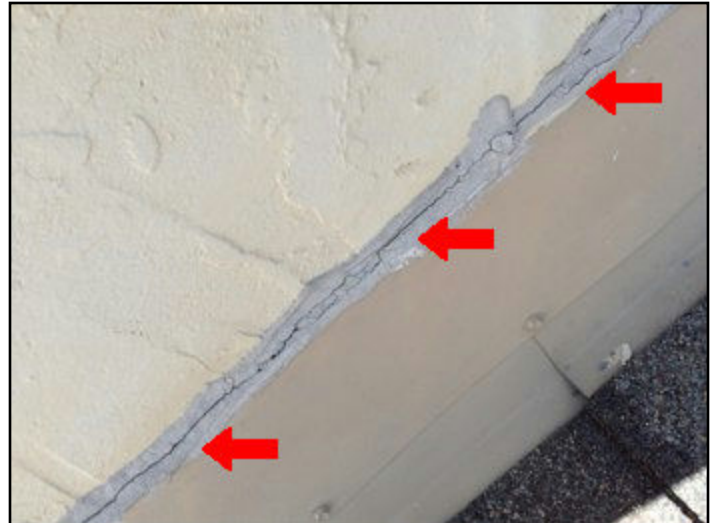
The sealant on the flashings throughout the roof were old and cracked allowing possible moisture intrusion. Some exposed fasteners were observed. Recommend sealing all flashing seams, joints and exposed fasteners as needed.

3. Inspect & repair, as needed.

4. Inspect & repair, as needed.

**Task:** Seal flashings with appropriate caulking

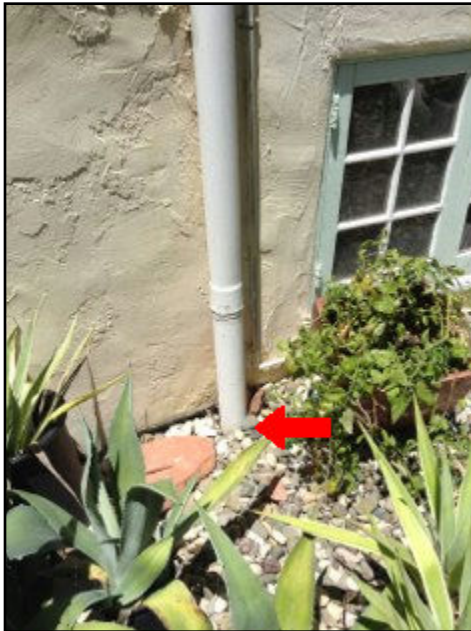
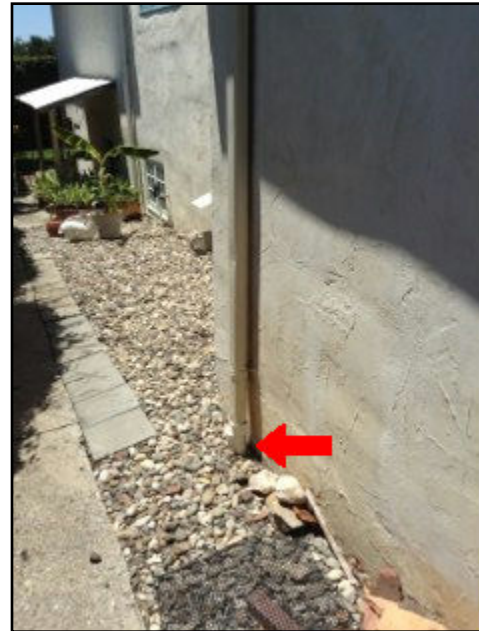
The downspouts on the east side of the home were discharging below grade and there was no visible termination point. Recommend testing and clearing the lines to ensure run off is being discharged and the drains are functioning as designed.

7. Below grade

8. Below grade

**Task:** Further evaluation and repair

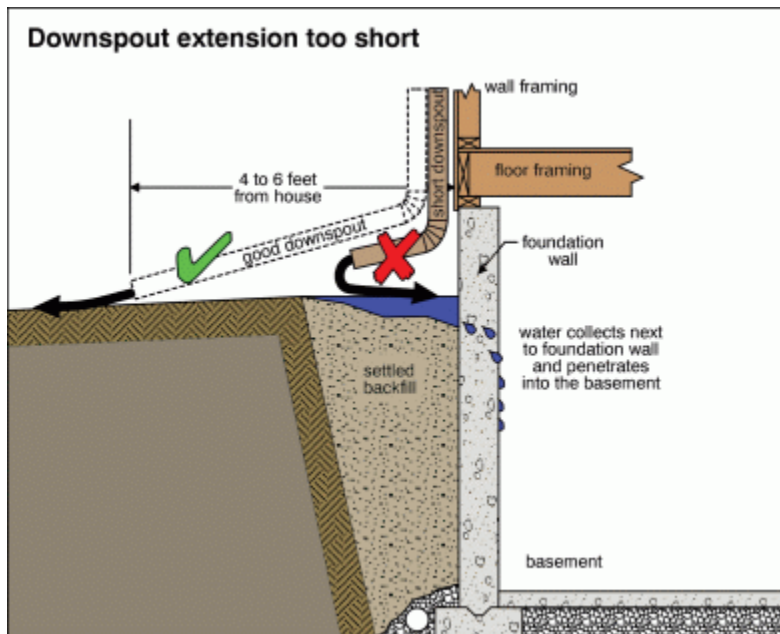
9. Downspouts end too close to building

**Task:** Extend away from home

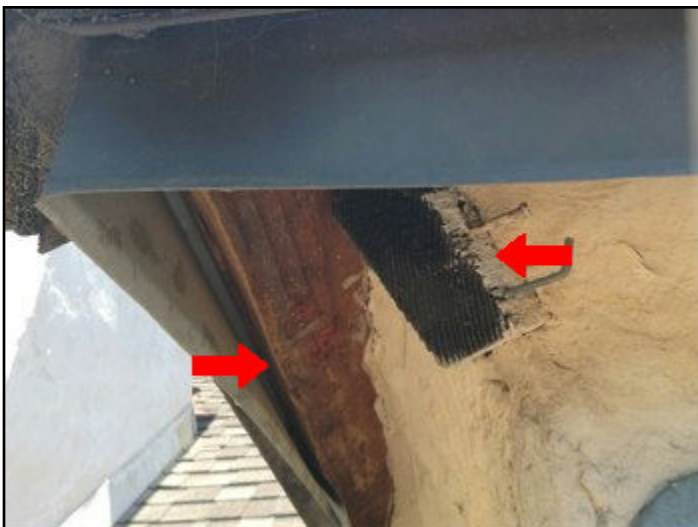
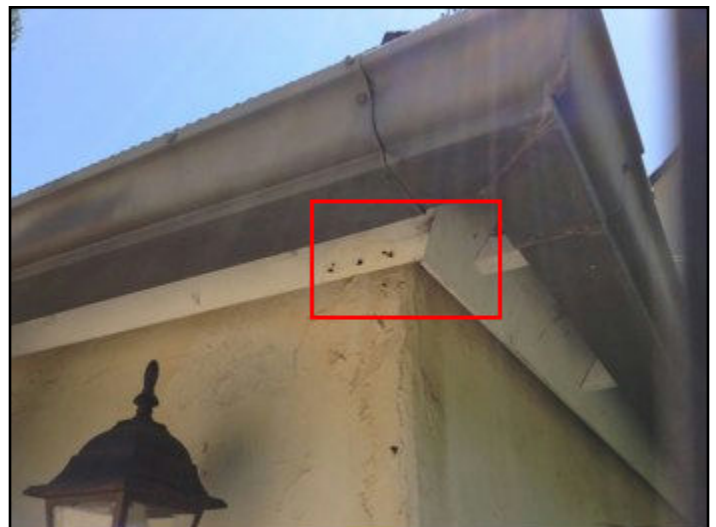
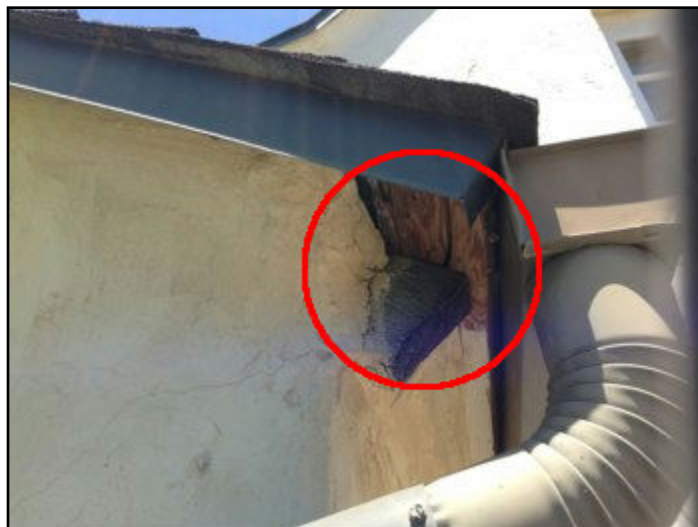
Evidence of rot and insect damage was observed on the fascia boards and rafter tails throughout the exterior.

13. Rot or insect damage

14. Rot or insect damage

15. Rot or insect damage

**Task:** Pest inspection and repair

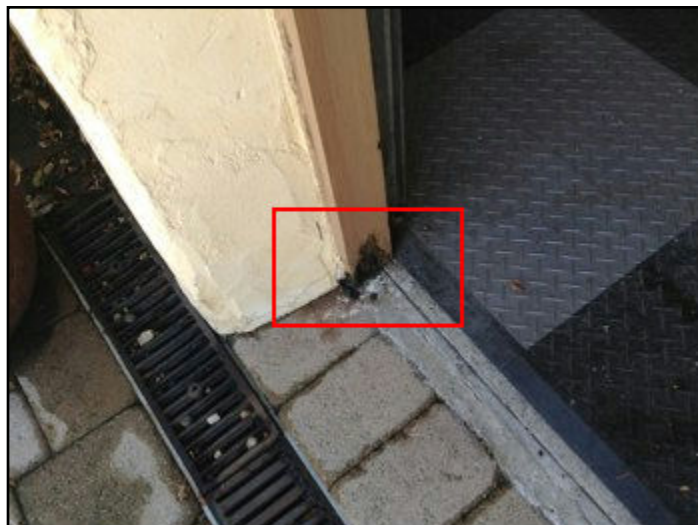
Rot and insect damage observed on garage door jamb.

16. Rot or insect damage

**Task:** Pest inspection and repair

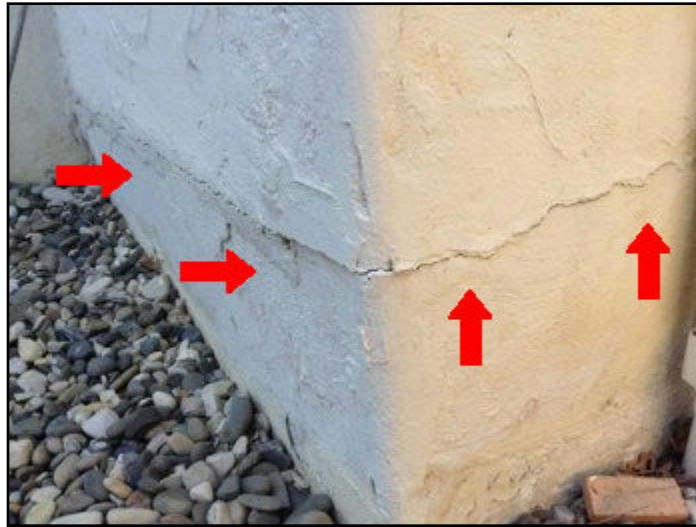
A crack with some lateral movement was observed on the southeast corner of the garage. Recommend further evaluation from a licensed foundation contractor and repair as needed.

17. Cracked

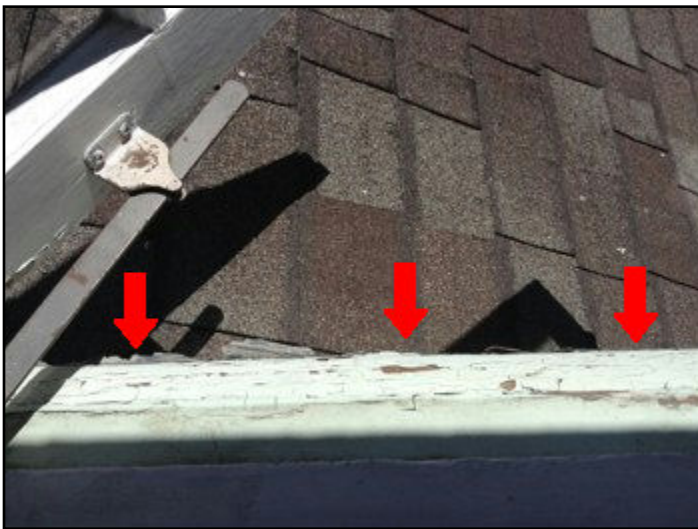
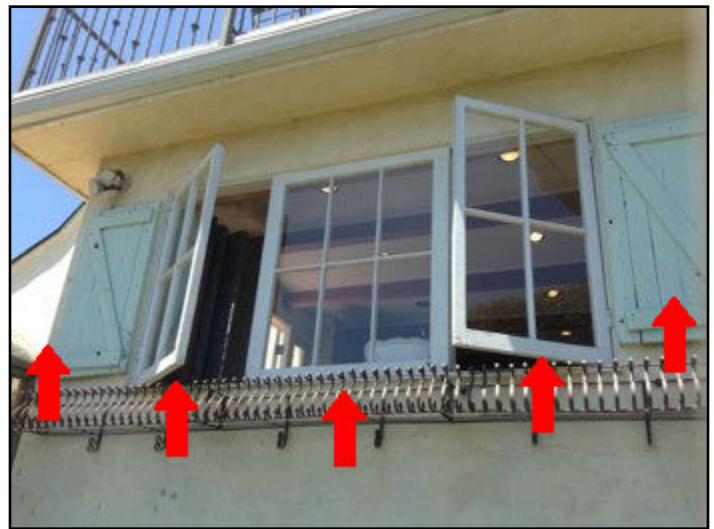
**Condition:** • Many original single pane windows were observed throughout the home. Some were painted shut and others were difficult to open. Deferred maintenance was observed on many. Sealing and painting was needed to deter further material deterioration.

18. Material deterioration

19. Material deterioration

**Task:** Repair or replace

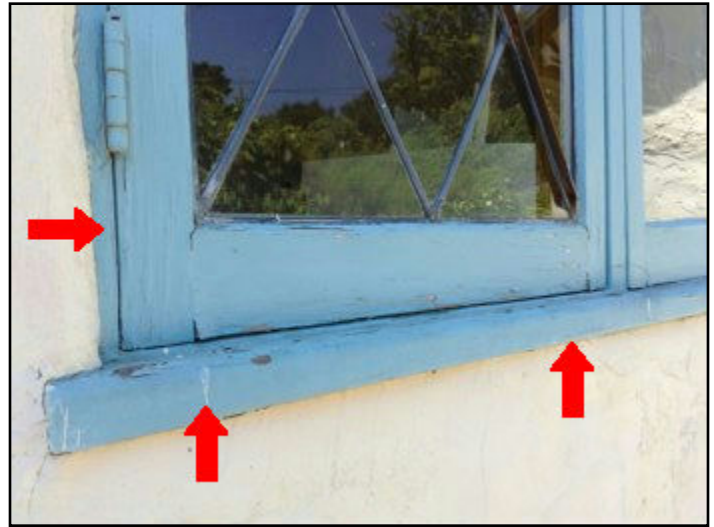
21. Material deterioration

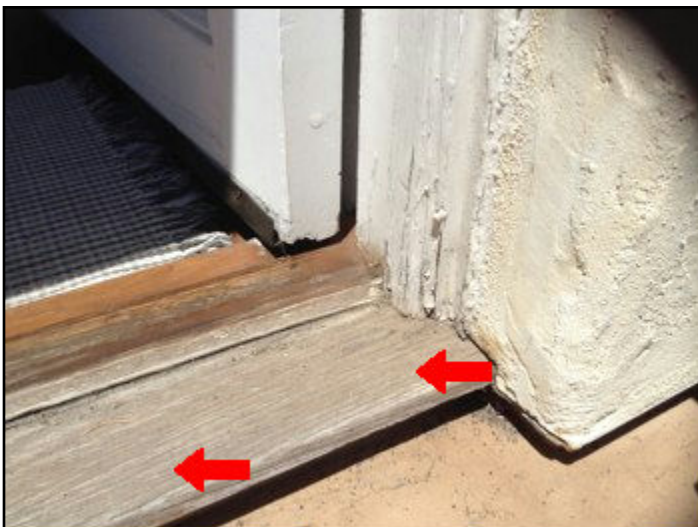
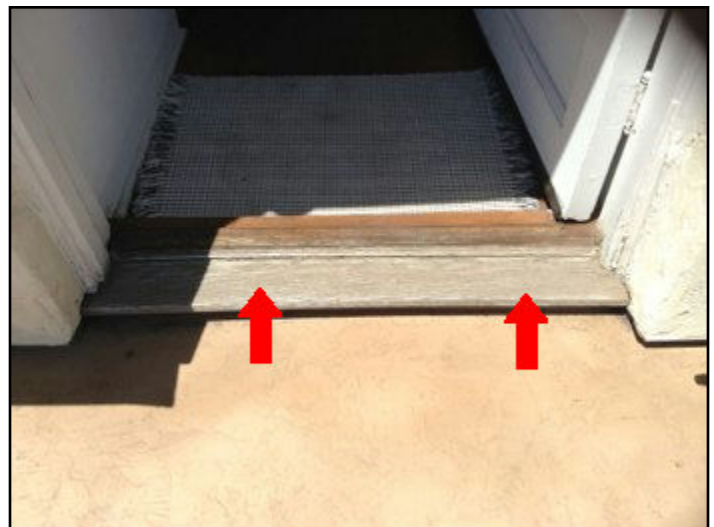
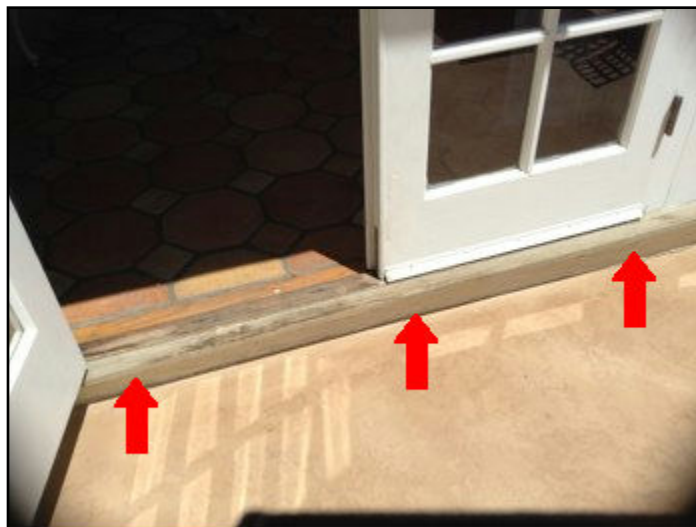
22. Paint or stain needed

23. Paint or stain needed

24. *Paint or stain needed*

**Task:** Paint or stain

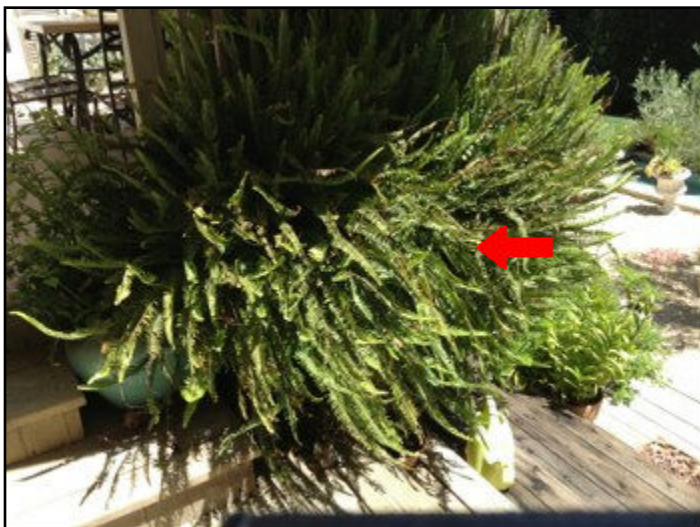
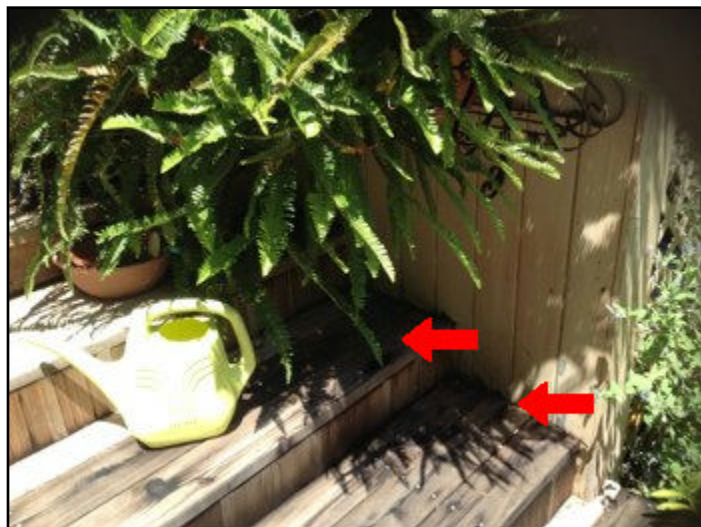
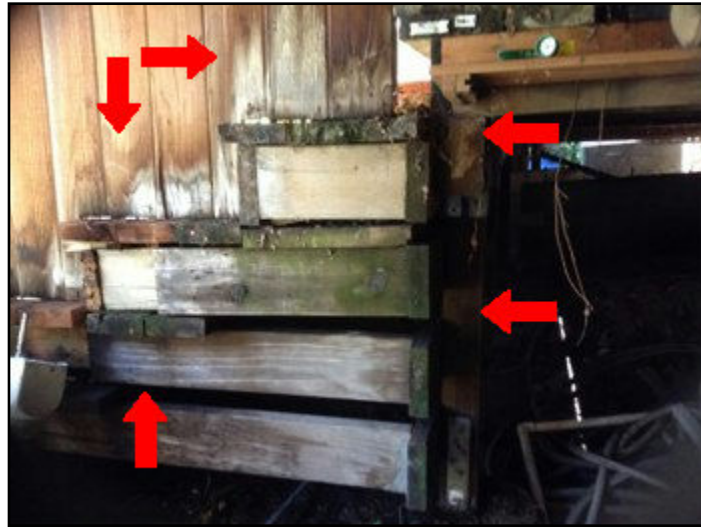
Vegetation irrigation has led to moisture damage on a portion of the south deck. Recommend removing vegetation and replacing damaged decking as needed.

25. *Moisture damage*

26. *Moisture damage*

27. Under deck

**Task:** Repair

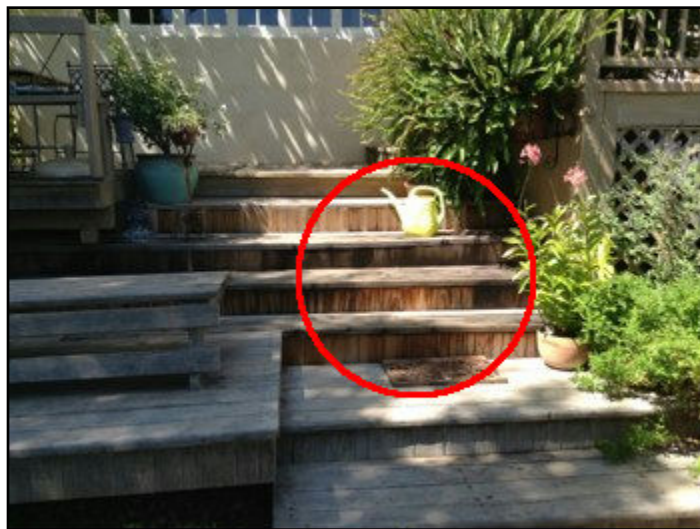
No handrail was observed at the deck staircase. Handrails shall be provided on at least one side of each continuous run of treads or flight with four or more risers. Recommend providing.

28. Missing

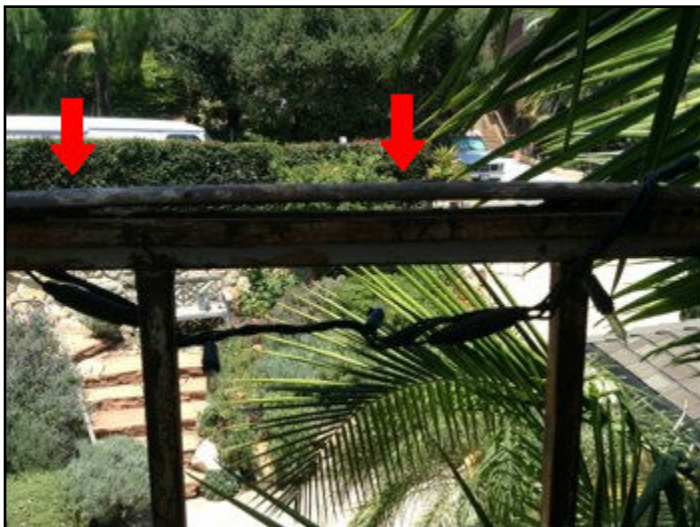
The front balcony, stairs and railing were in general disrepair. The balcony tiles were broken, loose or damaged. The railing was rusted, broken and did not meeting current safety standards.

29. Disrepair

**Task:** Repair or replace

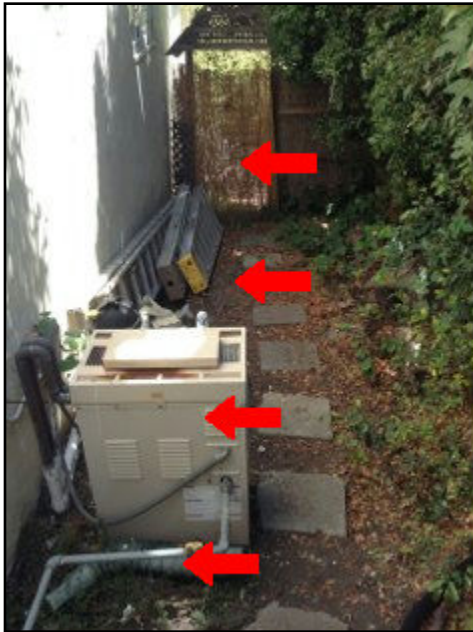
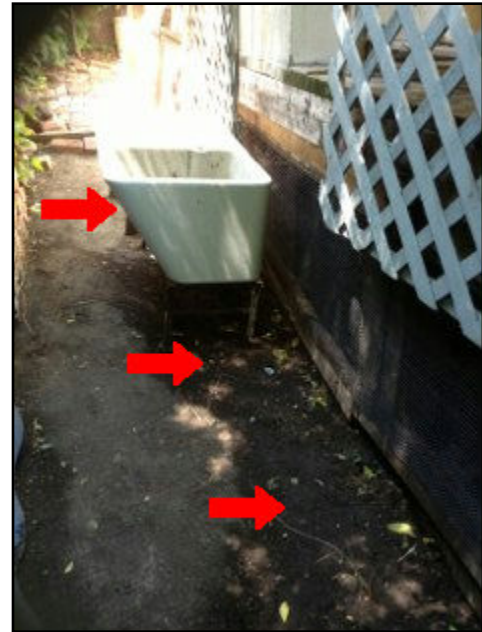
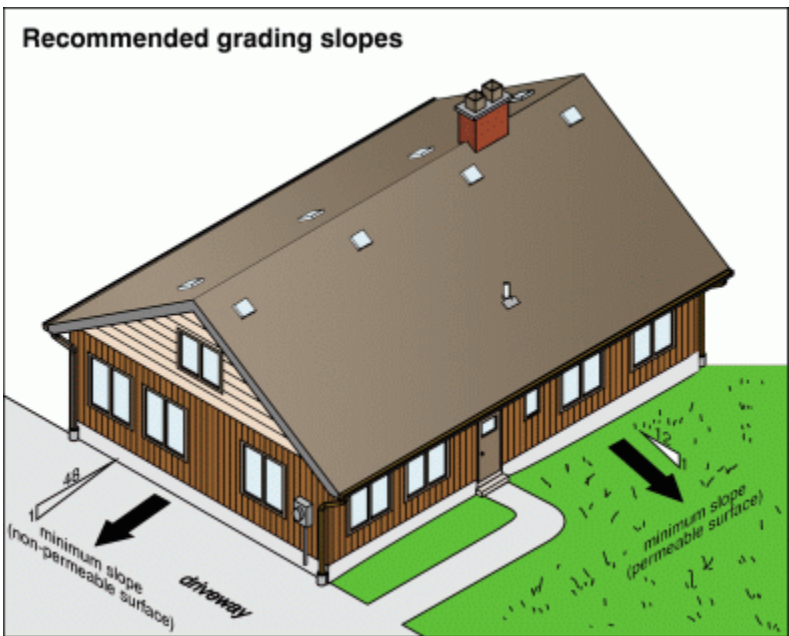
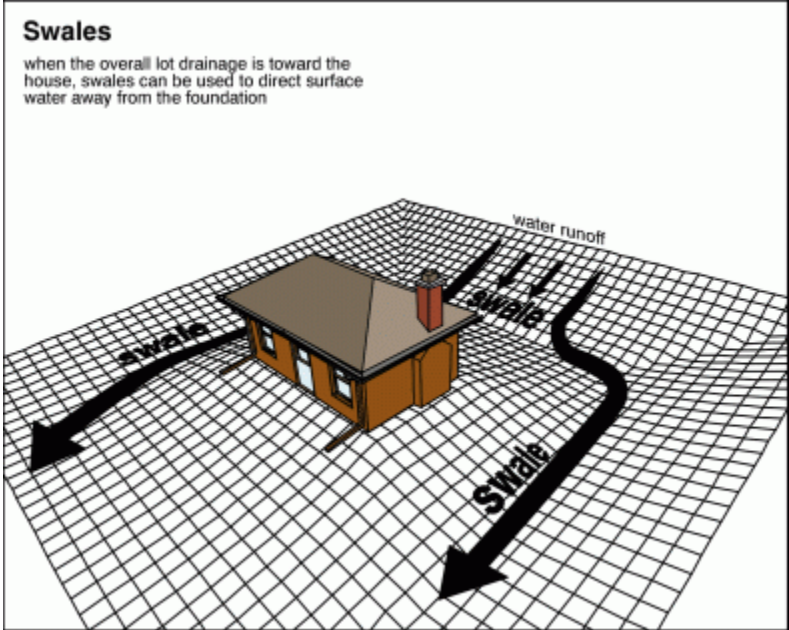
The west exterior walkway did not appear to have a proper slope or drainage system resulting in moisture intrusion along the west foundation wall. Recommend regrading and installing drainage system to manage water appropriately.

34. *Improper slope*

35. *Improper slope*

**Task:** Regrade and control water run off

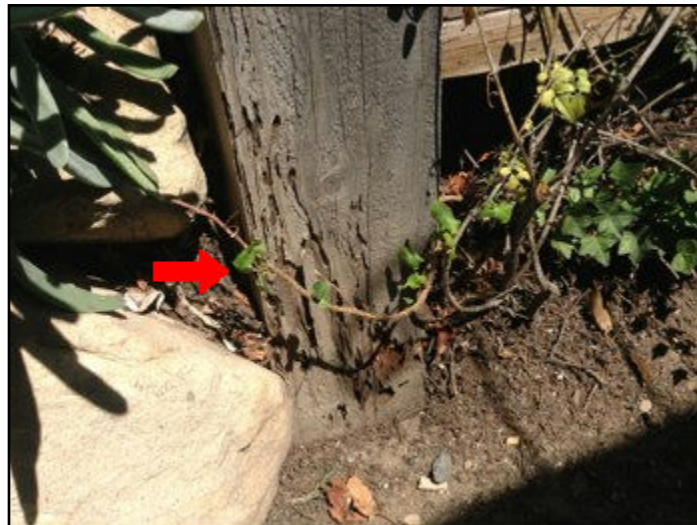
Evidence of termites observed on perimeter fence.

40. Rot or insect damage

**Task:** Pest evaluation and repair

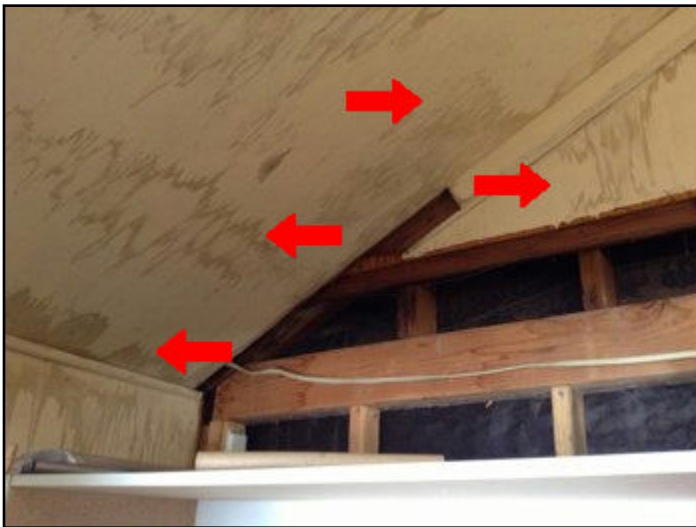
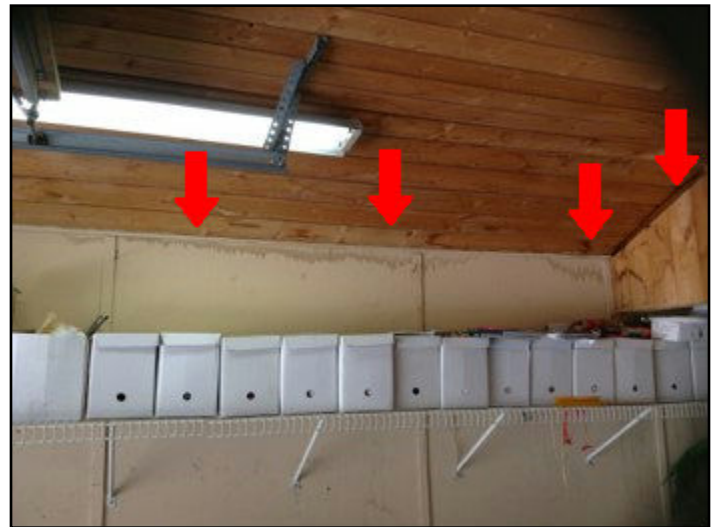
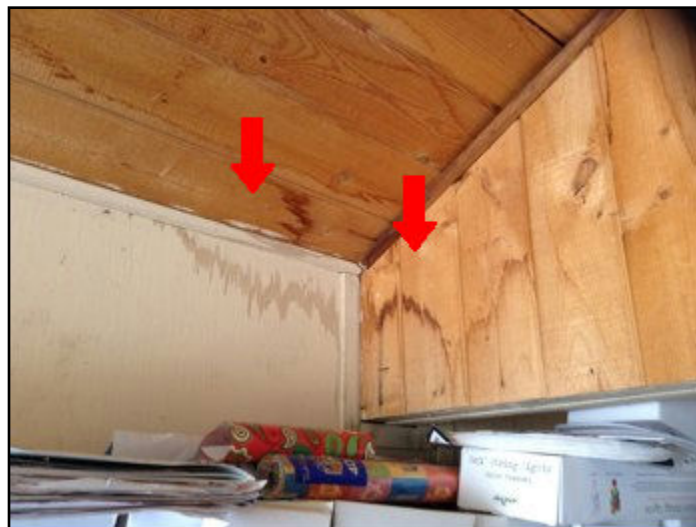
**Condition:** • **Moisture stains were observed on east and south walls of garage.** They could be old stains or a seasonal issue. Recommend requesting disclosure as to whether the issue was solved and if not further evaluation from a licensed roofing contractor.

41. Moisture stains

42. Moisture stains

43. Moisture stains

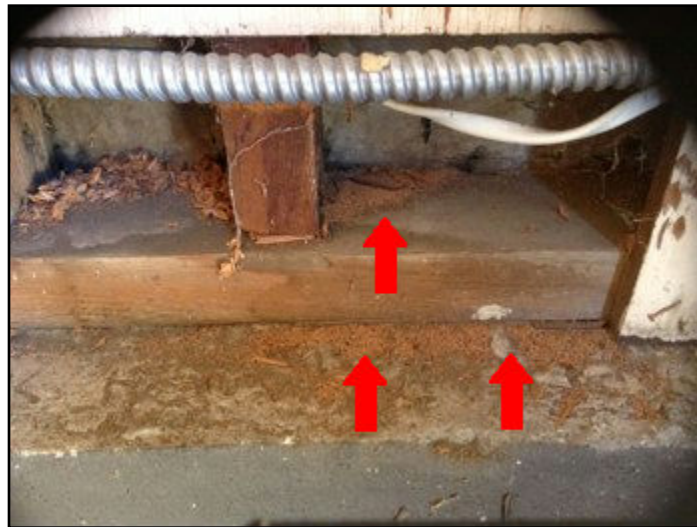
Evidence of termites observed on west wall of garage.

44. Insect damage

**Task:** Pest evaluation and repair

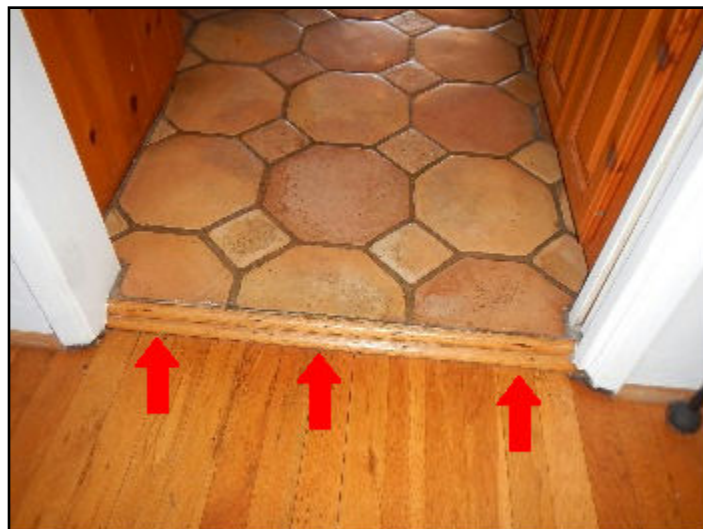
50. Settled

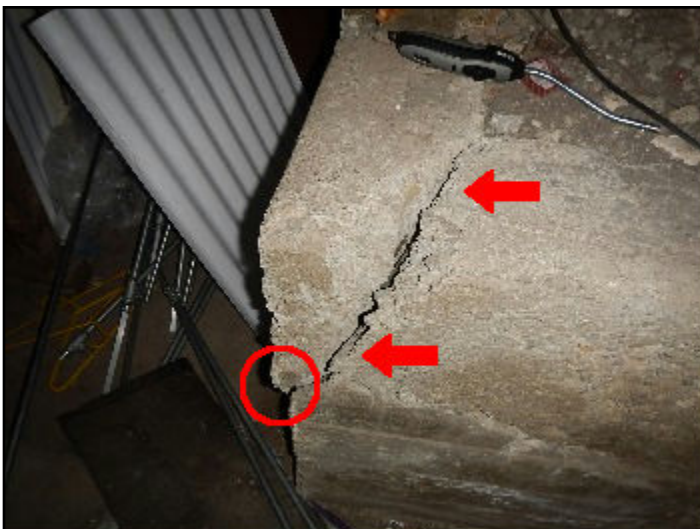
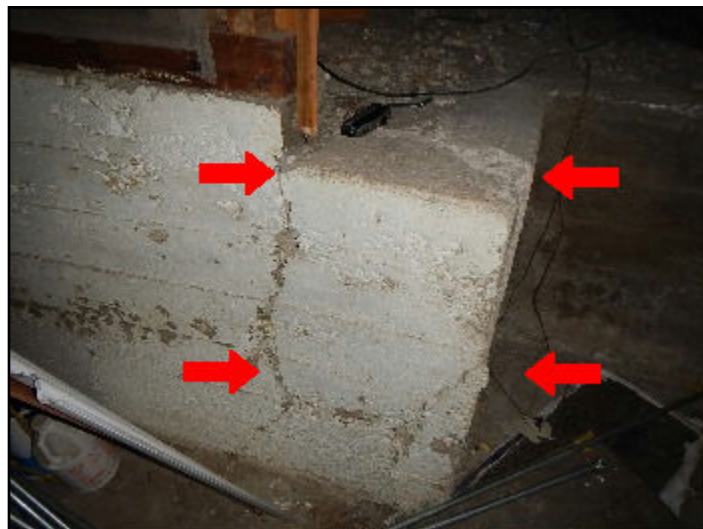
A large crack was observed on an interior corner of the foundation wall. Recommend further evaluation and repair by a licensed foundation contractor.

51. Cracked

52. Cracked

**Task:** Further evaluation

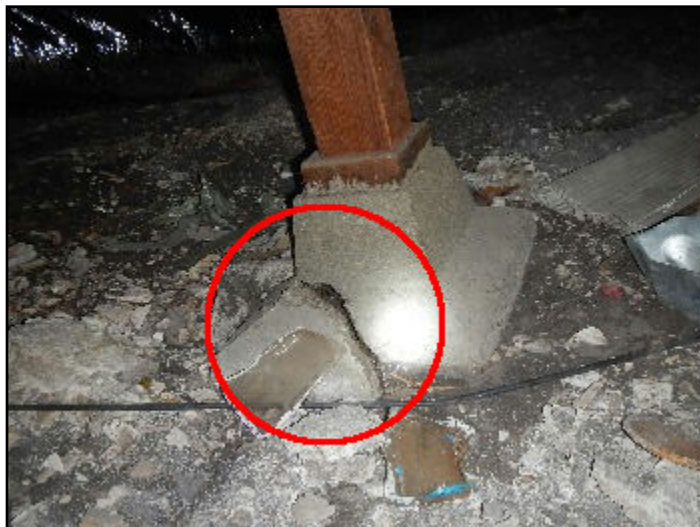
53. Mechanical damage

**Task:** Further evaluation and repair

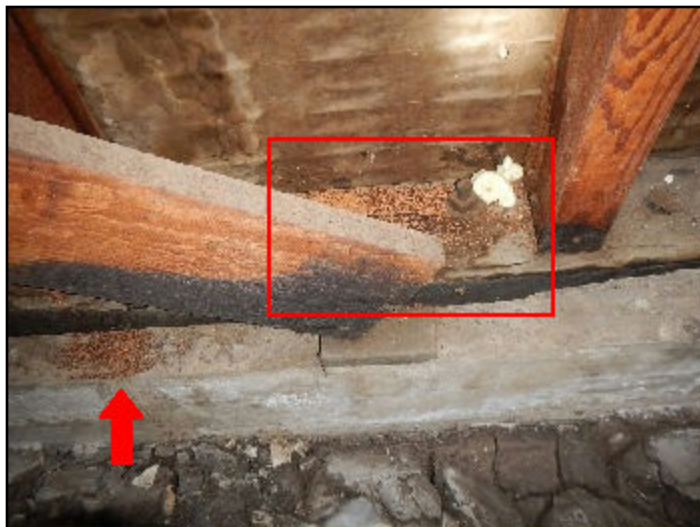
54. Rot or insect damage

**Task:** Pest inspection and repair

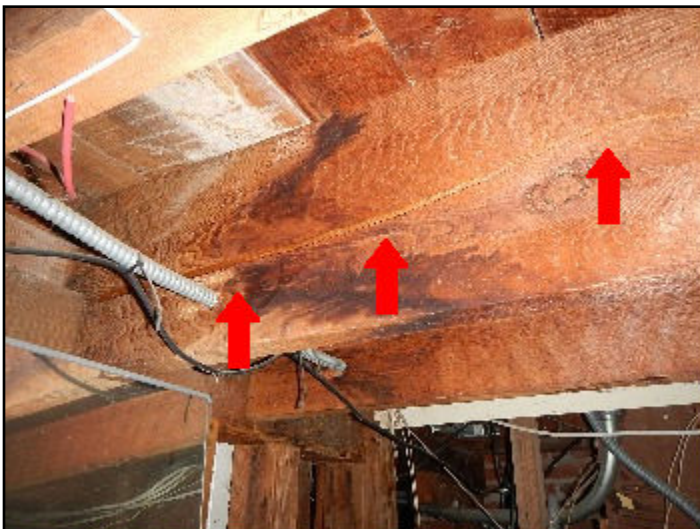
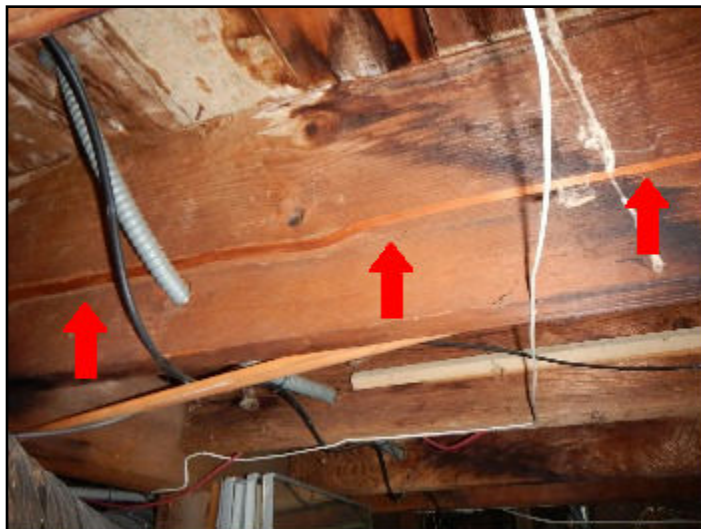
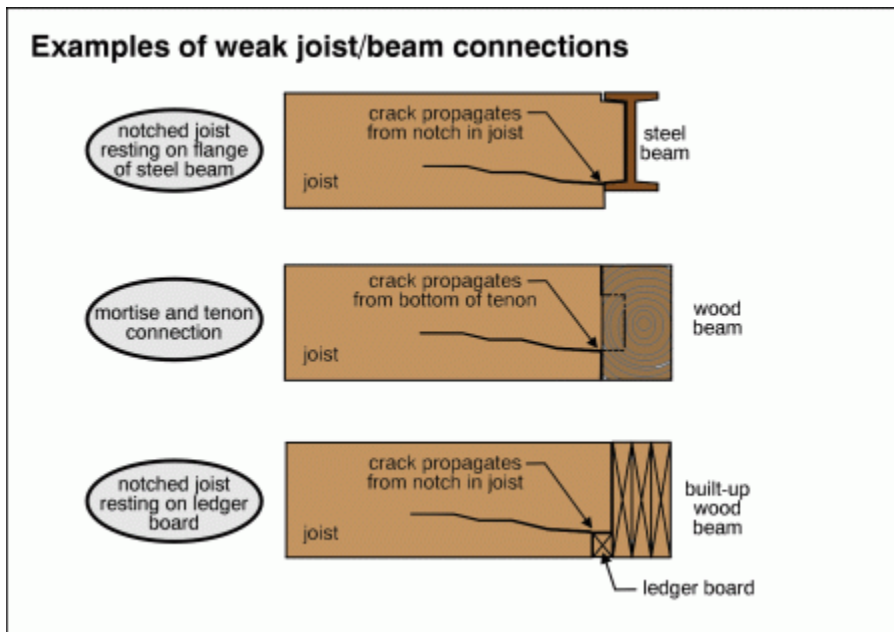
55. Split or damaged

56. Split or damaged

**Task:** Repair

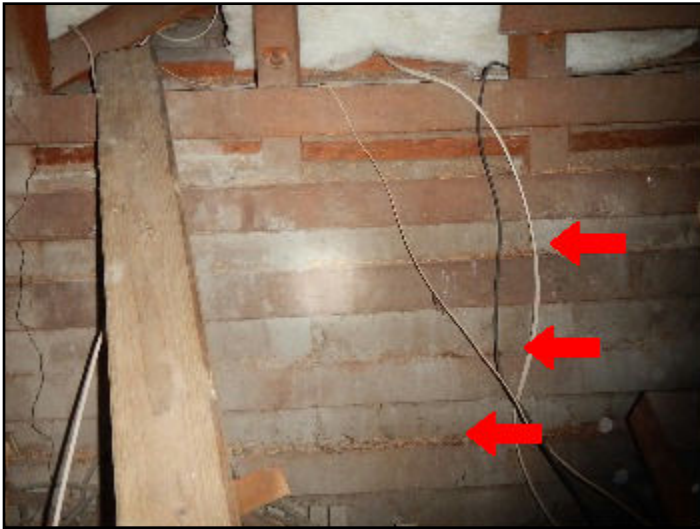
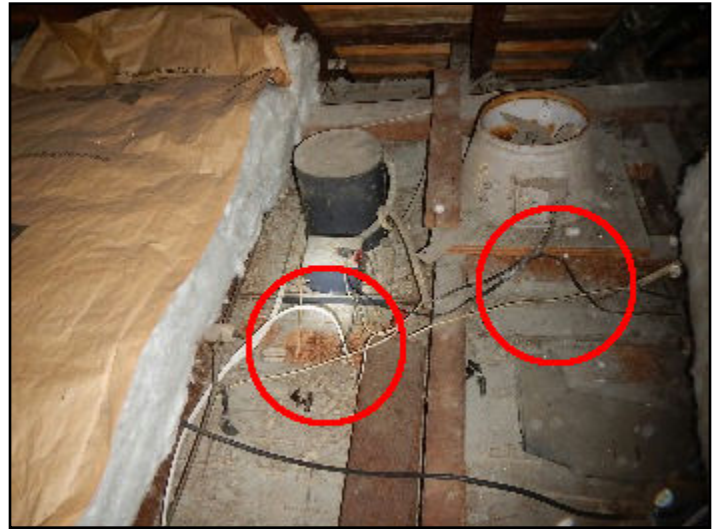
Minor evidence of termites observed in attic. Recommend further evaluation by a pest inspector.

57. Insect damage

58. Insect damage

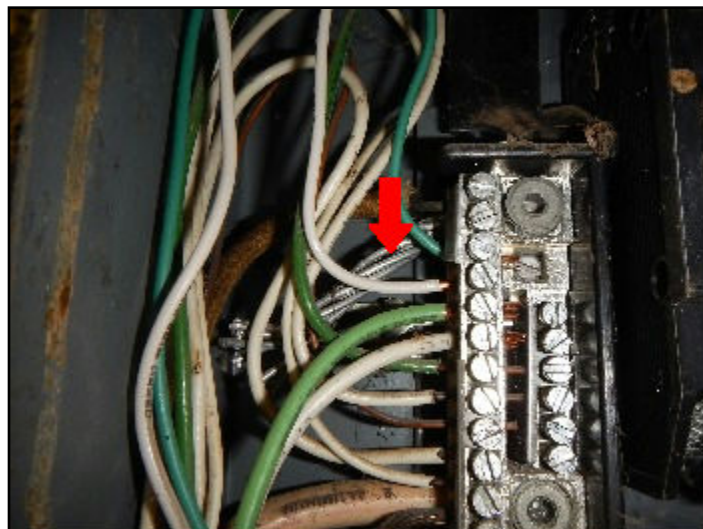
64. Abandoned wires in panel

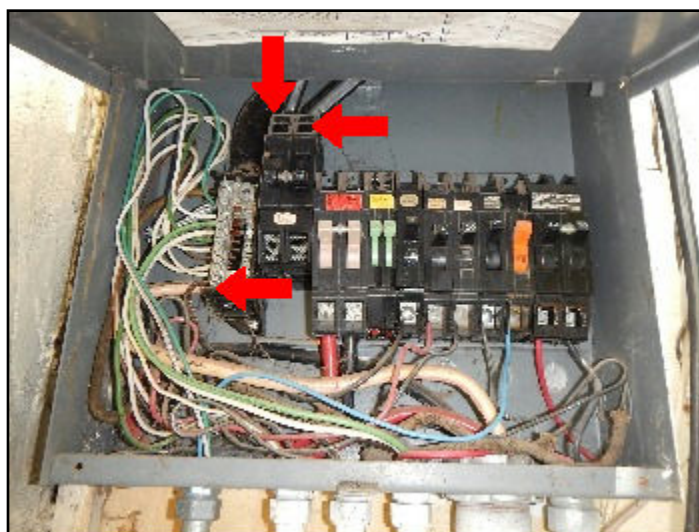
65. Anti-oxidant missing on aluminum wire

Task: Provide

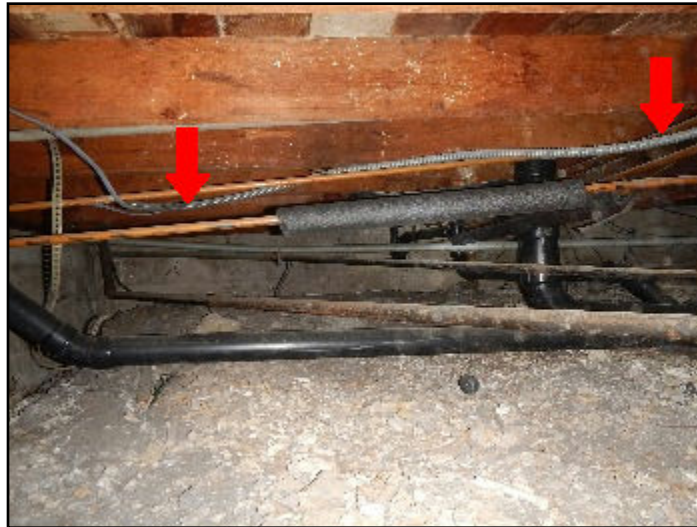
Improperly or under-secured metallic sheathing was observed throughout crawlspace.

66. Not well secured

Task: Repair

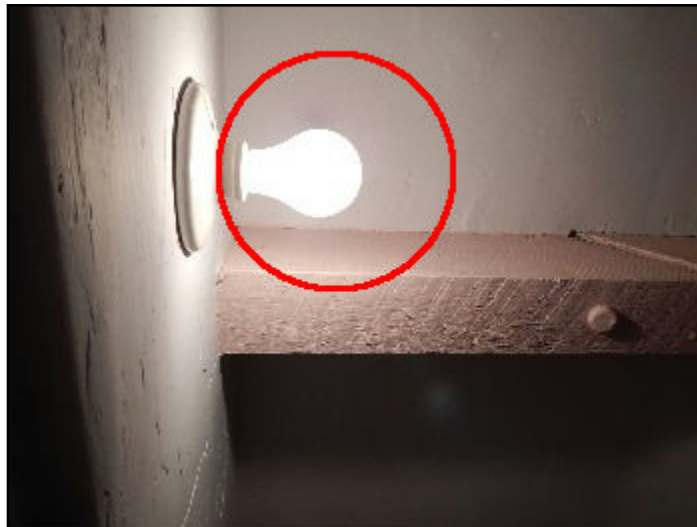
67. Improper closet lighting

**Task:** Repair or replace

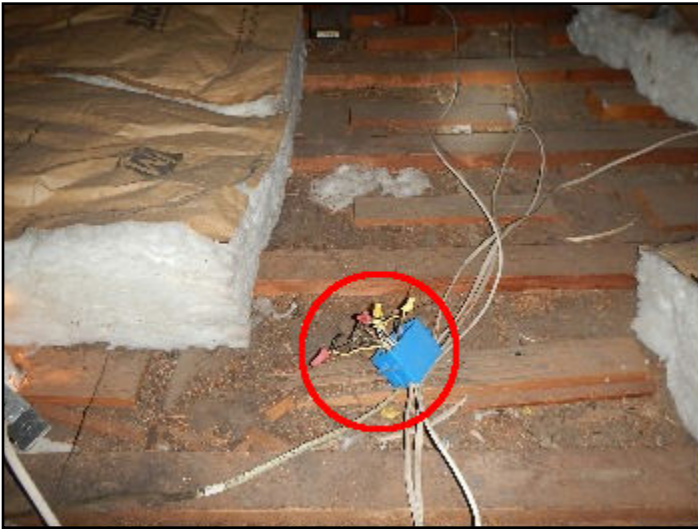
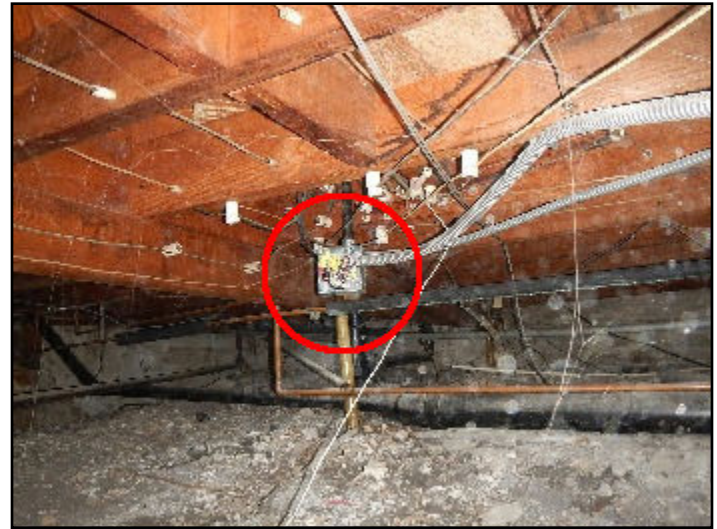
68. Cover loose or missing

69. Cover loose or missing

**Task:** Repair

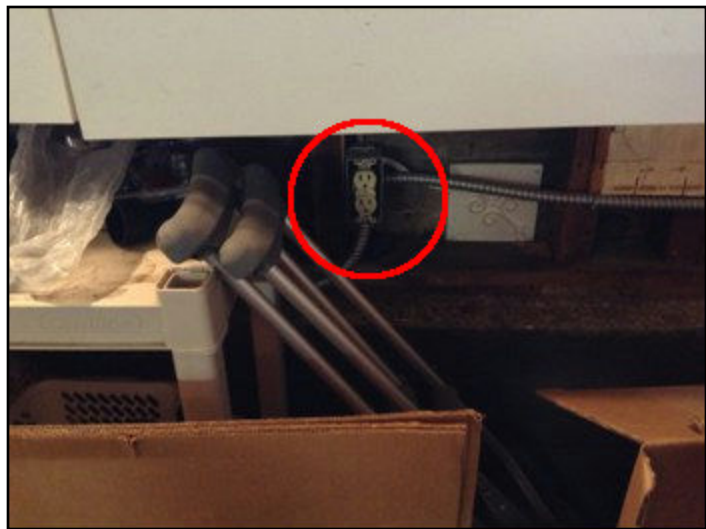
**70. Missing**

**Task:** Provide

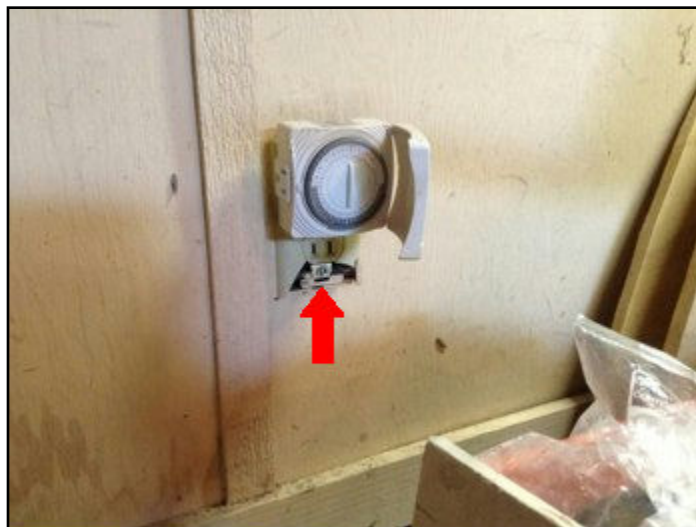
71. Damaged

**Task:** Provide

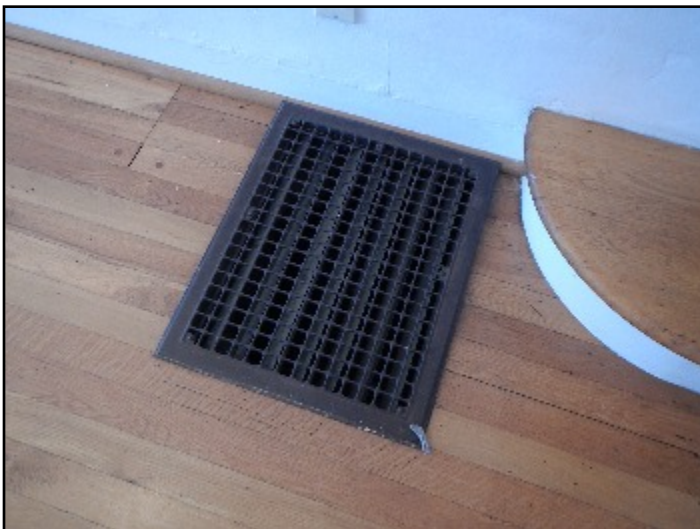
The furnace appears to be the original gravity style gas furnace. Although it functioned as designed when tested, I would recommend servicing by a licensed heating contractor and upgrading when necessary. There was a strong odor evident when tested.

76. Near end of life expectancy

**Task:** Repair or replace

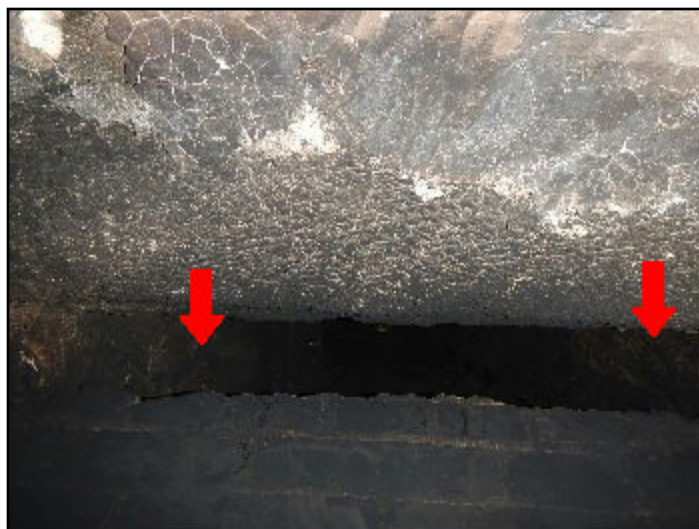
78. Missing

**Task:** Provide

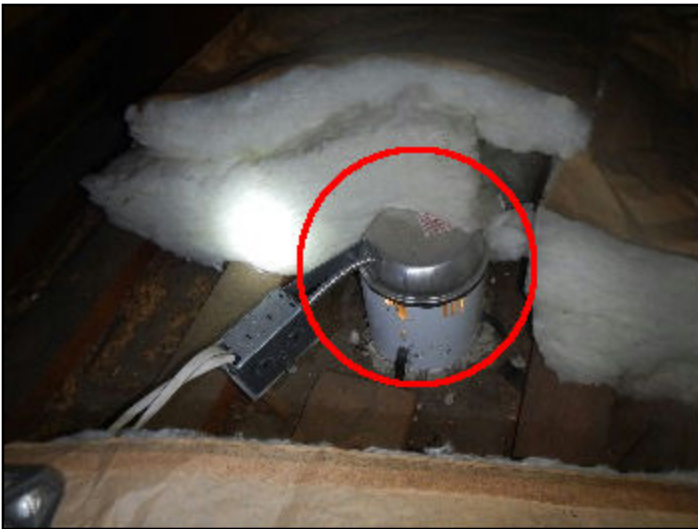
82. Covering can lights

**Task:** Repair

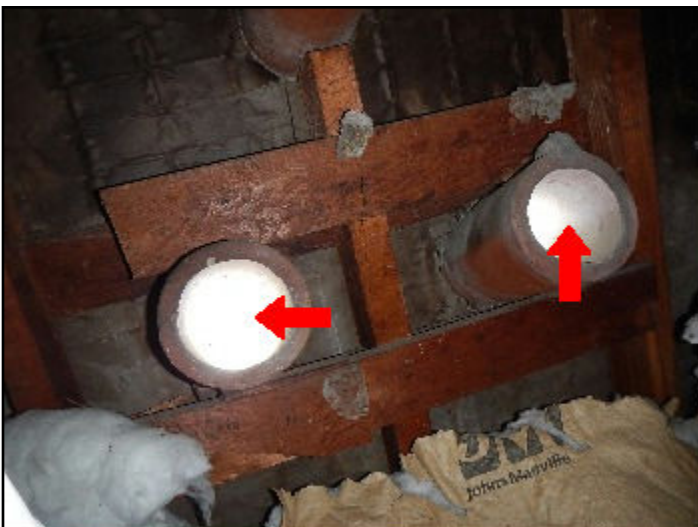
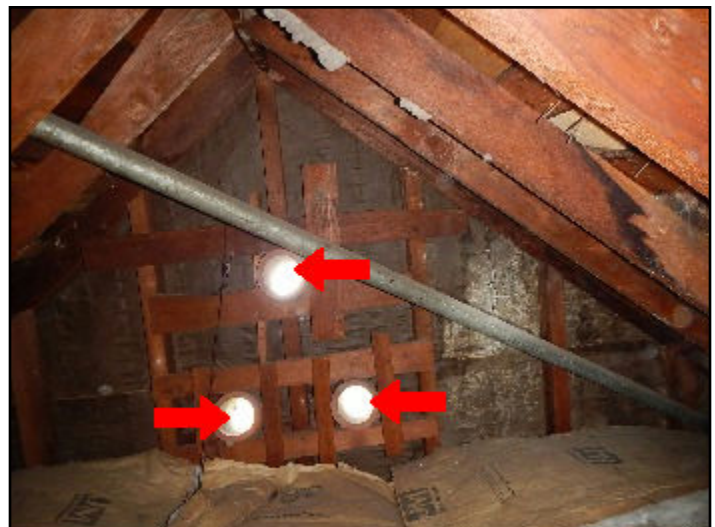
**Condition:** • Screens were missing from the clay gable vents allowing pest and insect entry into the attic.

84. Screens missing

85. Screens missing

**Task:** Repair

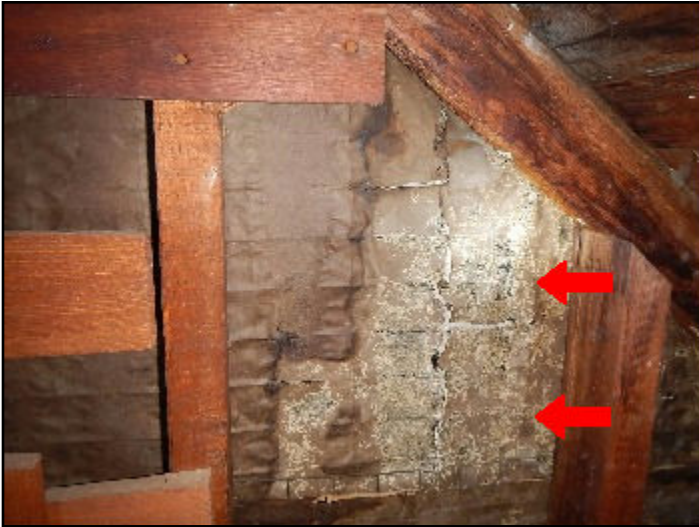
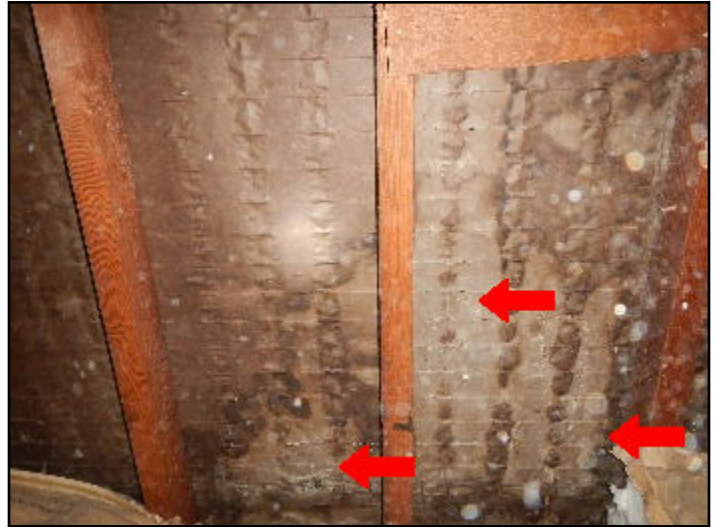
**Condition:** • The weather resistant barrier under the stucco had deteriorated in many areas.

86. Deteriorated

87. Deteriorated

**Task:** Repair or replace

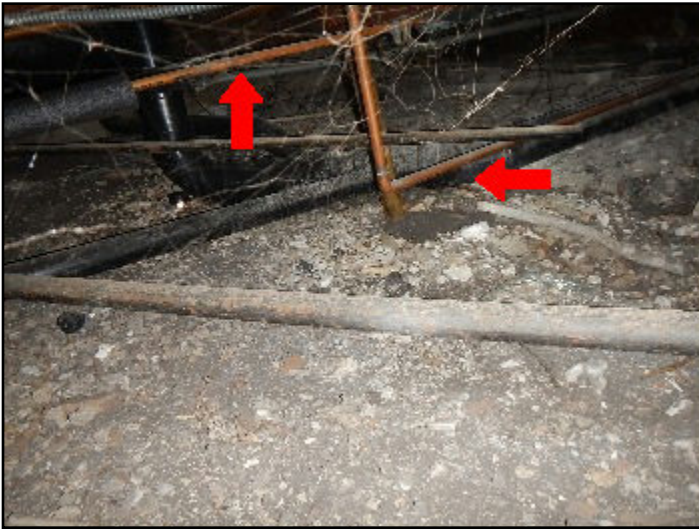
Improper or poorly supported water lines were observed throughout the crawlspace.

93. Poor support

**Task:** Repair

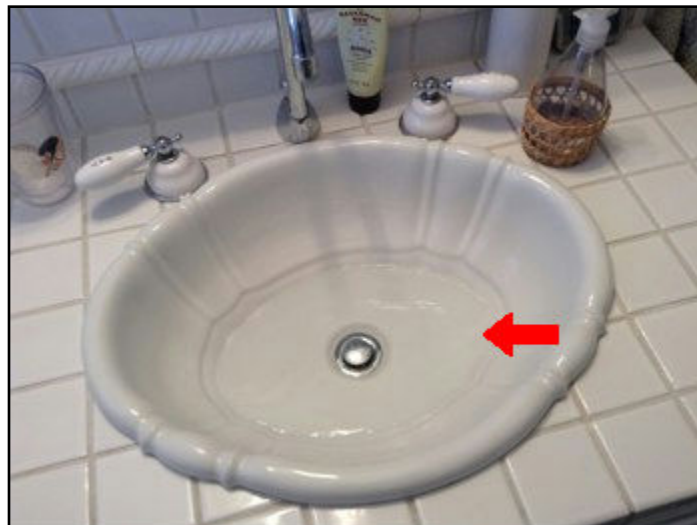
95. Slow drains

**Task:** Repair

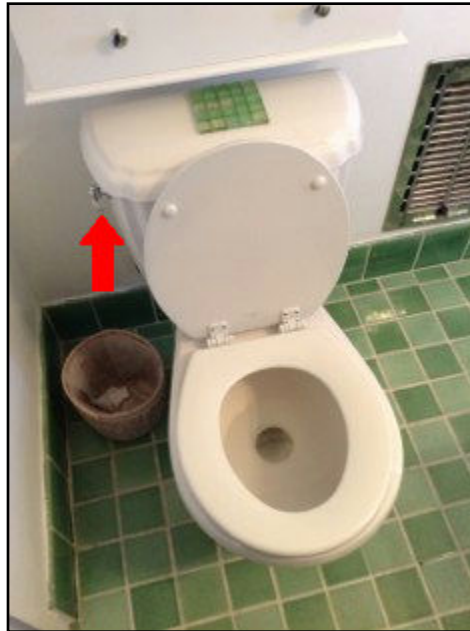
The flushing mechanism sticks in the open position causing the water to run continuously. Recommend repairing.

96. *Running continuously*

**Task:** Repair
