# YOUR INSPECTION REPORT

857 Cheltenham Rd  
Santa Barbara, CA 93105

Sunday, July 14, 2013

Report No. 1075, v.0

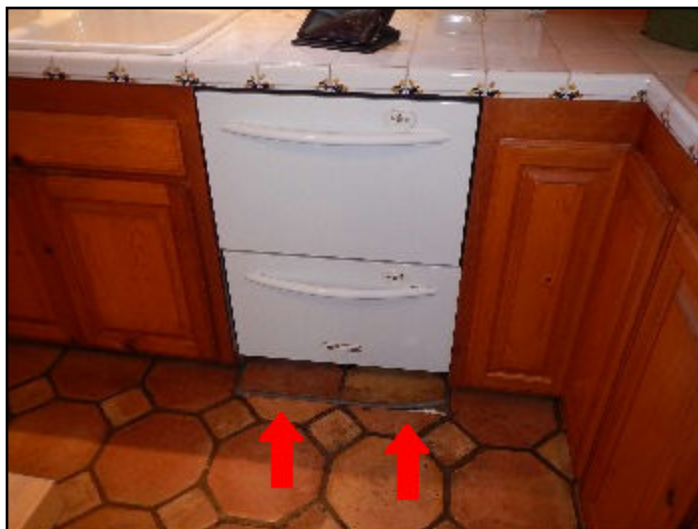
Some kind of foam insulation was placed in the grout lines in front of the dishwasher and was loose. Recommend using grout to fill spaces between tiles.

97. Grout missing

**Task:** Repair

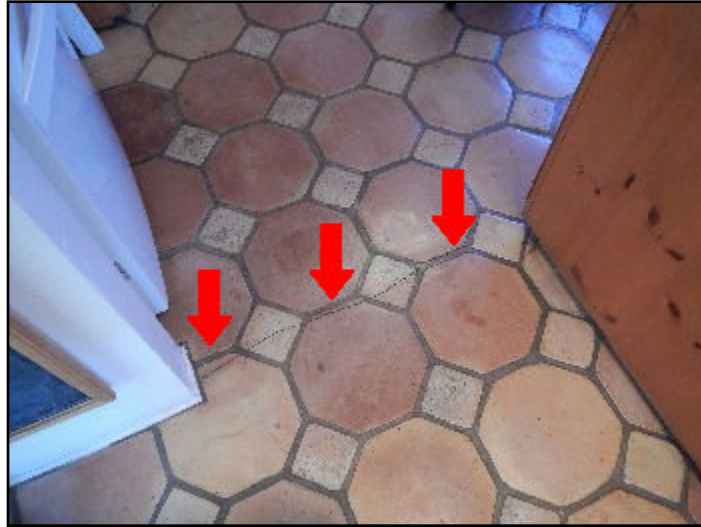
What appeared to be a settling crack was observed on the kitchen floor.

98. Tiles cracked

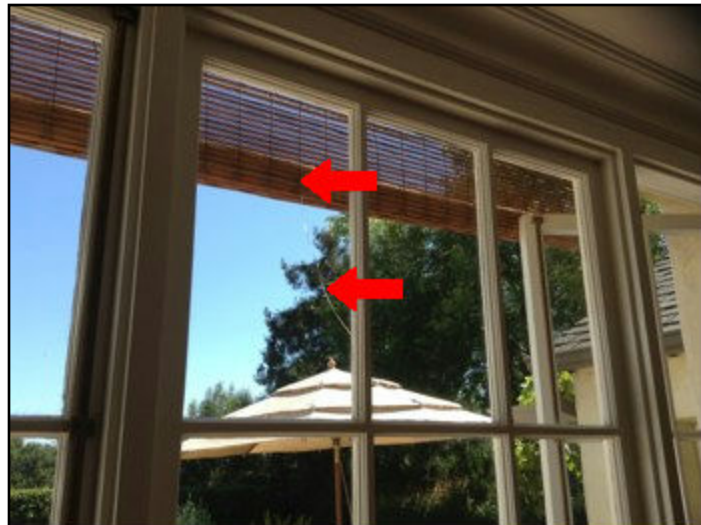
99. Cracked

Task: Replace

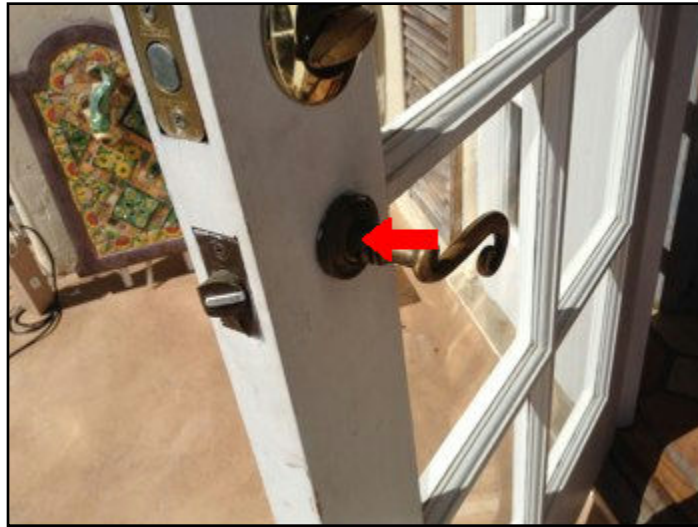
100. Loose

Task: Repair

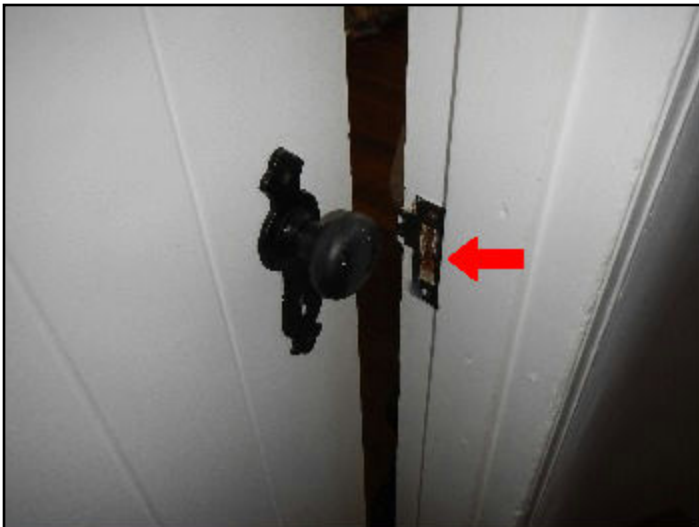
101. Ineffective

**Task:** Repair

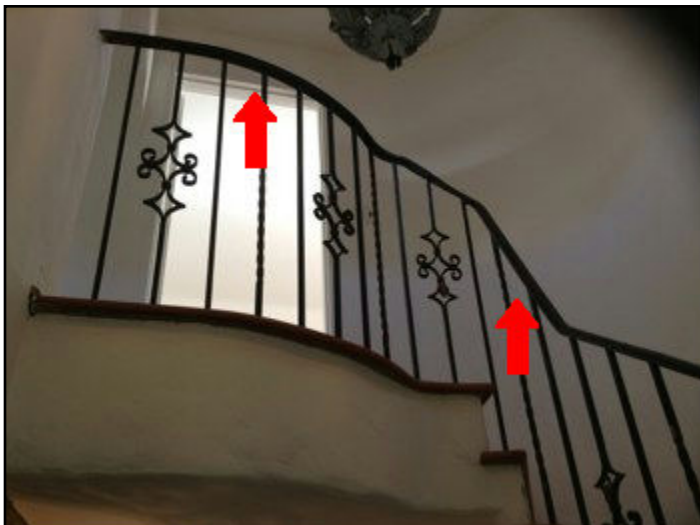
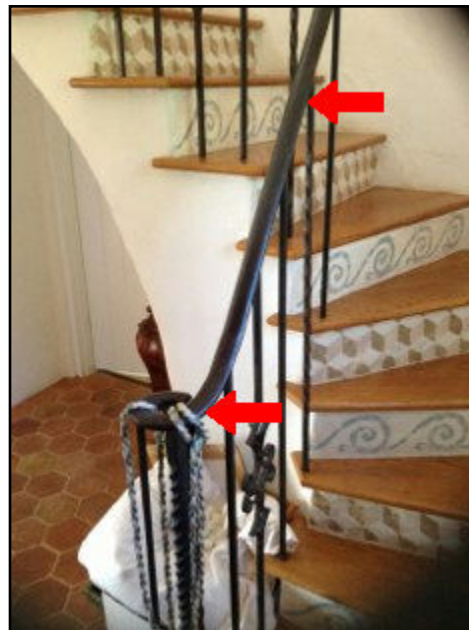
103. Loose

104. Loose

Task: Repair or replace

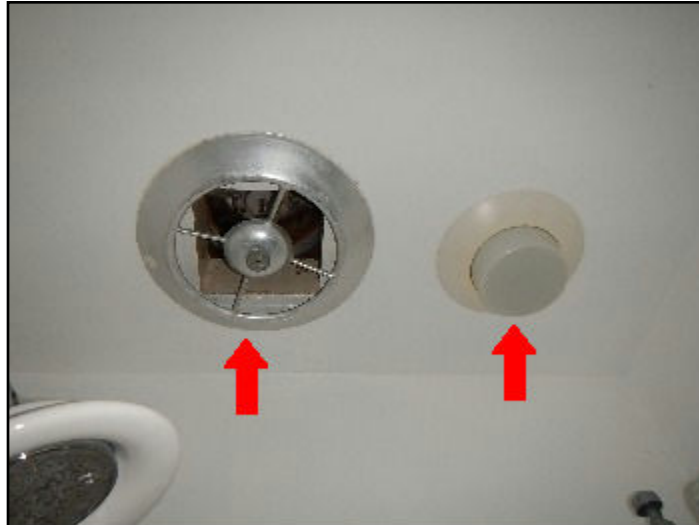
**107. Inoperative**

**Task:** Repair or replace

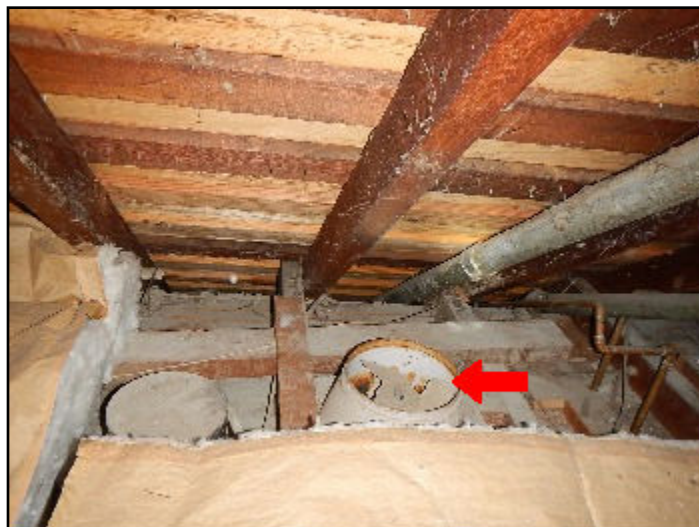
**108. Not vented to exterior**

**Task:** Repair
