# YOUR INSPECTION REPORT

5632 Marbury Dr  
Goleta, CA 93117

Thursday, April 18, 2013

Report No. 1034

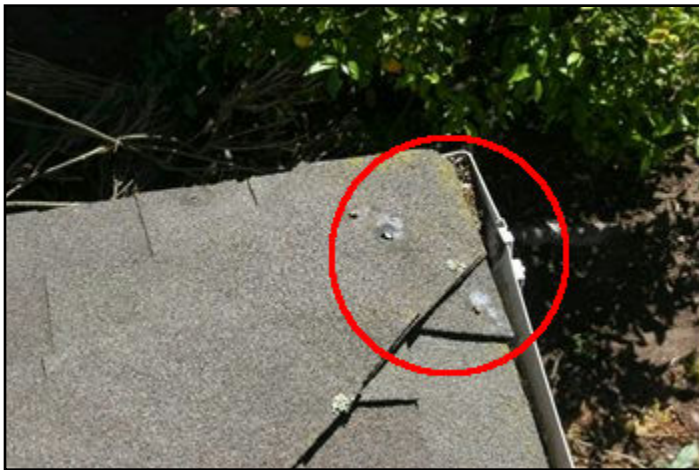
Several exposed fasteners were observed on shingles throughout the roof. Recommend sealing with silicone or asphalt to prevent moisture intrusion.

2. Exposed fasteners

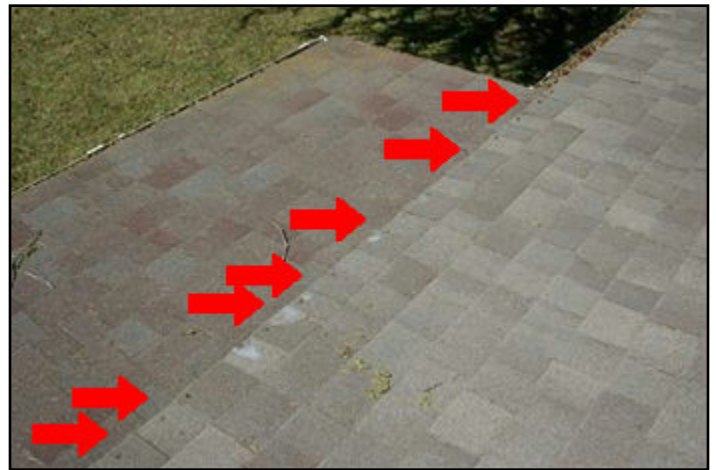
3. Exposed fasteners

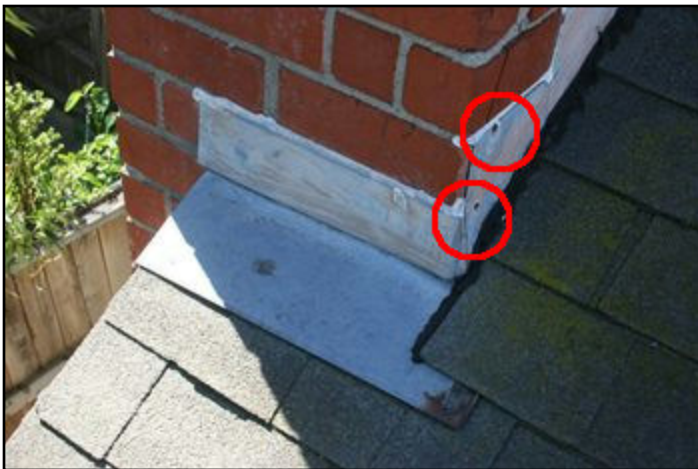
There is evidence of active leaks at the chimney/wall and chimney /roof flashings due to the deterioration of the caulking. Recommend sealing to eliminate gaps, cracks and holes.

5. Damage, loose, open seams, patched

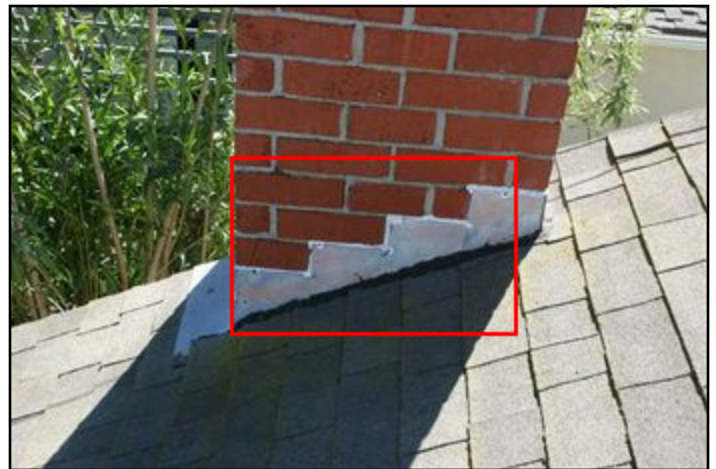
6. Damage, loose, open seams, patched

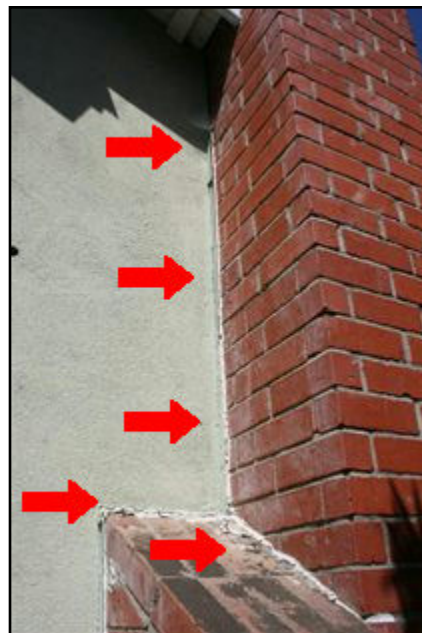
8. Damage, loose, open seams, patched

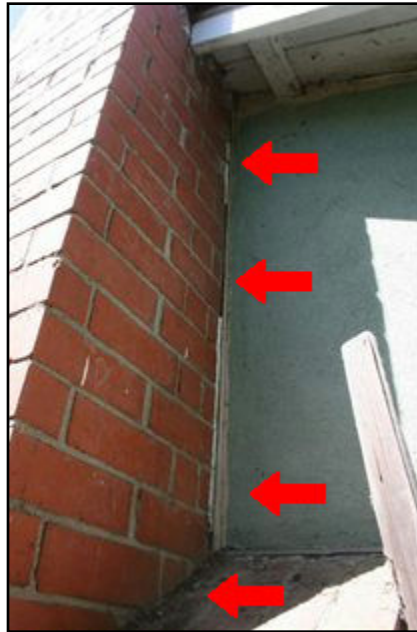
9. Damage, loose, open seams, patched

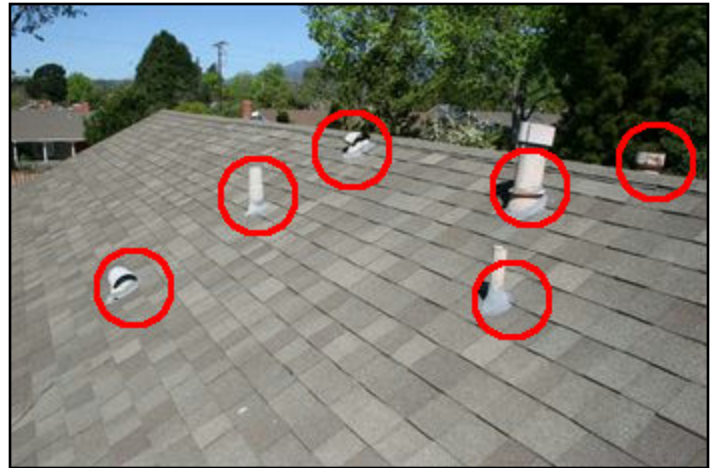
The caulking on several of the pipe/stack flashings was deteriorated. Recommend sealing with appropriate caulking.

11. Exposed joint

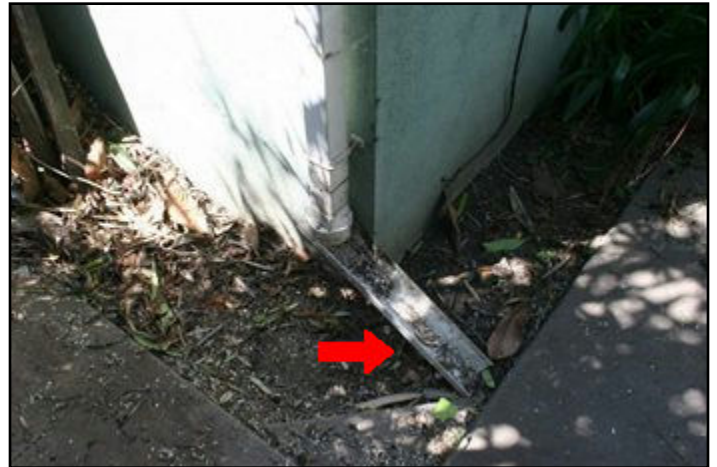
Several downspouts were noted discharging close to the home. In order to prevent seasonal undermining of the foundation I recommend elongating the downspout to at least 6' away from the edge of the home where possible.

16. Should discharge 6ft. from home

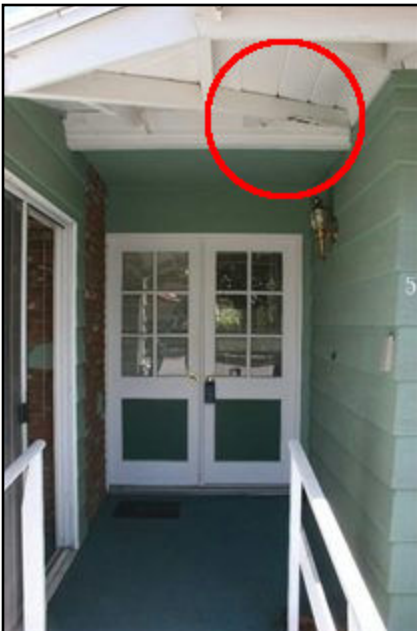
Several areas of dry rot and insect damage were observed on various parts of the fascia and soffit. Recommend pest inspection. Recommend repairing as needed..

17. Rot or insect damage

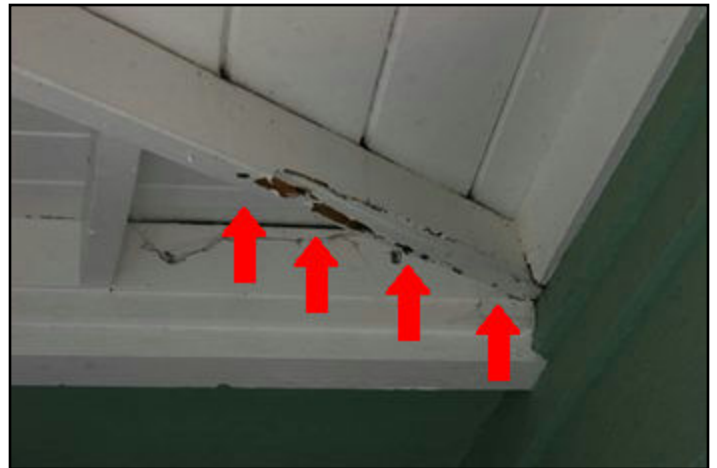
18. Rot or insect damage

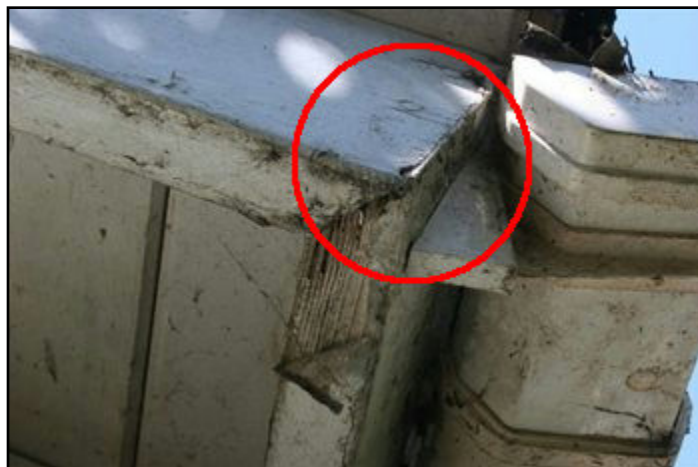
19. Rot or insect damage

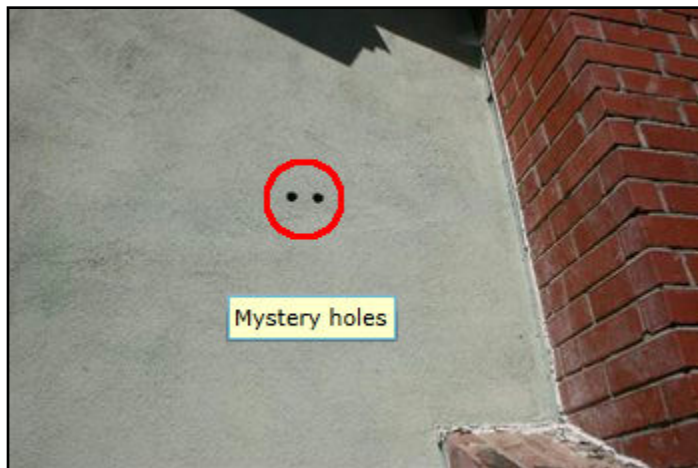
Holes in the stucco were observed on the east side of the exterior wall. Recommend filling to prevent moisture intrusion.

20. Moisture penetration

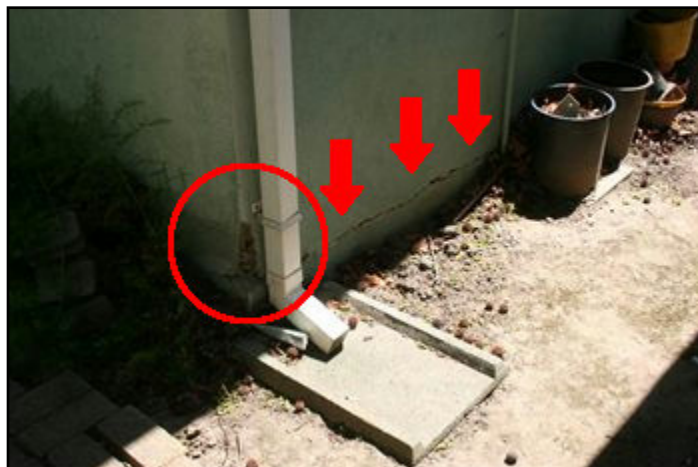
A large crack and damaged corner was noted. Recommend repair to prevent moisture intrusion or further material deterioration.

21. Mechanical damage

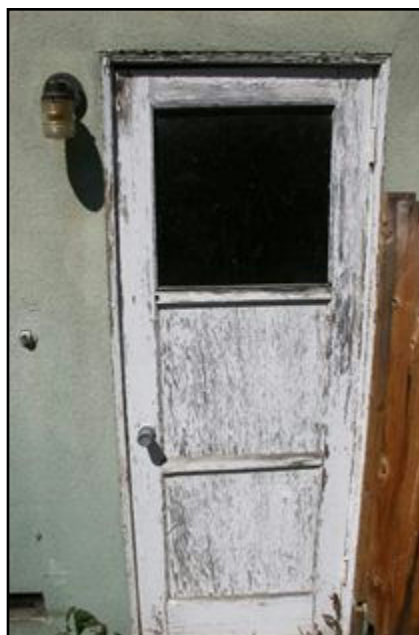
Implication(s): Cosmetic defects | Chance of damage to finishes and structure | Poor security

22. Damage

Task: Replace

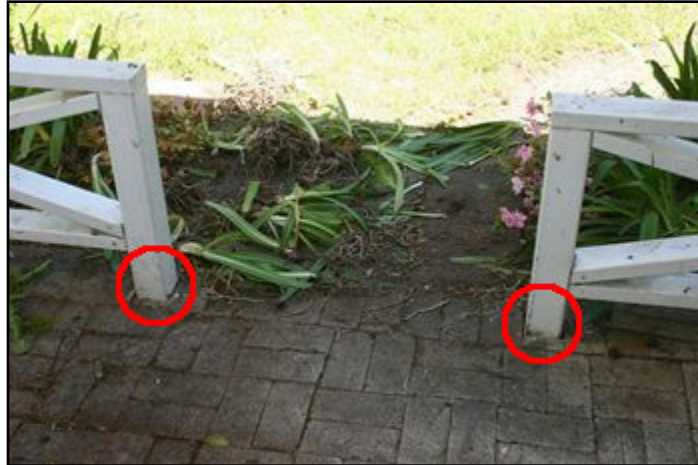
Rot was observed at the rear porch handrail where soil and wood were in contact.

23. Rot

Task: Repair or replace

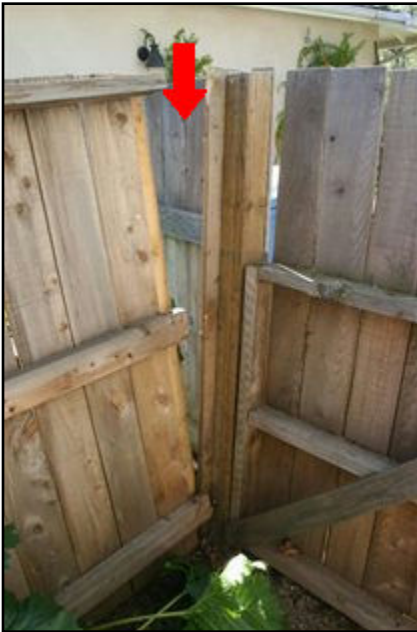
25. Gate damaged

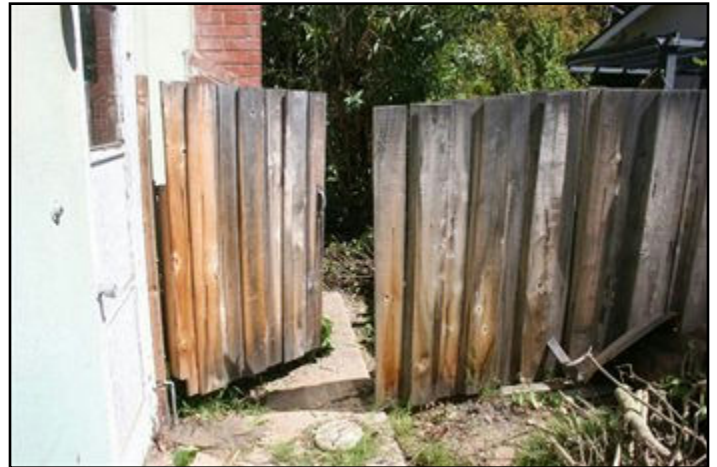
26. Gate damaged

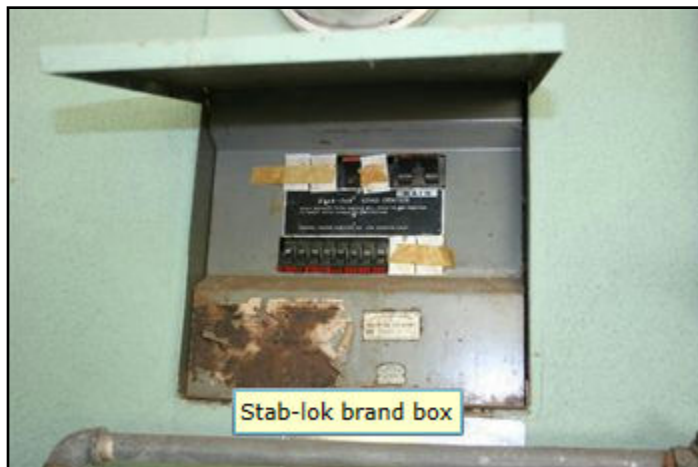
FPE Stab-lok breaker boxes and breakers were observed at residence; Federal Pacific Electric (FPE) sold millions of panels between the 1950's and 1980's. Testing by the Consumer Product Safety Commission has shown these breakers to have an unacceptably high rate of failure, which creates a safety hazard. Testing has proven that virtually every panel installed in the United States contains defective breakers. FPE falsified their UL testing, making their UL listing void. Approximately 1 out of 3 breakers are defective. If a breaker fails to trip when it should, the wires in the home that are supposed to be protected can start on fire. Further evaluation by a licensed electrician is recommended.

33. Obsolete service box

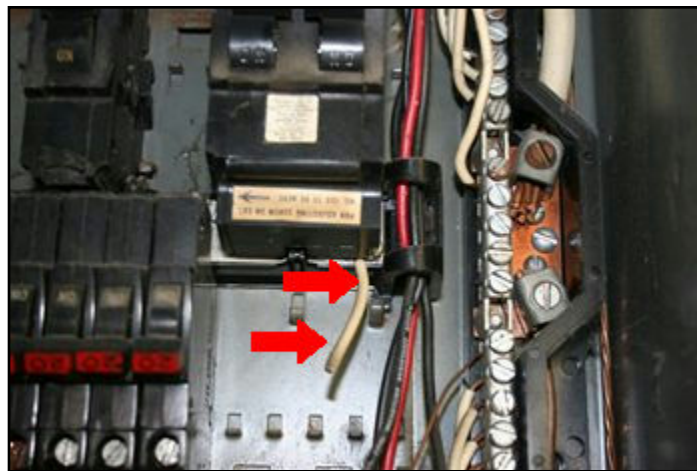
35. Abandoned wires in panel

Task: Remove

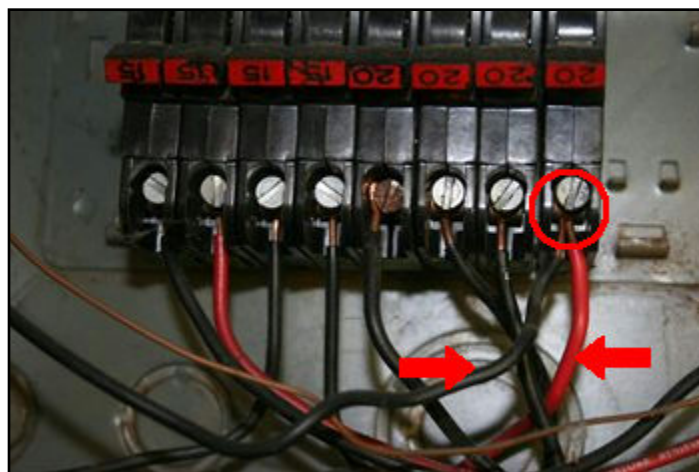
A double tap was observed at the service panel. Recommend repair by a licensed electrician.

36. Double taps

Task: Correct wiring

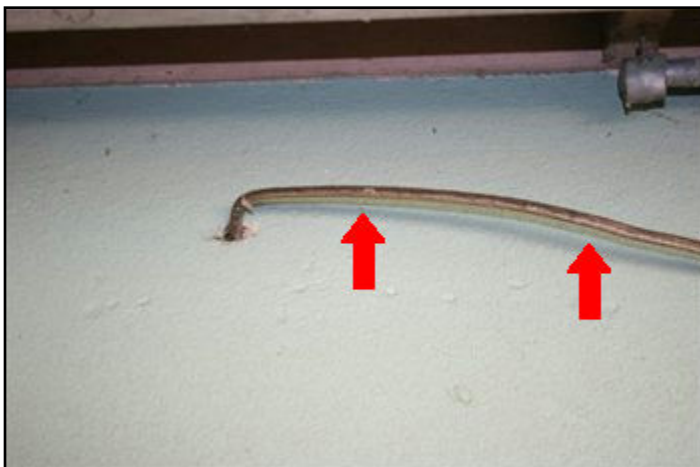
A variety of improper wiring installations were observed in the exterior utility closet as well as the garage and kitchen. Recommend a licensed electrician evaluate and correct.

37. Improper

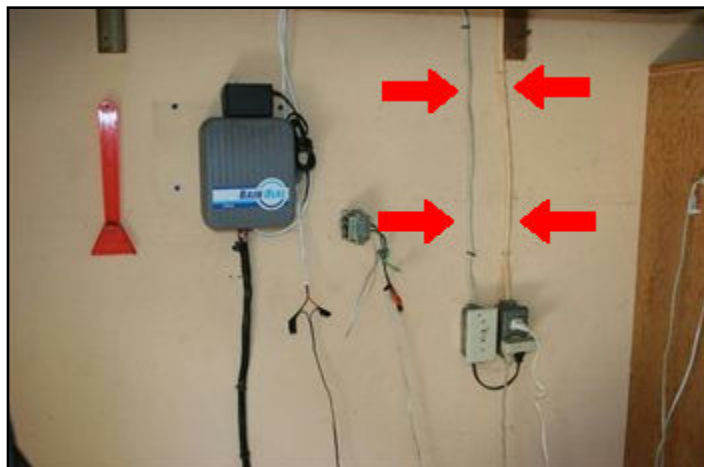
38. Improper

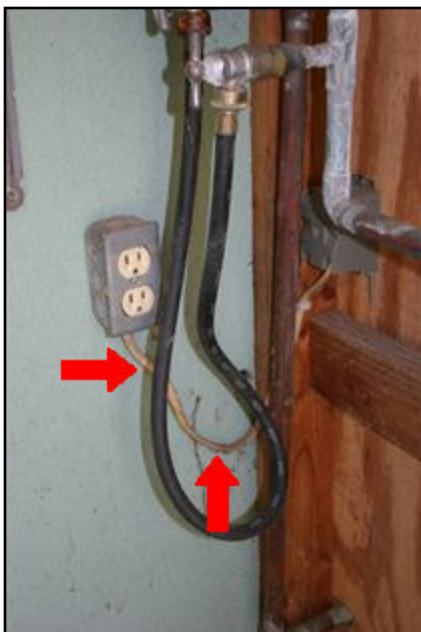
39. Improper

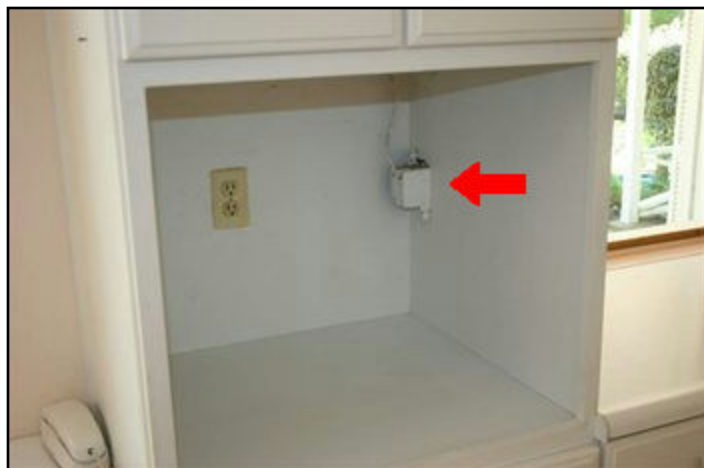
40. Improper

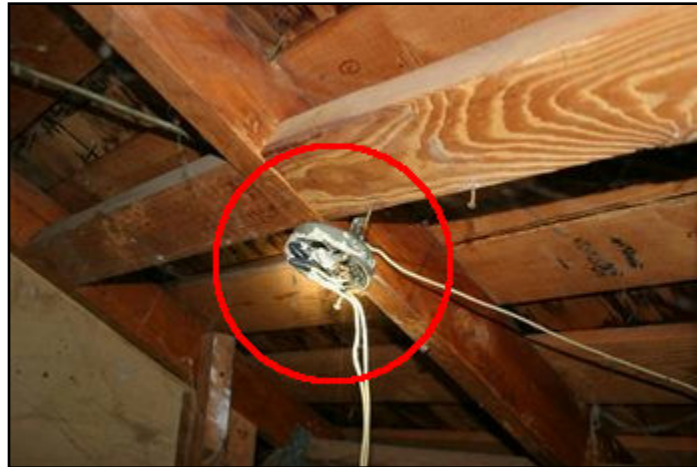
41. Cover loose or missing

Task: Replace cover

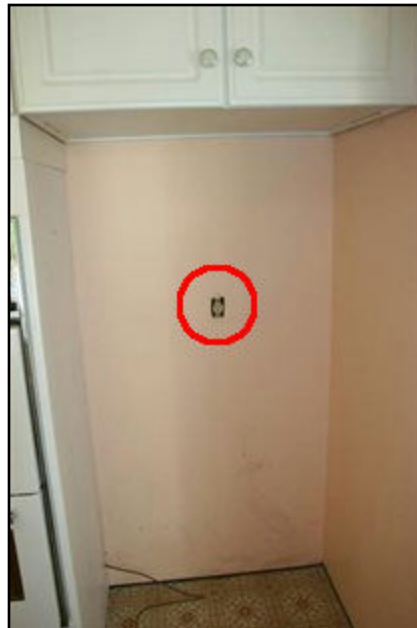
42. Missing

**Task:** Replace

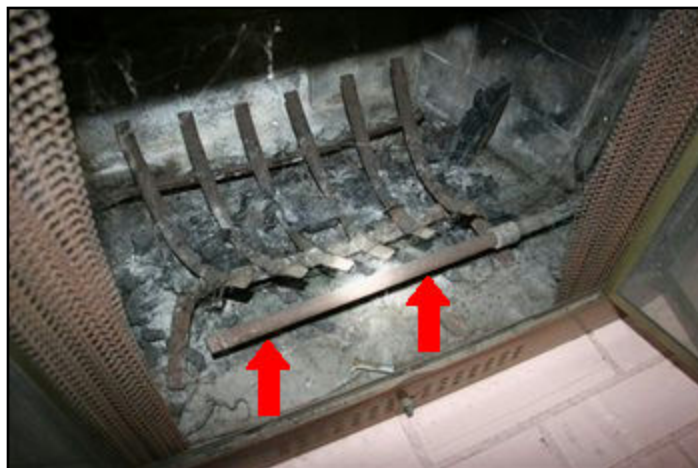
46. Pipe rusted

Task: Replace

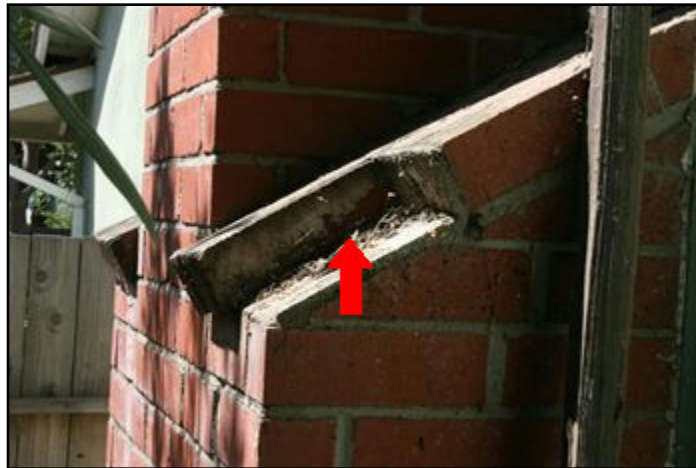
*47. Loose, missing or deteriorated masonry*

**Task:** Repair

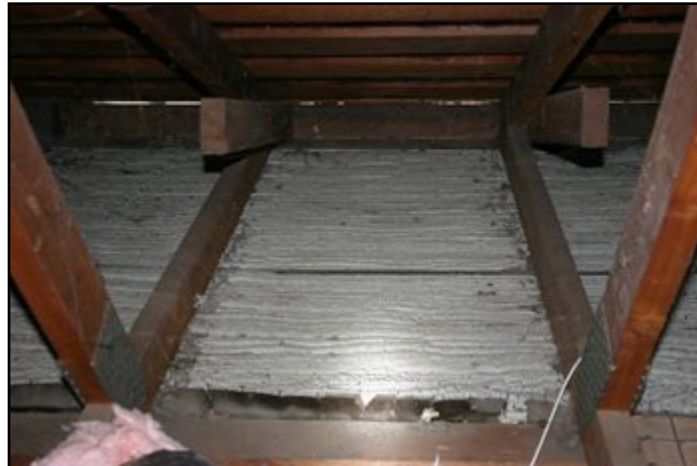
The amount of insulation observed in the attic space was inconsistent. Some areas had some while other areas had none. Recommend evaluating needs and providing recommended amounts to control heating and cooling costs.

48. Amount inadequate

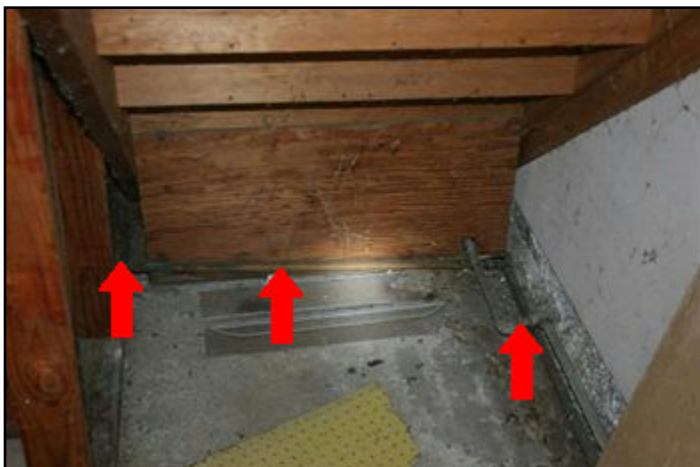
• **Condition:** Improperly run gas and water lines were observed in the garage. Recommend further evaluation and correction from a licensed plumber.

50. Improper

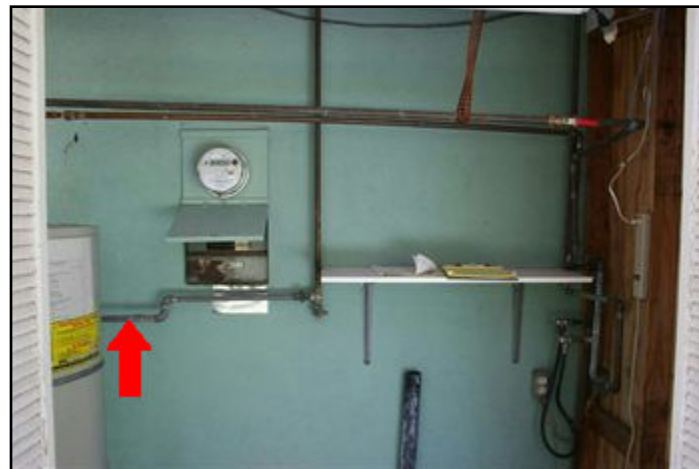
The gas supply line was not properly supported. Recommend further evaluation and correction by a licensed plumber.

55. Inadequate support

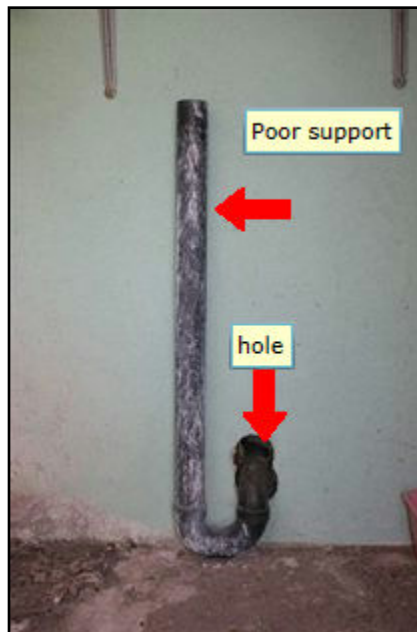
The drain pipe for the washing machine was not supported properly and there was a hole in the stucco at the entry point into the house. Recommend supporting drain and patching hole.

56. Poor support

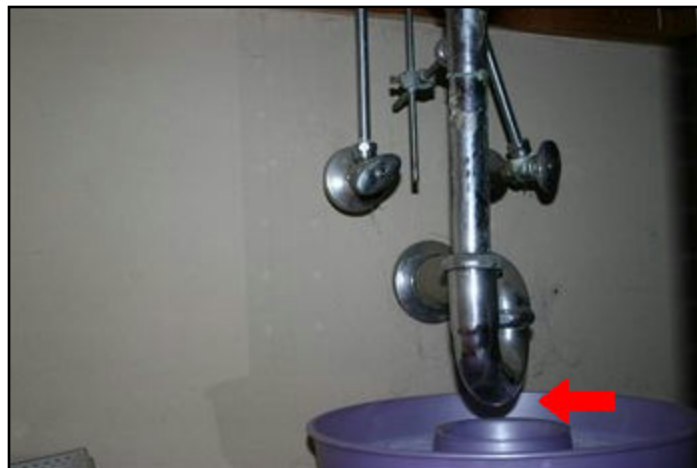
A leaky p-trap was observed in the master bedroom stand alone sink area.

57. Leak

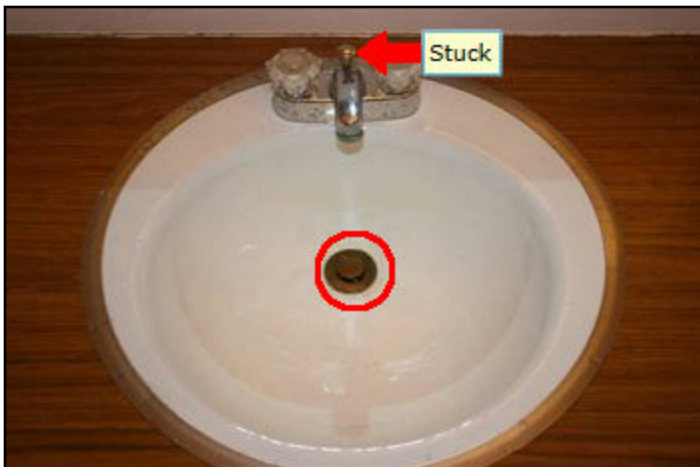
58. Drain stop ineffective

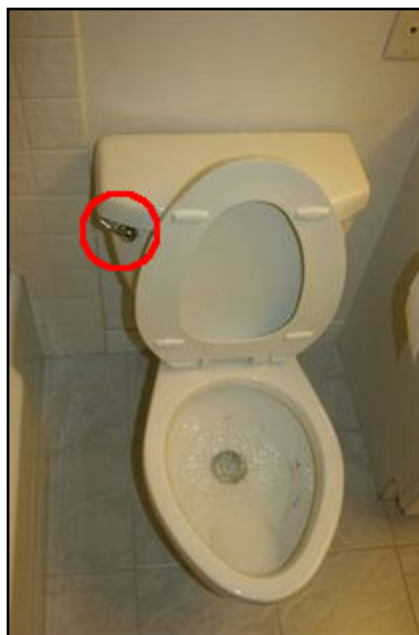
The flushing mechanism sticks in the open position causing the water to run continuously. Recommend repairing.

60. Running continuously

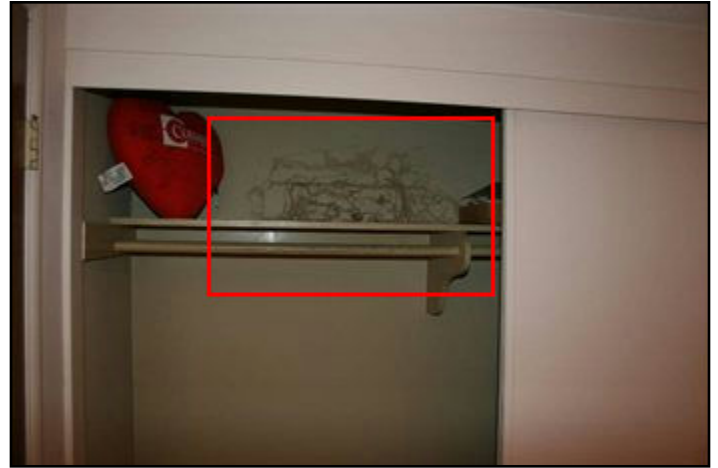
• **Condition:** Evidence of termite infestation was observed in multiple areas around the home. Recommend pest inspection, treatment and repair of affected areas.

62. Evidence of termites

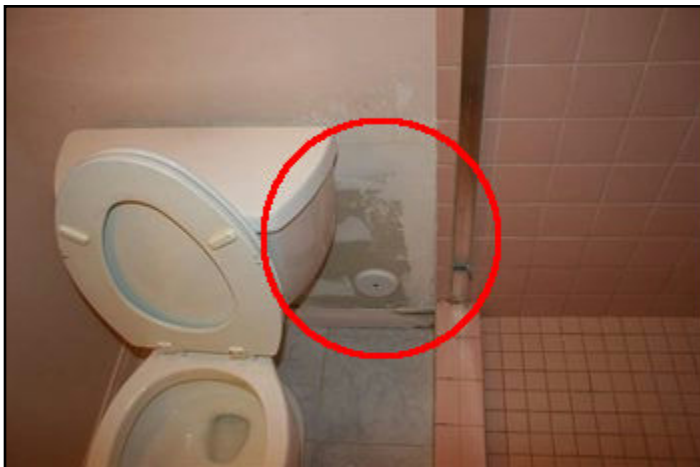
64. Water damage

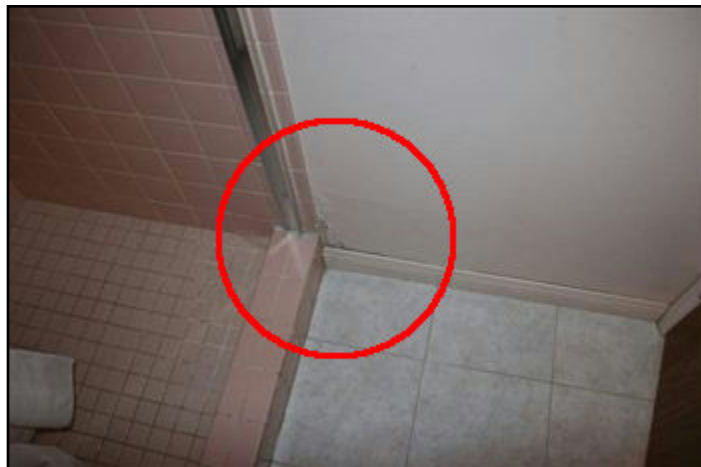
65. Water damage

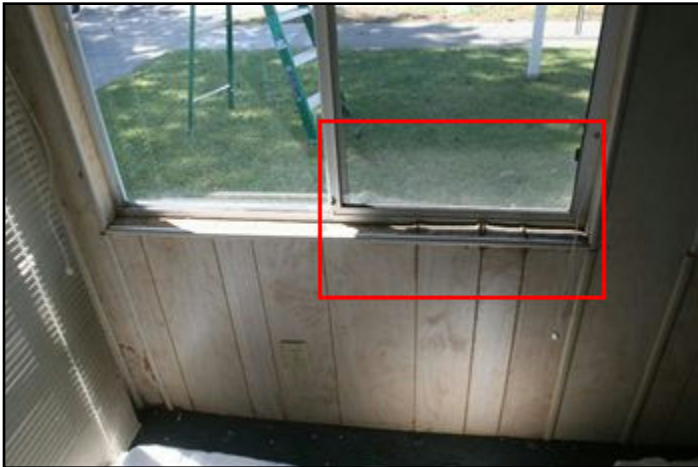
Evidence of moisture intrusion from either condensation or a water leak was observed in the sun-room and loft area windows. Recommend further evaluation and repair.

66. Water leaks

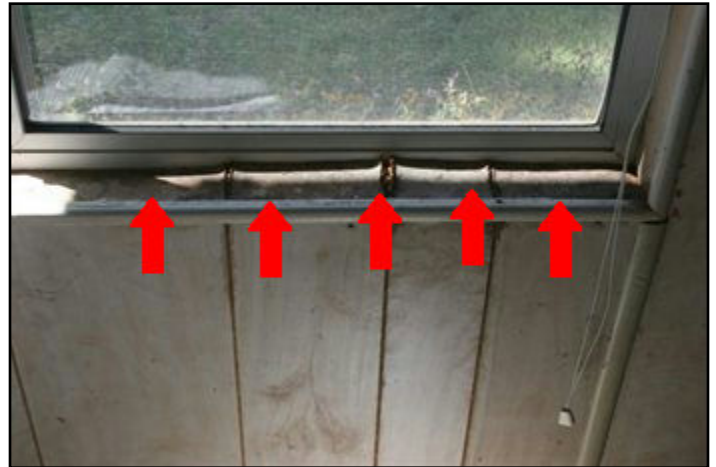
67. Water leaks

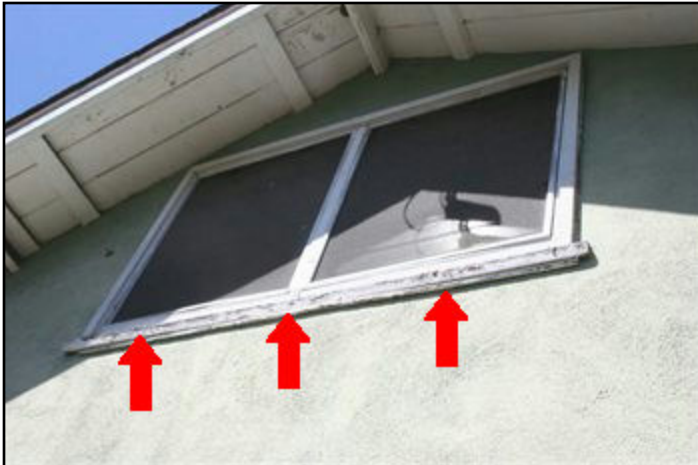
68. Water leaks

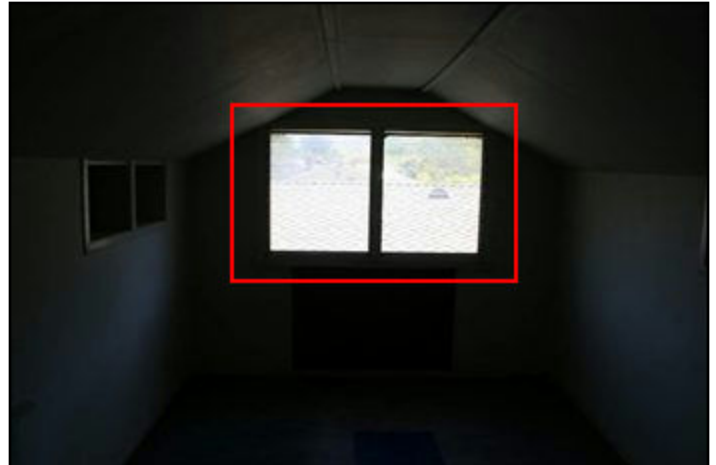
69. Water leaks

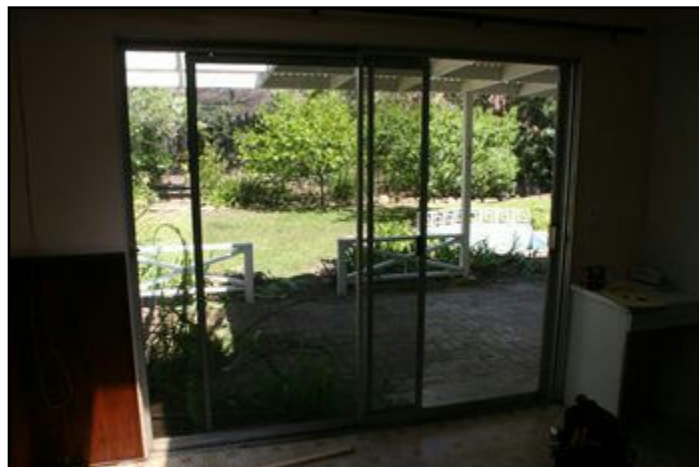
70. Stiff

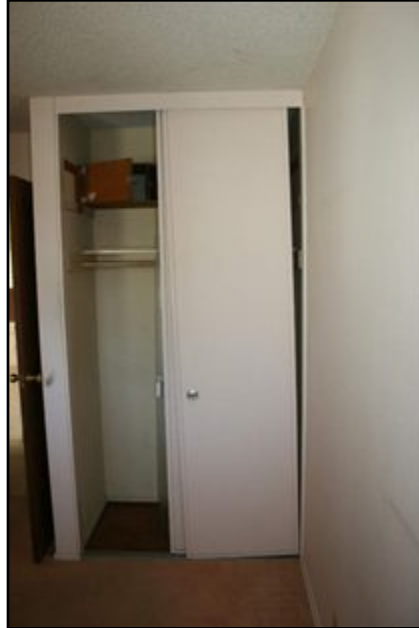
71. Inoperable

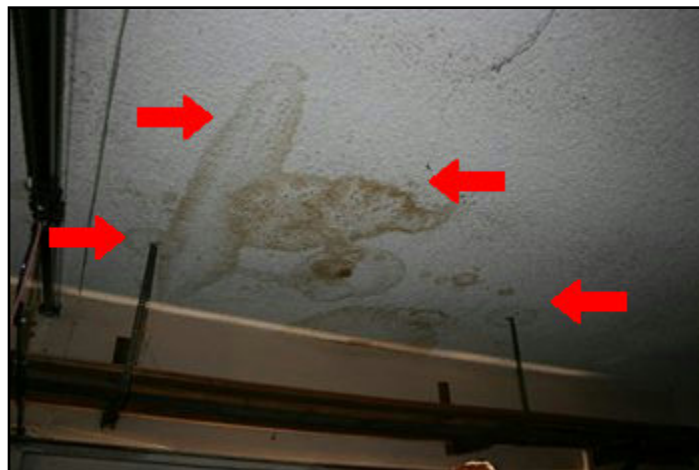
**Condition:** • Evidence of moisture intrusion was observed on the garage ceiling. It appears to be old but I recommend requesting disclosure to clarify if issue was resolved.

72. Evidence of moisture

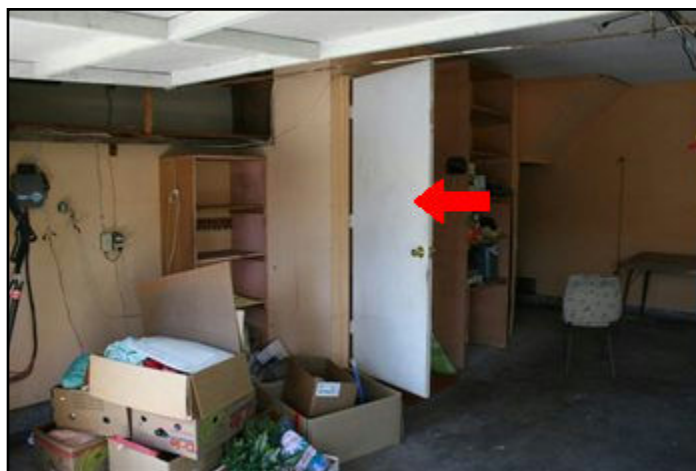
73. Door not fire rated or exterior type

Task: Replace

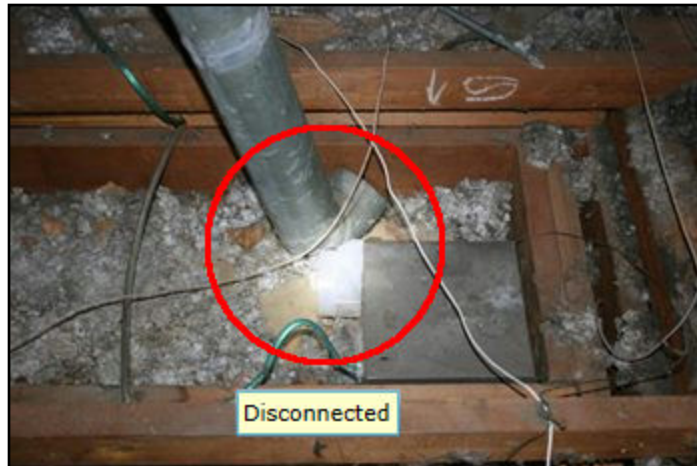
75. Leak

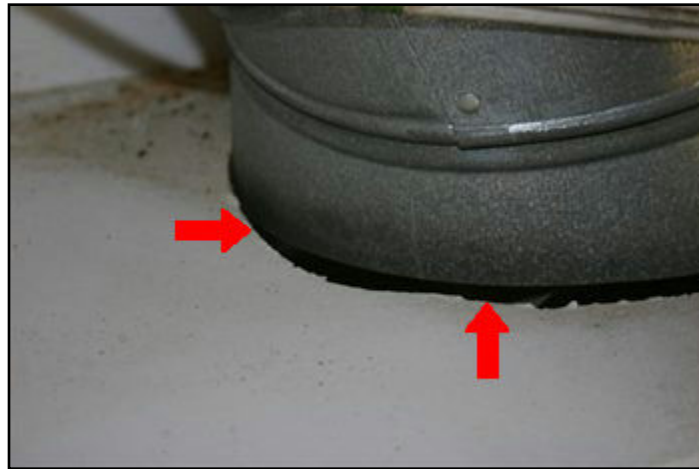
76. Leak

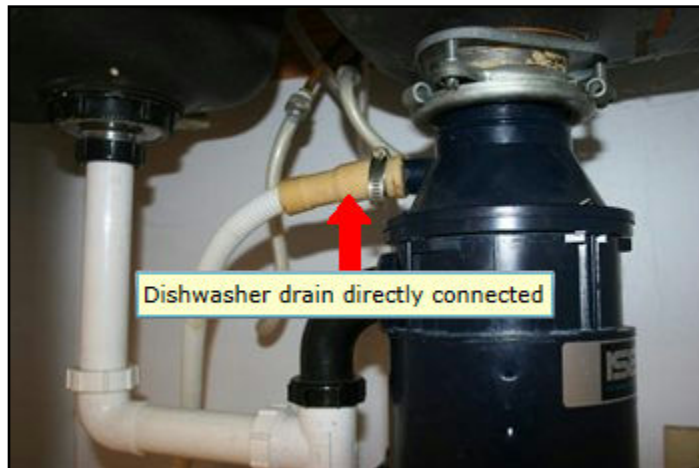
77. Backflow prevention missing

**Task:** Provide
