# YOUR INSPECTION REPORT

743 Woodland Drive  
Santa Barbara, CA 93108

Tuesday, May 14, 2013

Report No. 1043, v.2

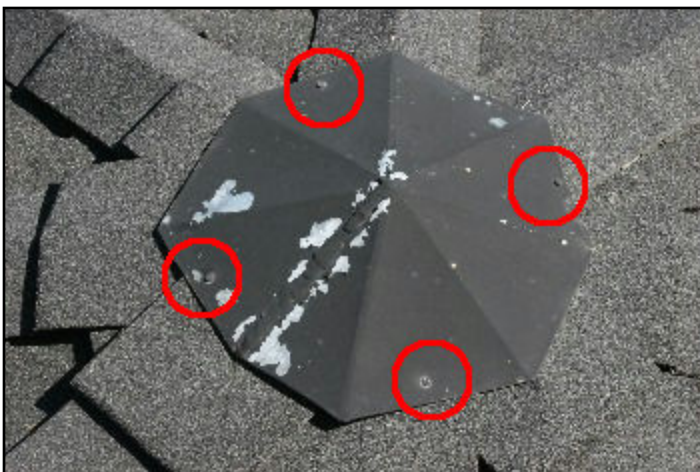
Exposed fasteners were observed on a variety of roof flashing including pipe/stack, chimney, and roof/wall. The pictures in this report give you a general idea of locations where the observations were made. Recommend locating and sealing all exposed fasteners on the roof.

2. Exposed fasteners

**Task:** Seal exposed fasteners

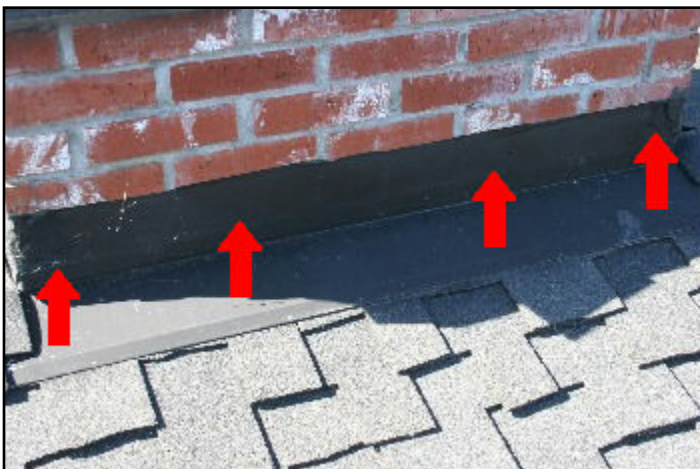
4. Exposed fasteners

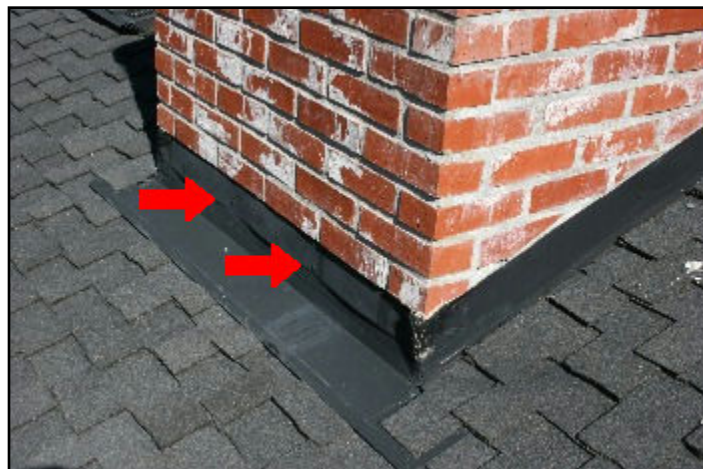
5. Exposed fasteners

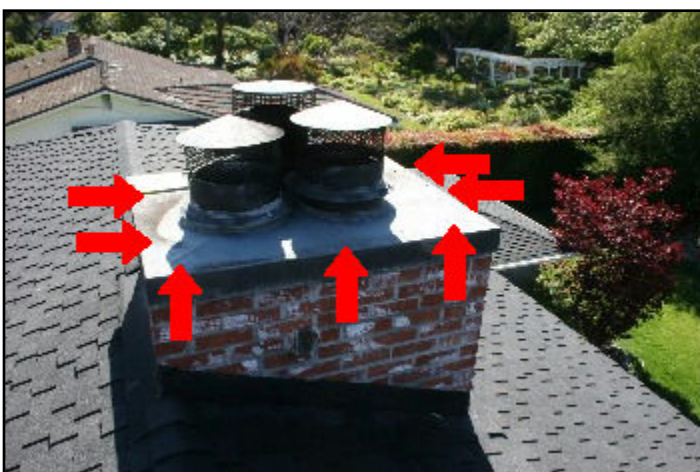
6. Exposed fasteners

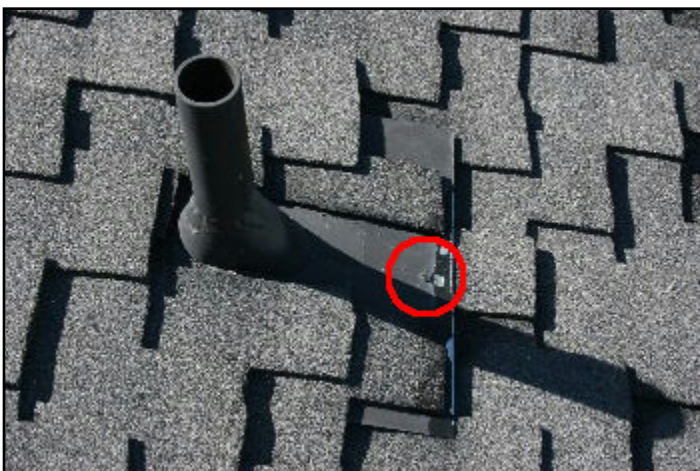
8. Exposed fasteners

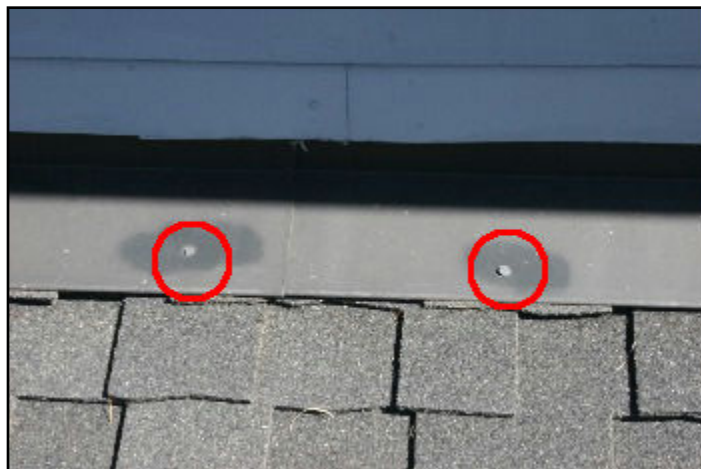
10. Exposed fasteners

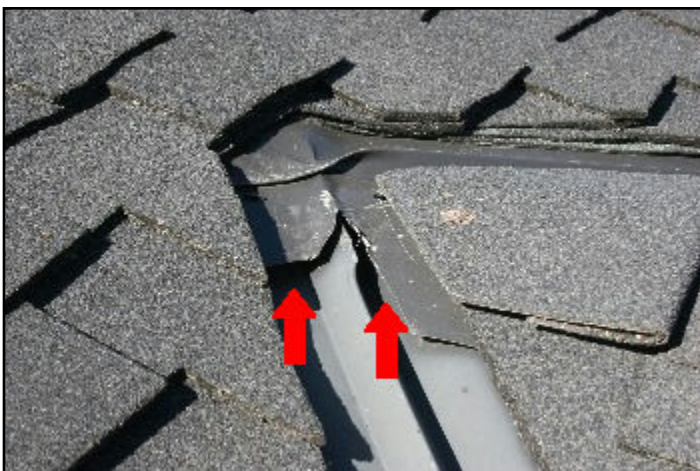
**Condition:** • Large gaps were noted on several pieces of the valley flashing overlap joints. Recommend caulking to prevent seasonal moisture intrusion.

11. Gap

**Task:** Seal gaps

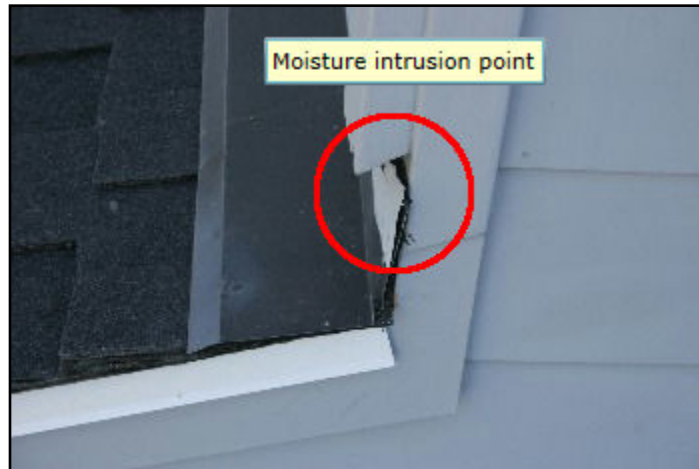
13. Open gap

**Task:** Seal with caulking

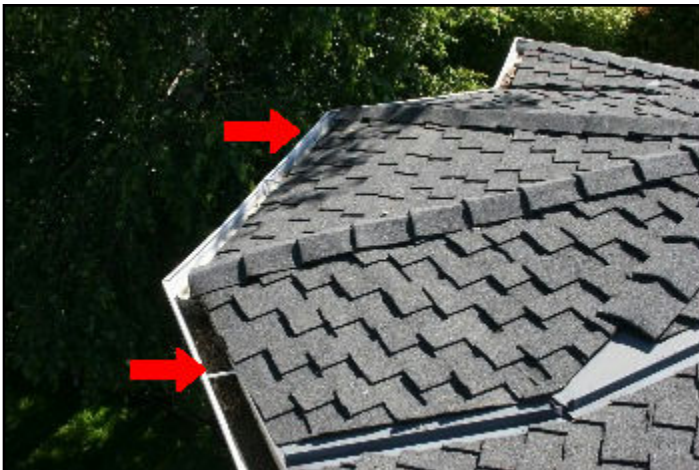
Some areas of gutter had a layer of seasonal debris clogging flow. Recommend cleaning to ensure proper flow.

19. Clogged

**Task:** Clean

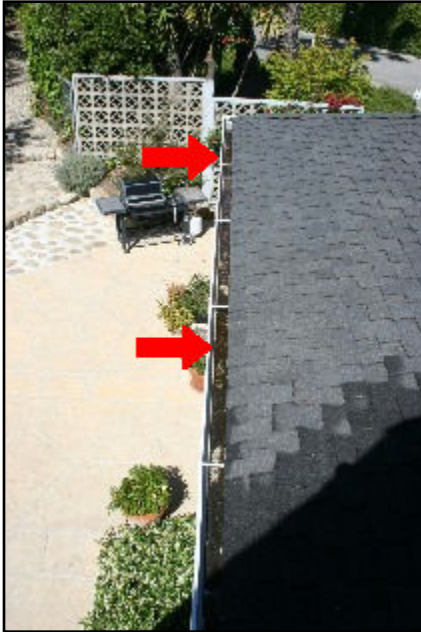
21. Clogged

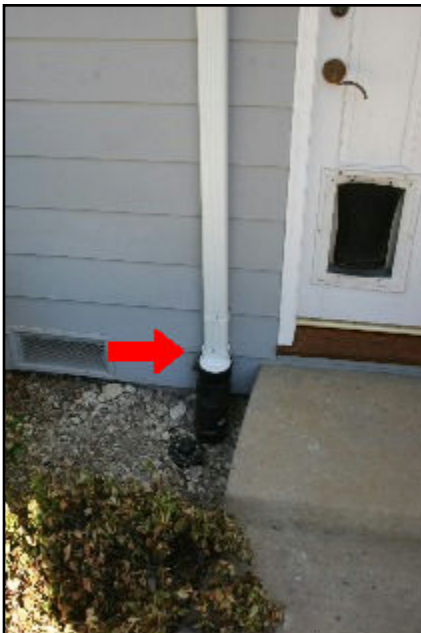
Several downspouts were observed discharging below grade. It is important to ensure proper water flow when discharging below grade as clogs often go unnoticed. Recommend testing and ensuring termination point is satisfactory.

23. Downspouts discharging below grade

**Task:** Test for flow and monitor

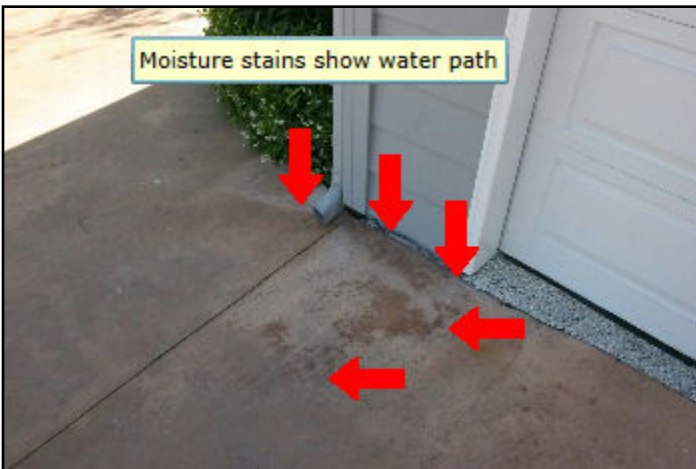
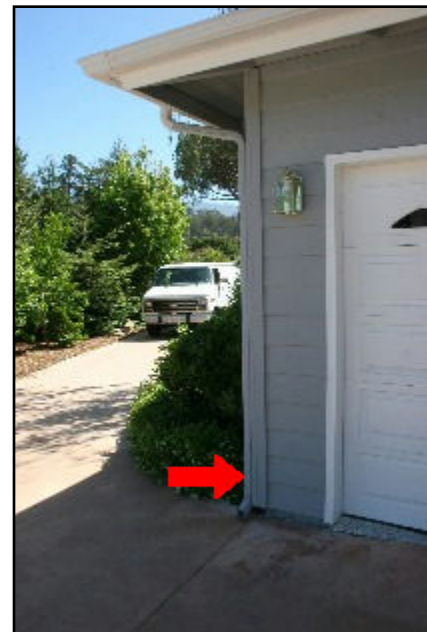
The downspout by the garage was observed discharging too close to the structure. Recommend elongating end of downspout to direct run off further away from garage and plant bed.

25. Downspouts end too close to building

26. Downspouts end too close to building

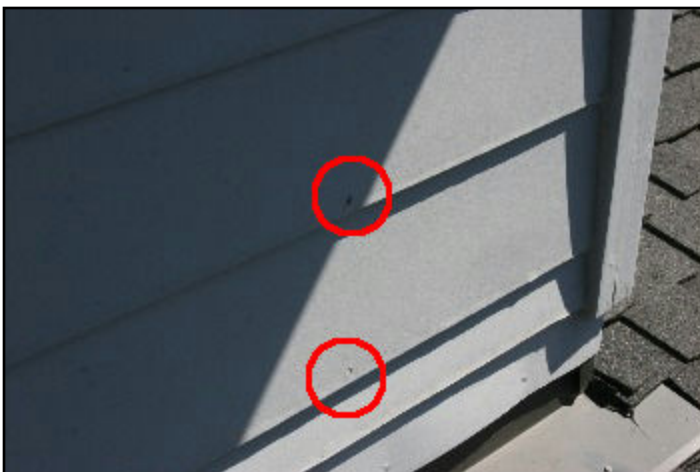
**Condition:** • The wooden siding had exposed fasteners in a variety of different areas. Recommend sealing the exposed nail heads with caulking or countersinking and patching as needed.

32. Exposed fasteners

**Task:** Protect with caulking

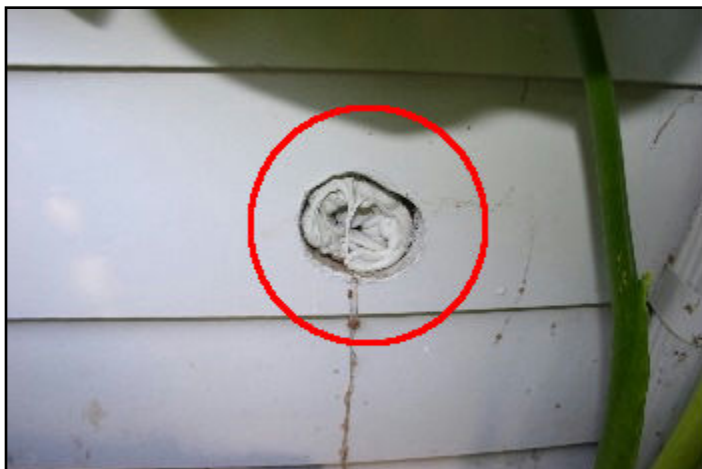
**Condition:** • Holes through the siding were observed at an exterior light fixture and speakers. Recommend sealing to prevent moisture or pest intrusion.

34. Hole in siding

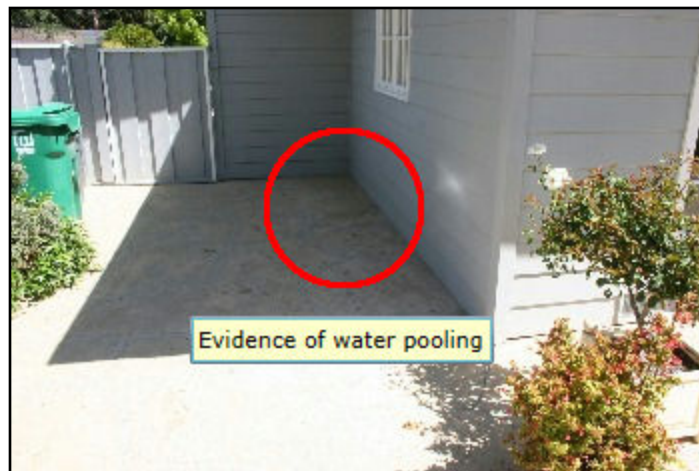
46. Slope toward house

**Task:** Redirect water

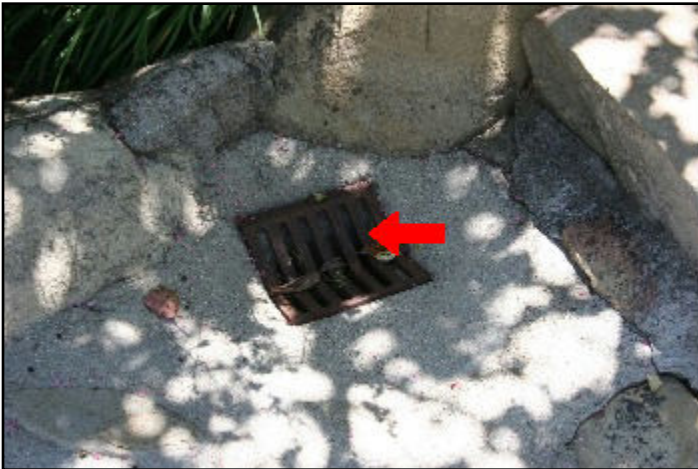
48. Clogged catch basins

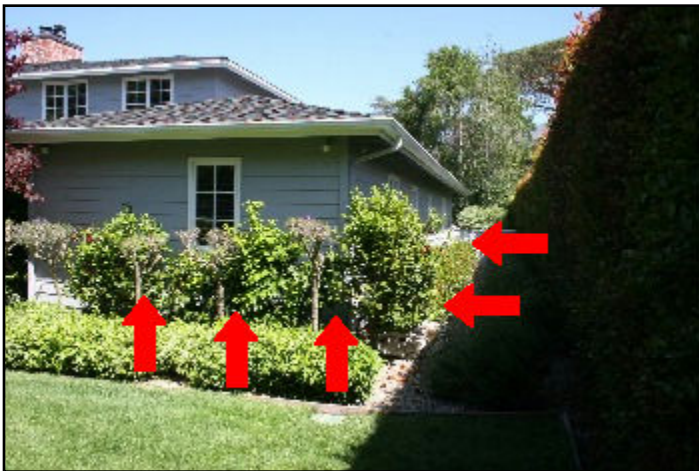
51. Trees or shrubs too close to house

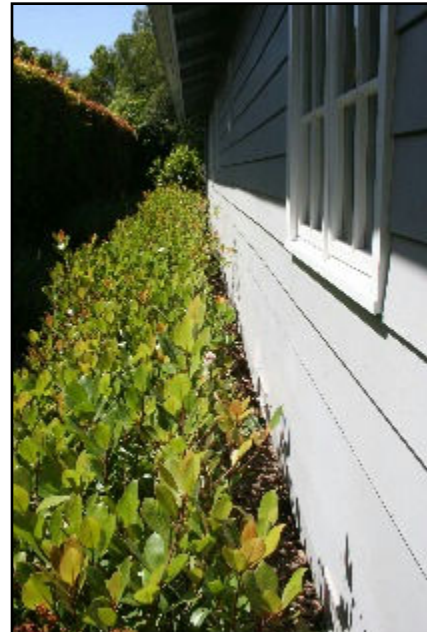
54. Trees or shrubs too close to house

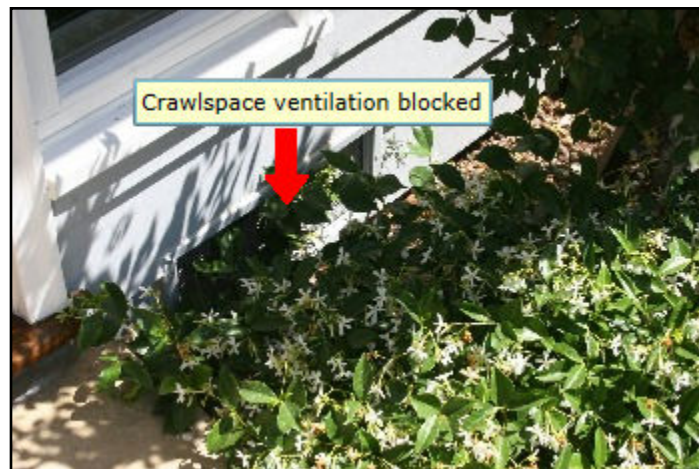
55. Trees or shrubs too close to house

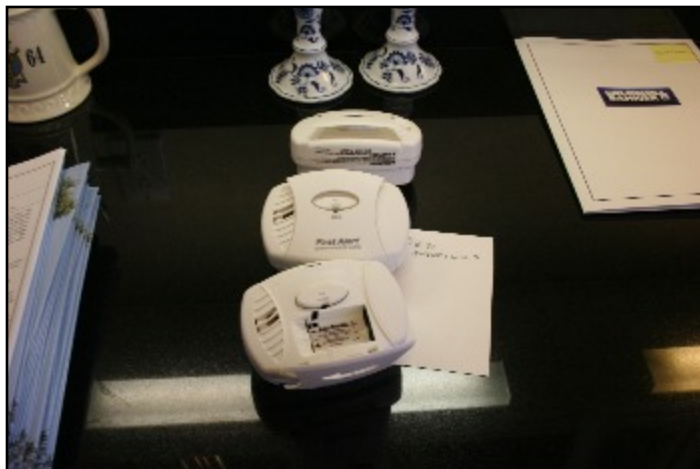
69. Need installation

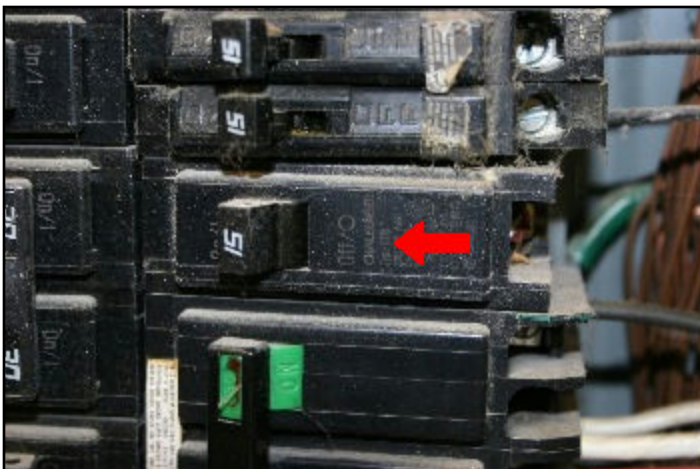
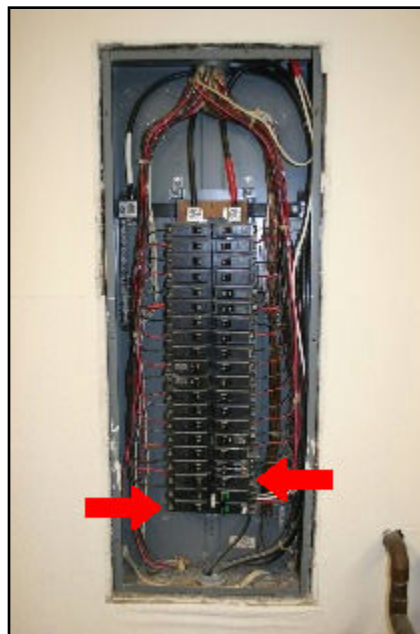
23. Condition: • 2 circuit breakers were observed in the on position but no live wire was attached.

70. On but not in use

71. On but not in use

Task: Turn off if unused

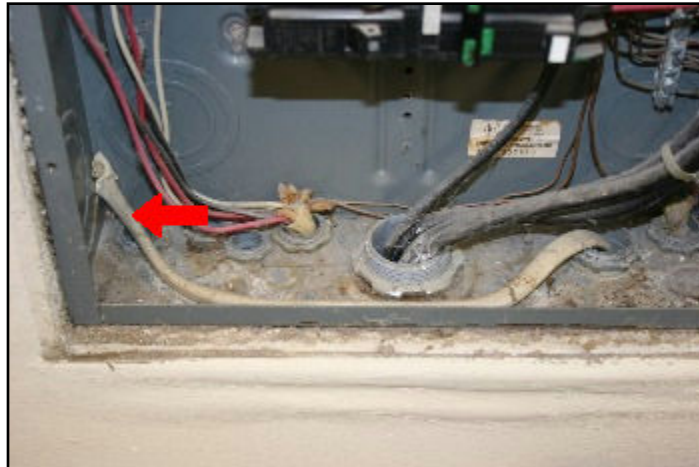
**24. Condition:** • An abandoned sheathed branch circuit conductor was observed in the garage distribution panel. Recommend proper capping or removal by a licensed electrician.

**Implication(s):** Electric shock; fire hazard

73. Abandoned wire

**Task:** Cap off properly

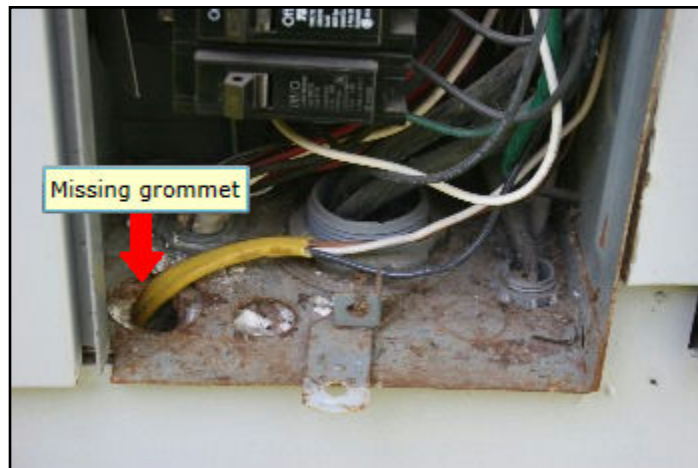
25. Condition: • [Not well secured](#)

Branch circuit conductor observed without appropriate fastener. Recommend repair by a licensed electrician.

74. Not well secured

**Task:** Secure using proper grommet

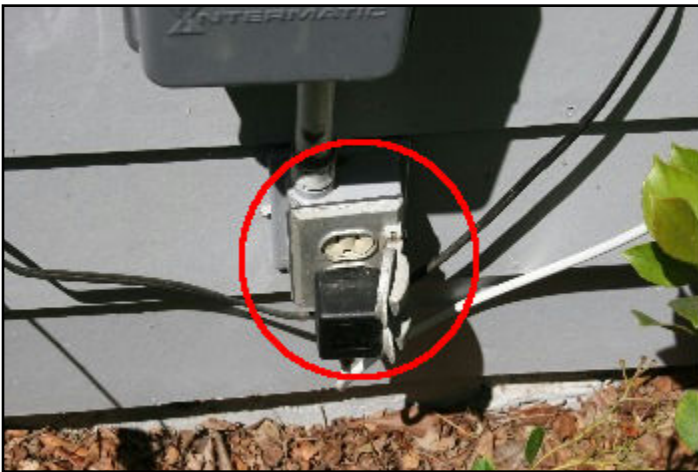
### **28. Condition:** • [Ground Fault Interrupter \(GFI\) needed](#)

GFCI receptacles are required by the US National Electrical Code in locations where water and electricity are likely to come into contact, such as in kitchens, bathrooms, garages, and outdoors. Several GFCI receptacles I tested were okay but several were non operational while others were faulty. Recommend having a licensed electrician install and replace GFCI receptacles as needed throughout.

77. Ground Fault Interrupter (GFI) needed

**Task:** Repair or replace as needed

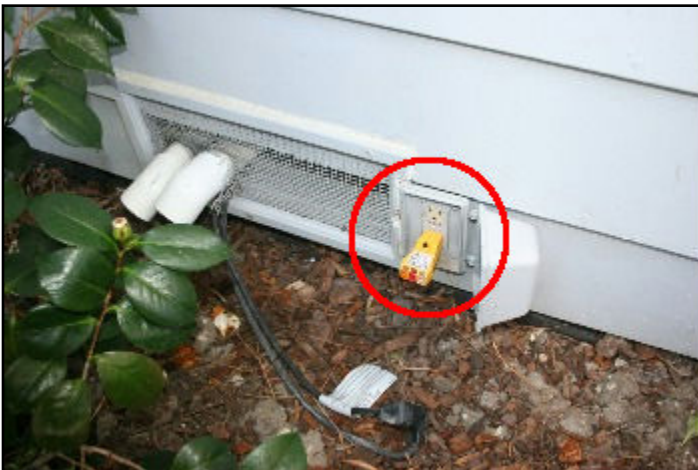
79. No power at GFCI

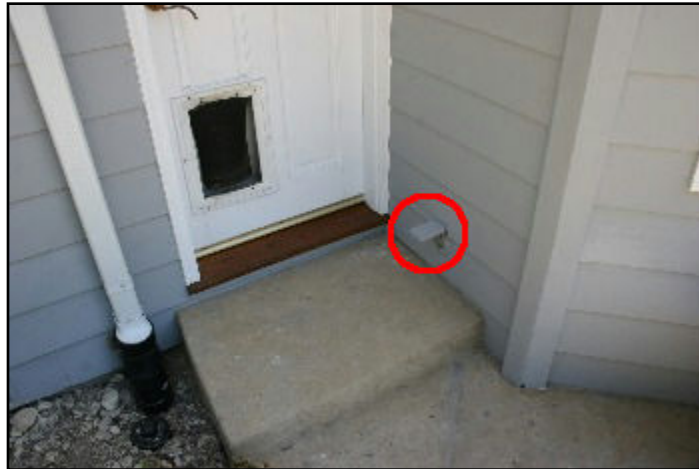
81. GFI test faulty

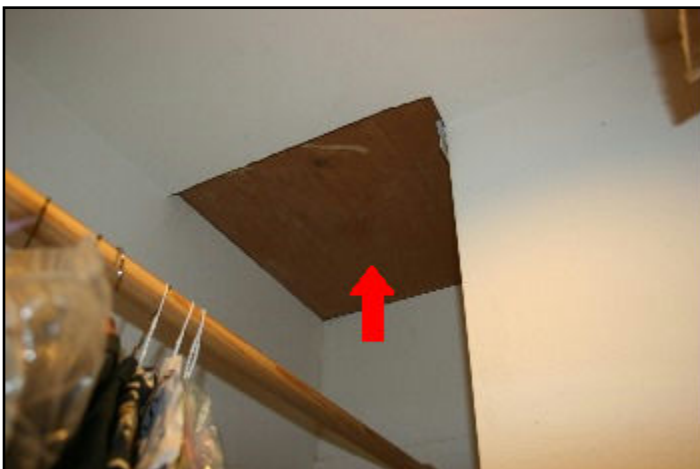
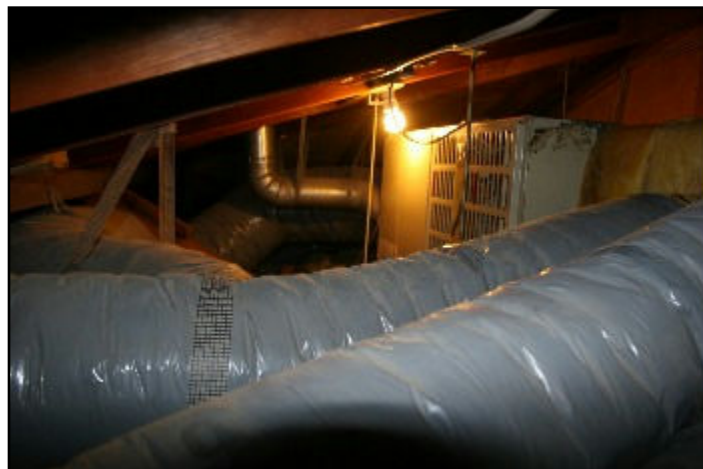
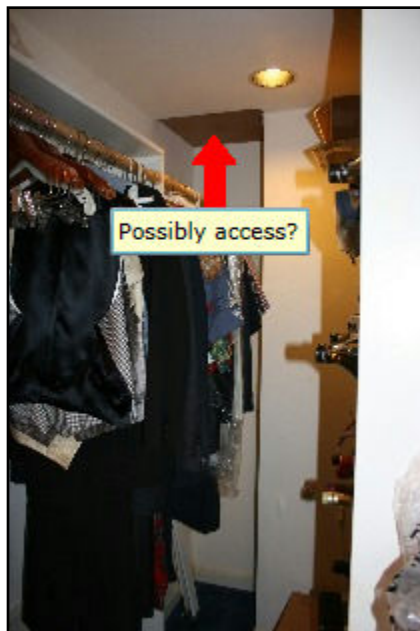
The access to the furnace was restricted through the attic hatch. There was no way to get to the service platform. Another hatch was observed in a closet but access to that hatch was restricted by clothing and storage.

89. Restricted access

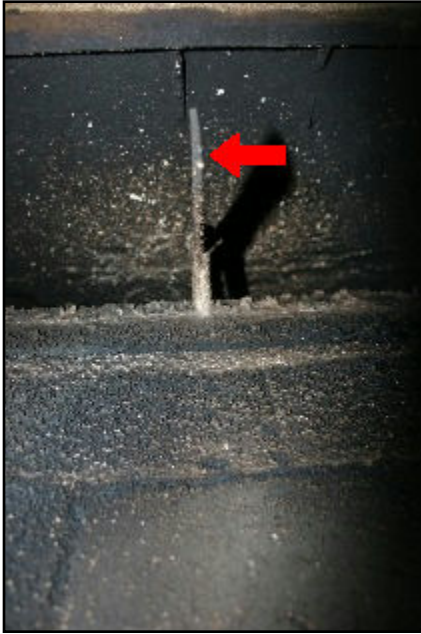
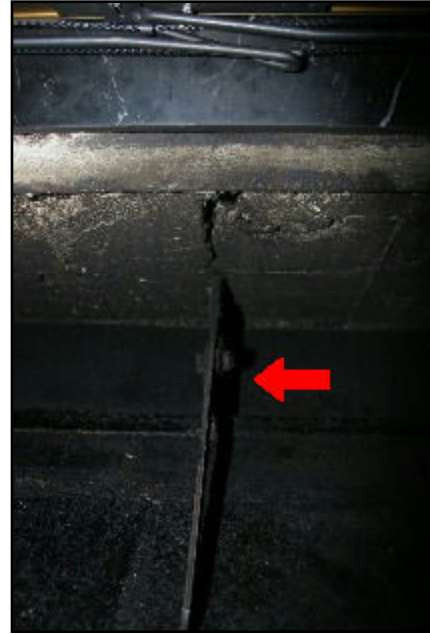
32. **Condition:** • [Damper in existing fireplace not fixed open](#)

Gas run fireplaces must have a fixed open damper to allow the escape of hazardous gases at all times. Recommend providing.

**Implication(s):** Hazardous combustion products entering home

92. Damper in existing fireplace not fixed open

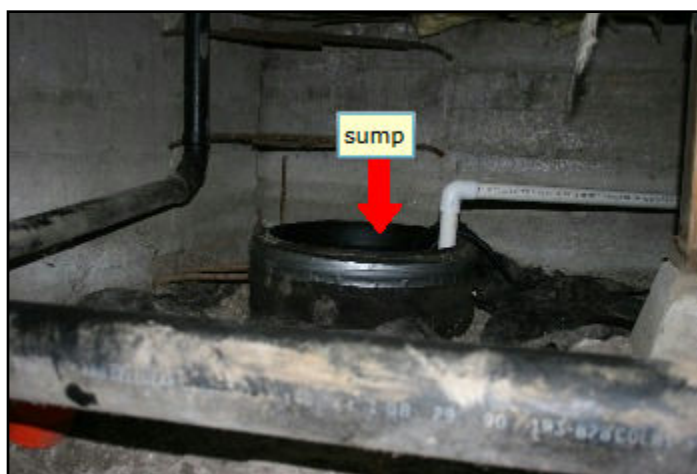
**35. Condition:** • [Inoperative](#)

**Implication(s):** Chance of water damage to contents, finishes and/or structure

103. Inoperative

**Task:** Request disclosure

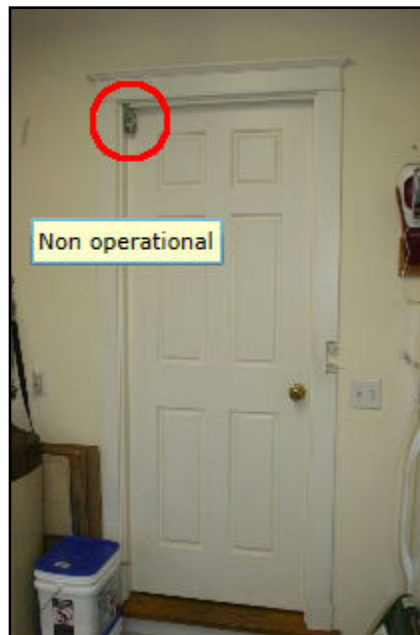
42. **Condition:** • [No self closer](#)

**Implication(s):** Hazardous combustion products entering home

111. No self closer

**Task:** Repair or replace
