YOUR INSPECTION REPORT

1111 Hodges Lane
Montecito, CA 93108

Monday, June 10, 2013

Report No. 1058

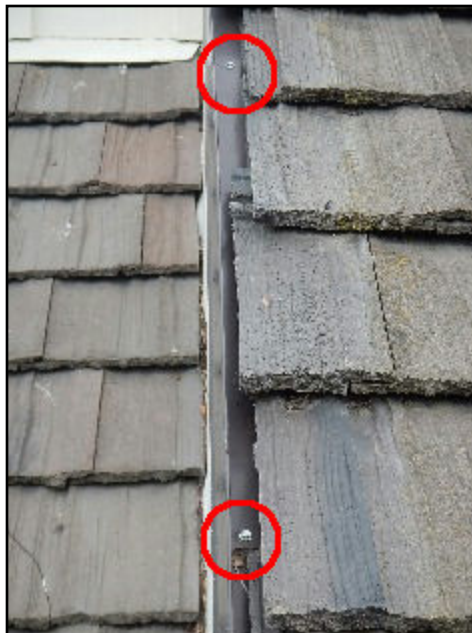
13. Exposed fasteners

Condition: • Exposed fasteners

Exposed fasteners were observed.

Implication(s): Chance of water damage to contents, finishes and/or structure

Task: Seal with appropriate caulking

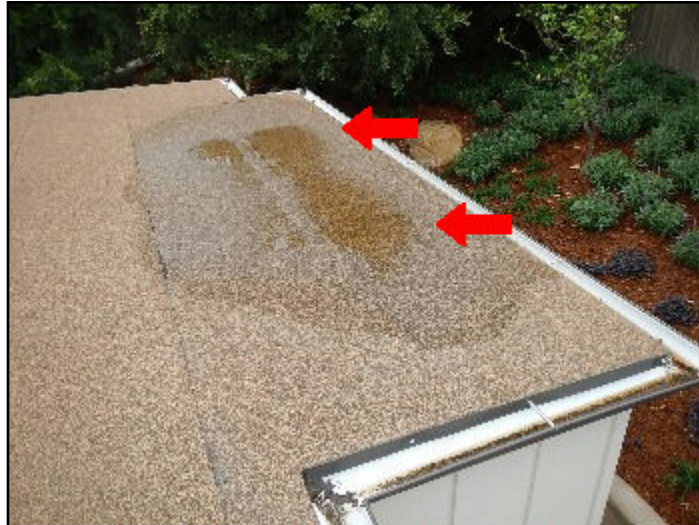
16. *Ponding*

Condition: • Ponding

Evidence of ponding was observed on the northeast side of the flat roof.

Implication(s): Chance of water damage to contents, finishes and/or structure | Chance of movement

Task: Monitor

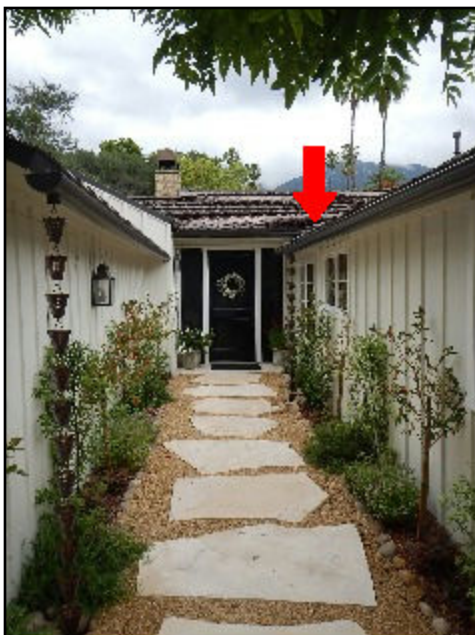
23. Discharging onto roof

Condition: • Discharging onto roof

The gutter above the entryway was discharging toward the slope of the roof. Recommend capping the end and making a drain into the gutter directly beneath it.

Implication(s): Material deterioration

Task: Redirect

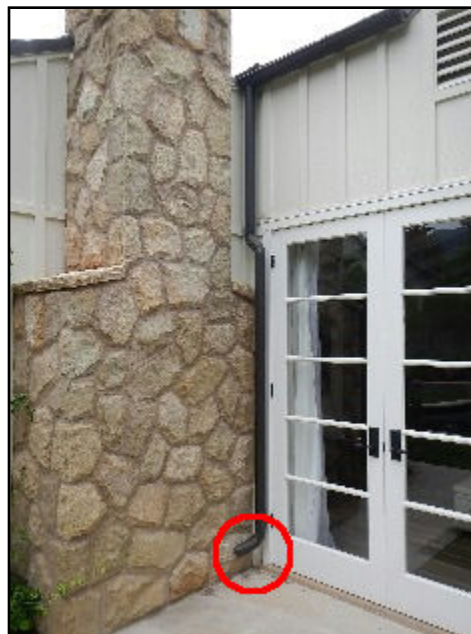
26. Downspouts end too close to building

Condition: • Downspouts end too close to building

Implication(s): Chance of water damage to contents, finishes and/or structure

Task: Extend

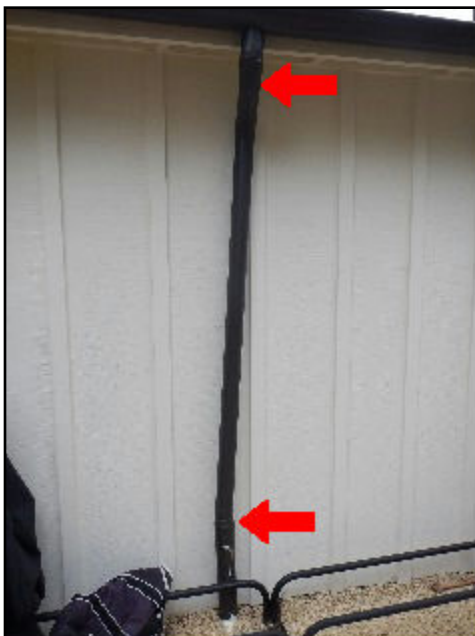
29. Not well secured

Condition: • Not well secured

Implication(s): Leakage

Task: Repair
