YOUR INSPECTION REPORT

2817 Samarkand Drive
Santa Barbara, CA 93105

Wednesday, May 22, 2013

Report No. 1050

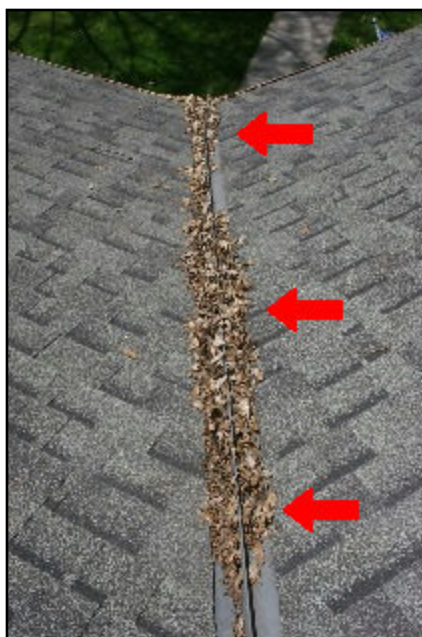
5. Full of debris

Condition: • The valley flashings were full of seasonal debris. Recommend cleaning to prevent material deterioration.

Task: Clean valley flashing

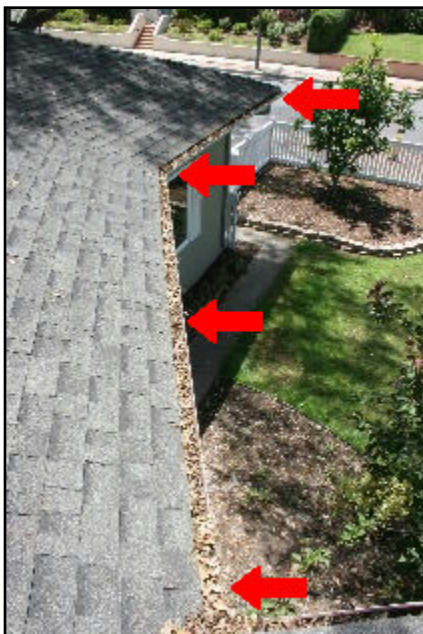
7. Clogged

Condition: • Clogged

The gutters were full of dirt and debris as well as vegetation. Recommend cleaning.

Task: Clean

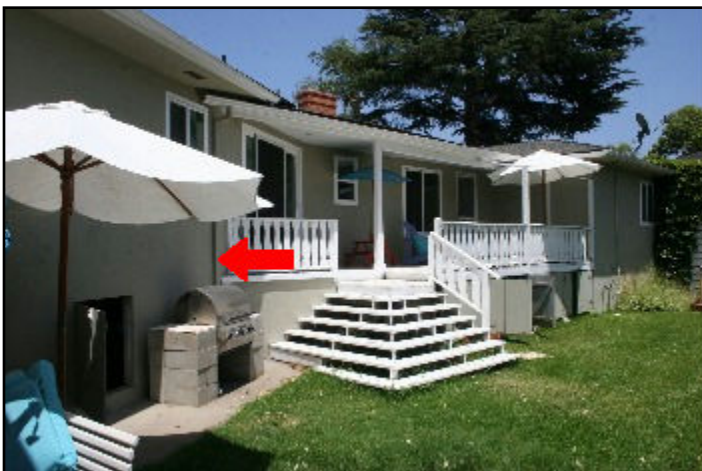
11. Should discharge 6ft. from home

Condition: • Should discharge 6ft. from home

Task: Correct

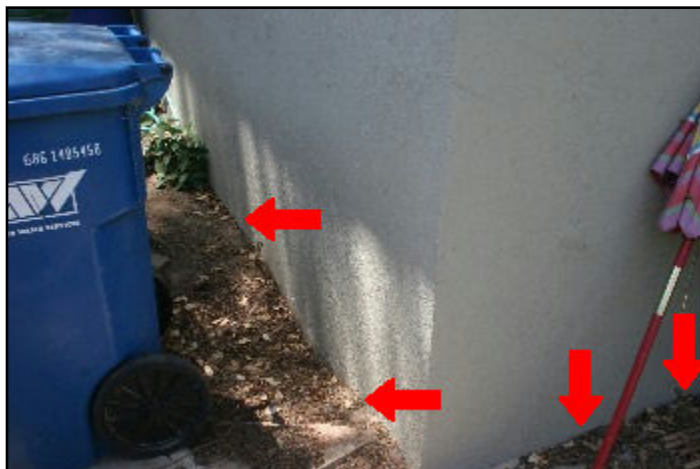
15. No drip screed

Condition: • **No drip screed**

This home was built prior to weep screed being required to allow stucco to completely dry after seasonal wet weather. Try to keep soil/stucco contact to a minimum as well as ensuring grade slopes away from home to prevent foundation undermining.

Task: Grade soil away from base

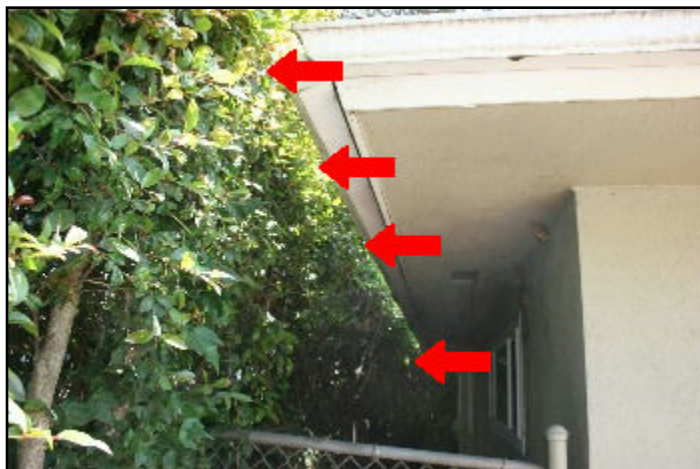
27. Trees or shrubs too close to house

Condition: • Trees or shrubs too close to house

The shrubs on the east side of the home were too close. They were resting on the east side roof and gutters which causes material deterioration.

Task: Cut back

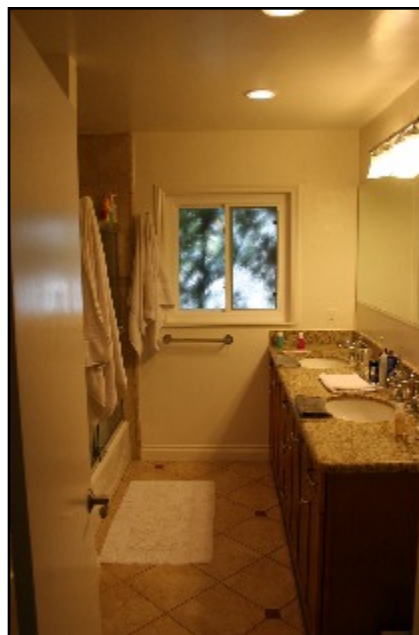
73. Inoperative

43. Condition: • [Stiff or inoperative](#)

Task: Repair

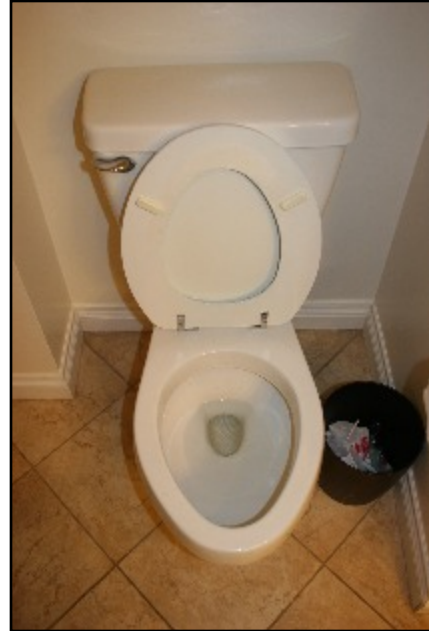
75. Obstructed or weak flush

44. Condition: • [Obstructed or weak flush](#)

Both toilets exhibited poor flushing mechanics at the time of this inspection. Recommend further evaluation and repair by a licensed plumber.

Implication(s): Chance of water damage to contents, finishes and/or structure | Sewage entering the house

Task: Repair or replace

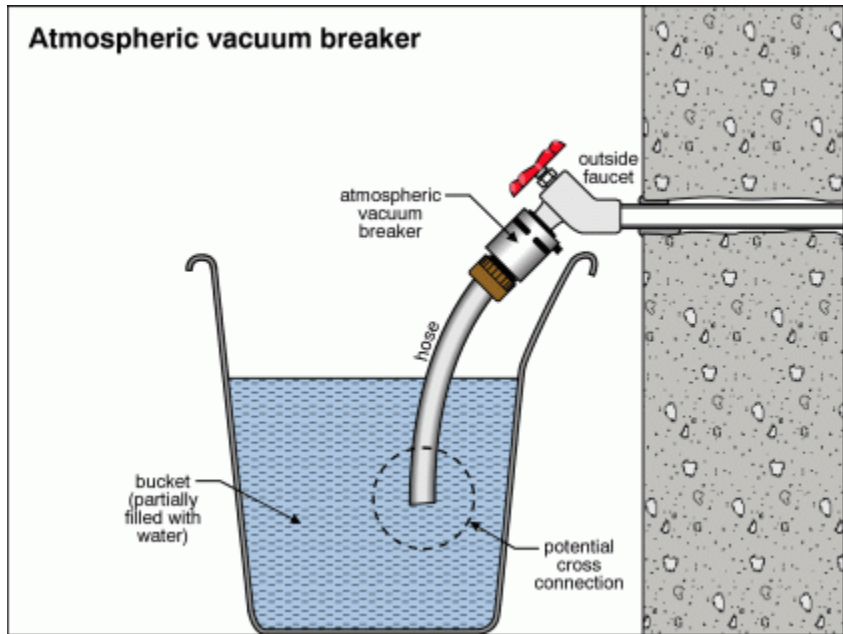
46. Condition: • [Backflow prevention missing](#)

Location: Throughout Exterior

Task: Provide

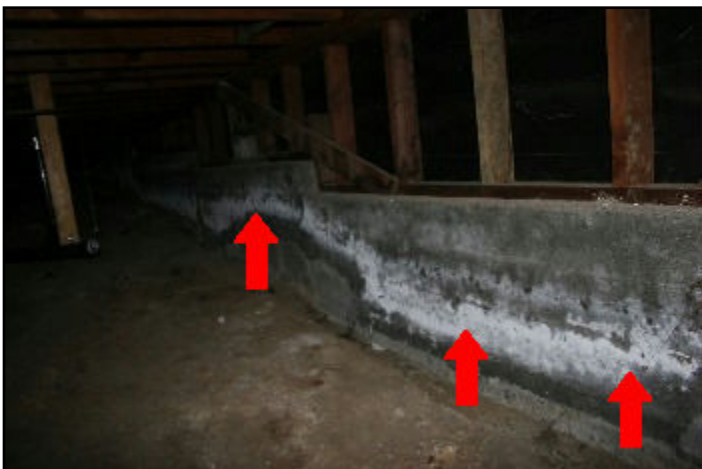
84. Efflorescence

51. Condition: • [Efflorescence](#)

Heavy efflorescence was observed on all of the perimeter foundation walls of the crawlspace indicating the presence of moisture. Moisture staining was observed beneath the crawlspace vent indicating moisture intrusion through the vent most likely seasonal. Recommend seeking professional help in formulating a water run off management plan to avoid moisture damage.

Implication(s): Cosmetic defects | Chance of water damage to contents, finishes and/or structure

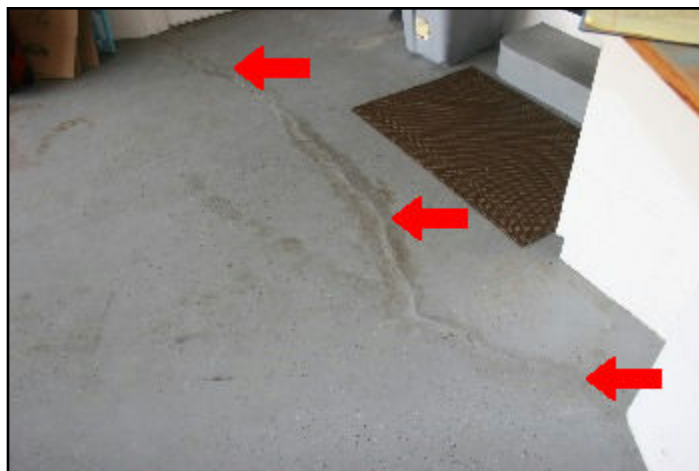
86. Patched

52. Condition: • [Cracked](#)

Large crack in garage floor was patched.

Task: Monitor

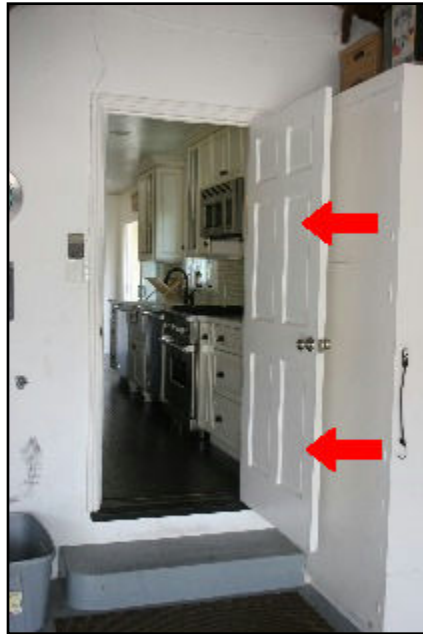
87. No self closer

53. Condition: • [No self closer](#)

The man-door from the garage to the house interior is required to be self closing. No self closing hardware was observed at the time of this inspection.

Task: Provide self closer
