YOUR INSPECTION REPORT

5025 Sungate Ranch Rd
Santa Barbara, CA 93111

Wednesday, July 17, 2013

Report No. 1078, v.0

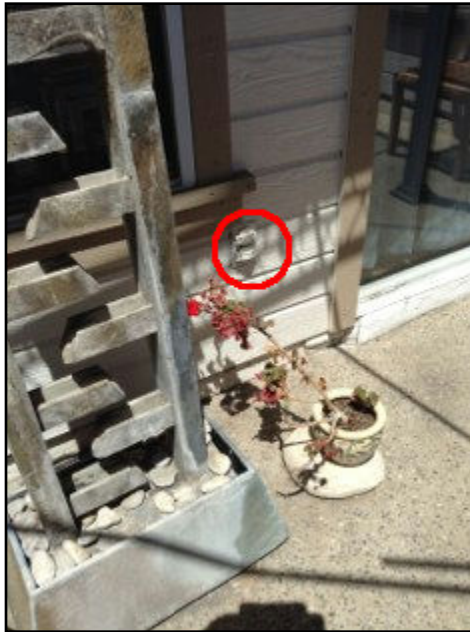
Condition: • Ground Fault Interrupter (GFI) needed

GFCI receptacles are required by the US National Electrical Code in locations where water and electricity are likely to come into contact, such as in kitchens, bathrooms, garages, and outdoors. Some areas had the required receptacles while others did not. Recommend having a licensed electrician install and replace GFCI receptacles as needed.

47. Ground Fault Interrupter (GFI) needed
