# YOUR INSPECTION REPORT

857 Cheltenham Rd  
Santa Barbara, CA 93105

Sunday, July 14, 2013

Report No. 1075, v.0

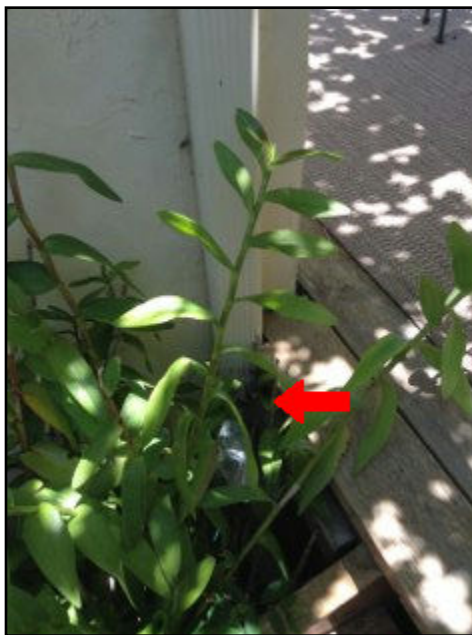
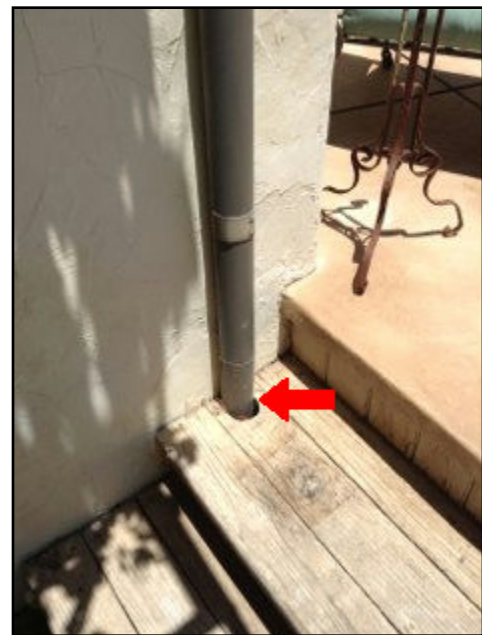
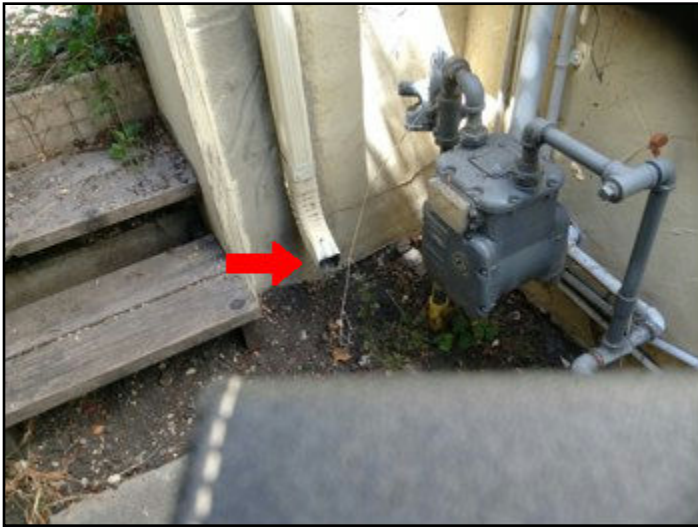
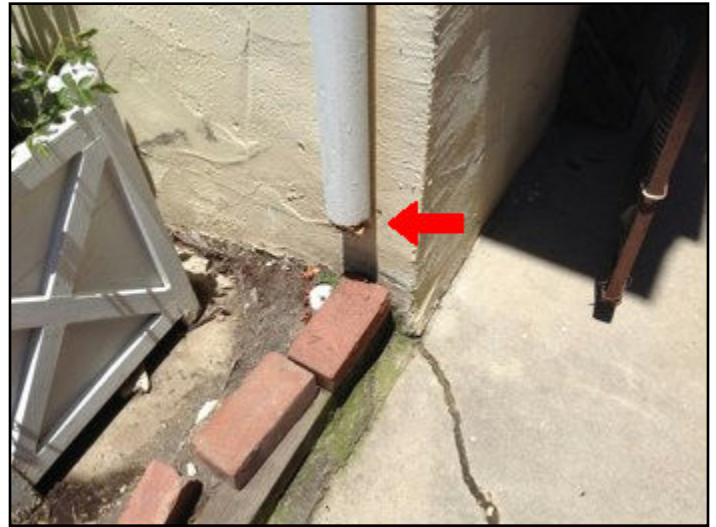
9. Downspouts end too close to building

10. Downspouts end too close to building

11. Downspouts end too close to building

12. Downspouts end too close to building

**Task:** Extend away from home

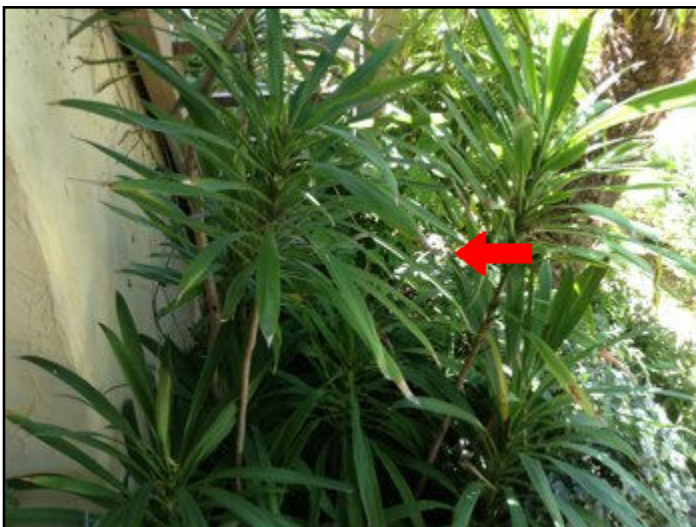
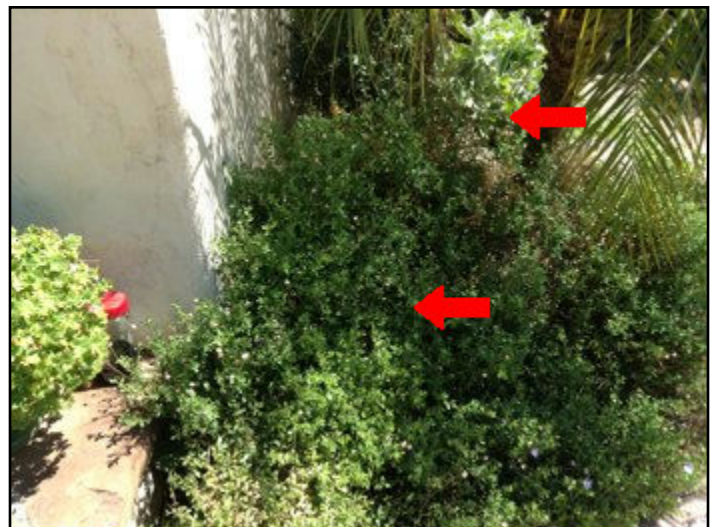
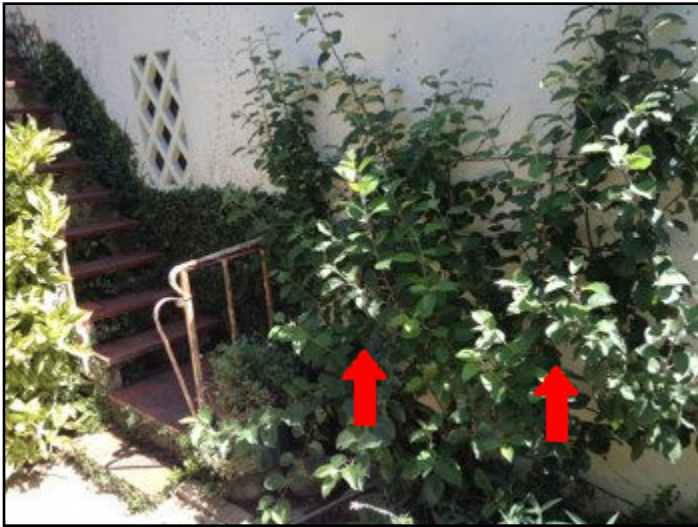
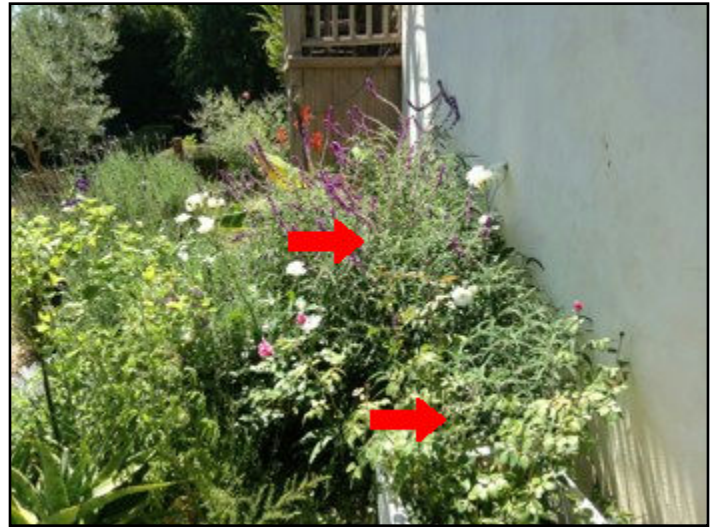
36. *Trees or shrubs too close to house*

37. *Trees or shrubs too close to house*

38. Trees or shrubs too close to house

39. Trees or shrubs too close to house

**Task:** Remove or cut back

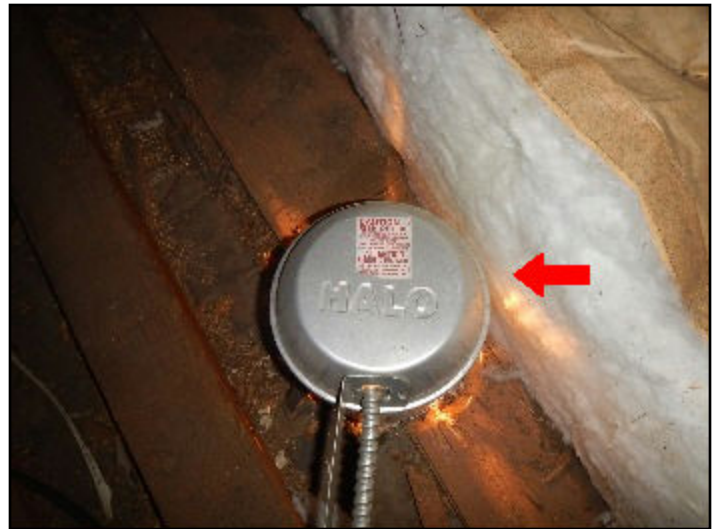
83. Covering can lights

44. **Condition:** • [Covering can lights](#)

**Implication(s):** Increased fire hazard

**Task:** Repair

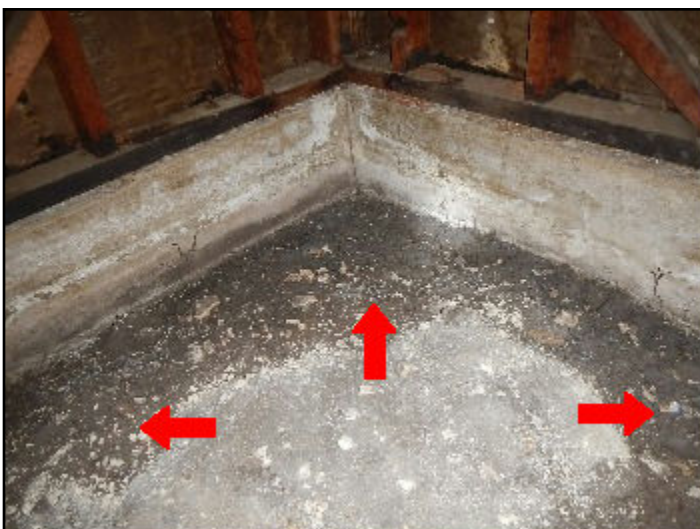
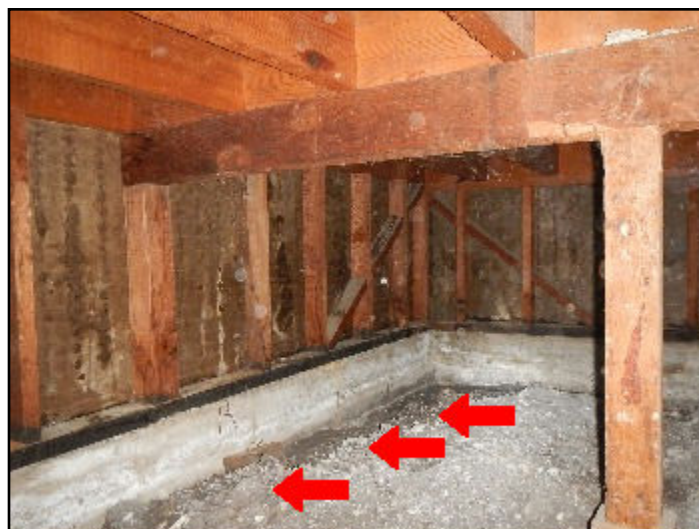
58. Condition: • [Dampness on floor or walls](#)

Moisture was observed along the west wall in the crawlspace. Recommend regrading west exterior away from home to control moisture intrusion. Seek assistance from a licensed drainage contractor.

Implication(s): Cosmetic defects | Chance of water damage to contents, finishes and/or structure | Material deterioration

Location: West Crawl Space

Task: Further evaluation
