# YOUR INSPECTION REPORT

5632 Marbury Dr  
Goleta, CA 93117

Thursday, April 18, 2013

Report No. 1034

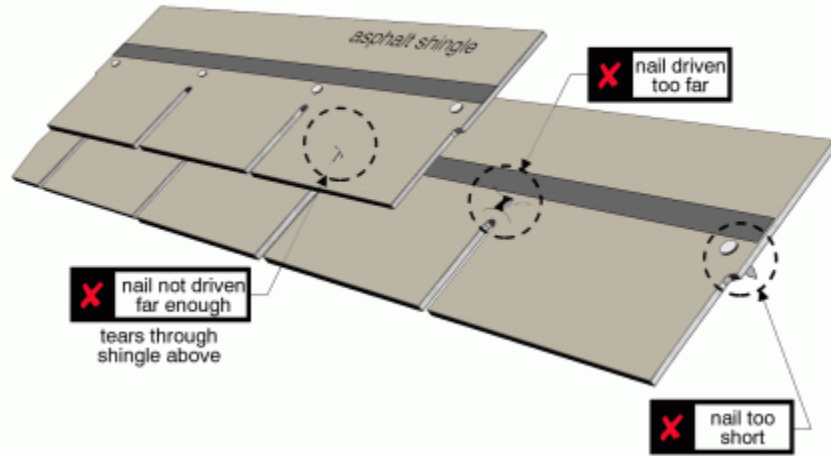
Several exposed fasteners were observed on shingles throughout the roof. Recommend sealing with silicone or asphalt to prevent moisture intrusion.

**Task:** Seal

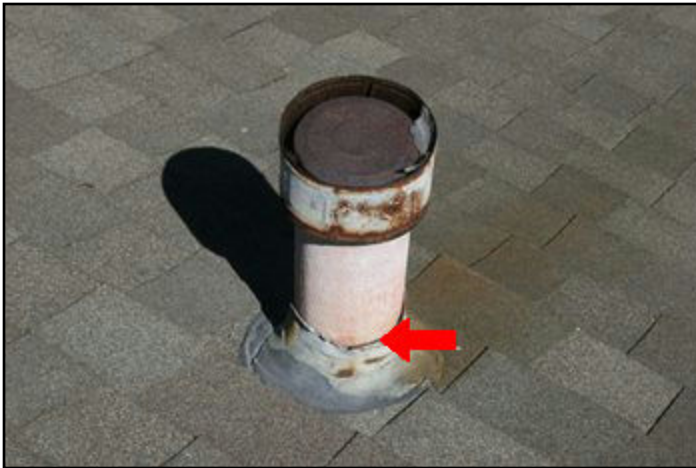
10. Exposed joint

The caulking on several of the pipe/stack flashings was deteriorated. Recommend sealing with appropriate caulking.

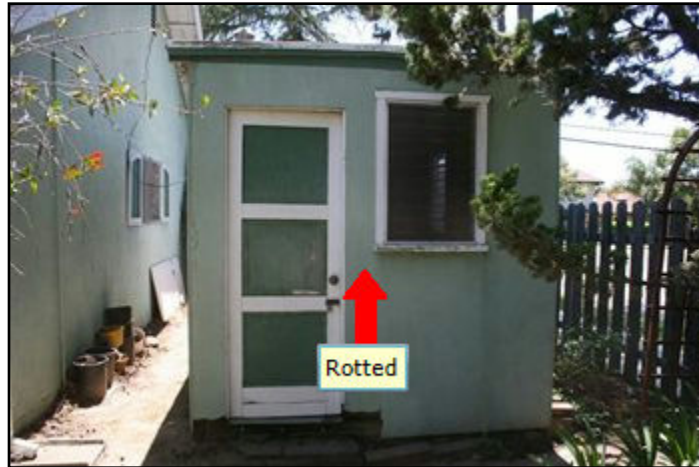
13. Remove shed

• **Condition:** The shed on the west side of the house was completely rotted. Additionally, gas and electricity were improperly run to the shed creating a health and safety issue. Recommend removing and properly terminating both gas and electrical at their origin.

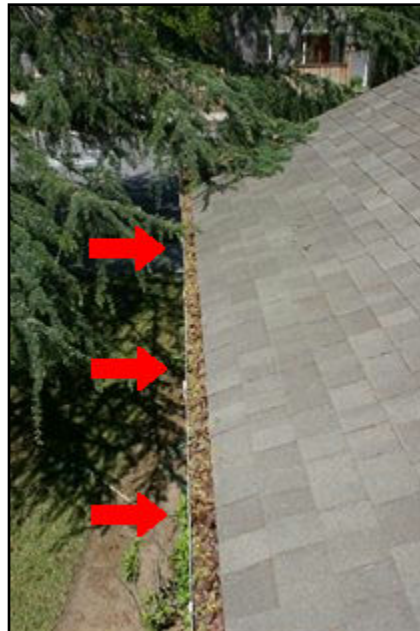
14. Clogged

Seasonal debris accumulation was noted in the valley flashings and gutters. Recommend cleaning.

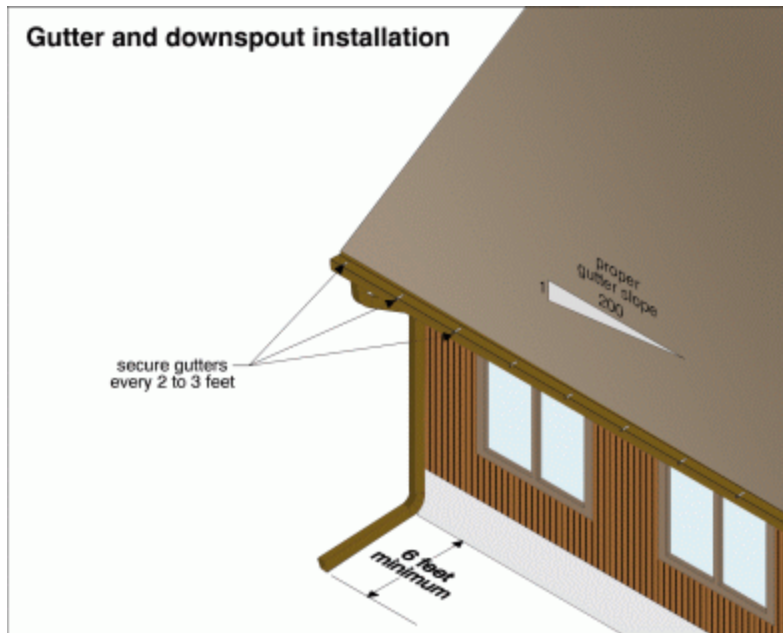
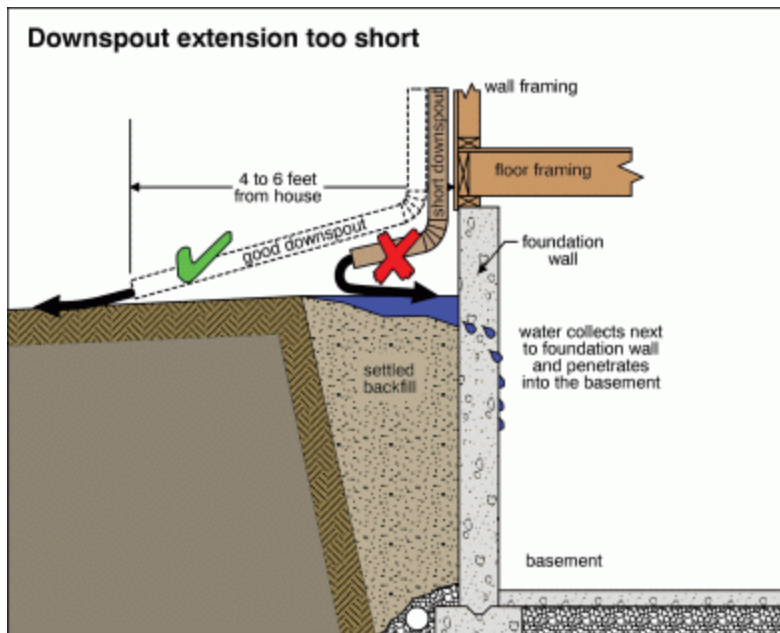
Several downspouts were noted discharging close to the home. In order to prevent seasonal undermining of the foundation I recommend elongating the downspout to at least 6' away from the edge of the home where possible.

**Task:** Improve

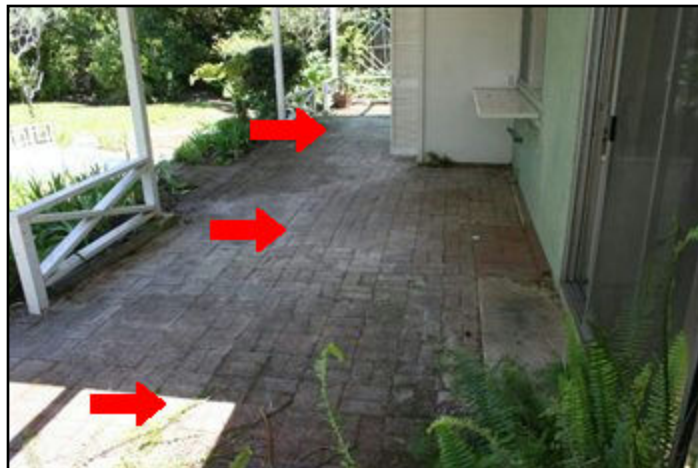
24. Slope toward house

The brick pavers installed in the back patio do not slope away from the house as required to prevent possible moisture intrusion. Recommend regrading the pavers.

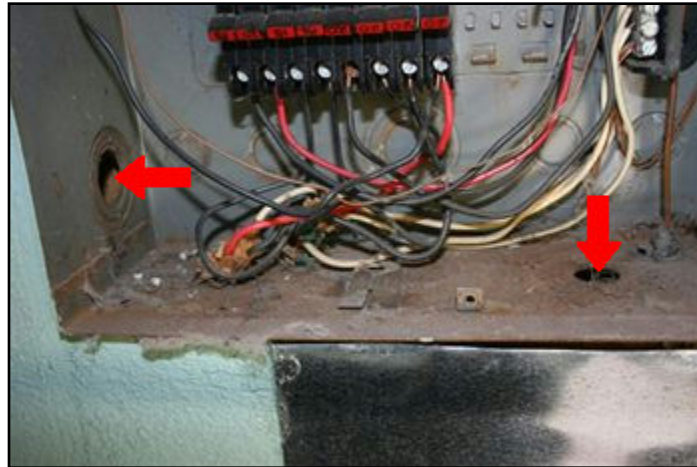
34. Unprotected openings

Unprotected openings were observed. Should be plugged by a licensed electrician.
