# YOUR INSPECTION REPORT

857 Cheltenham Rd  
Santa Barbara, CA 93105

Sunday, July 14, 2013

Report No. 1075, v.0

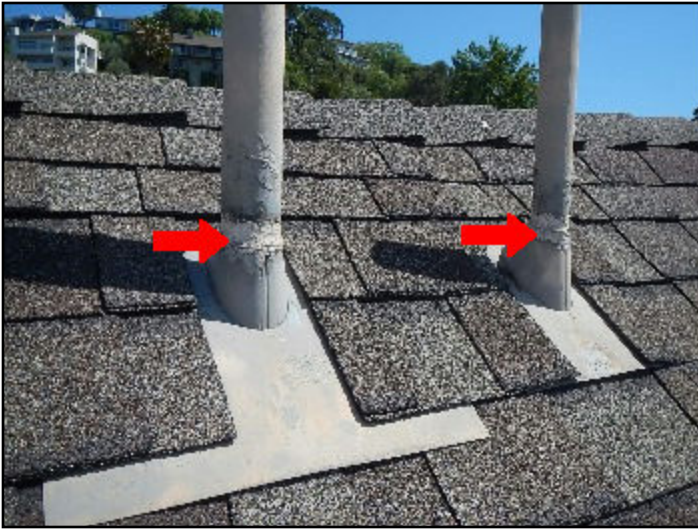
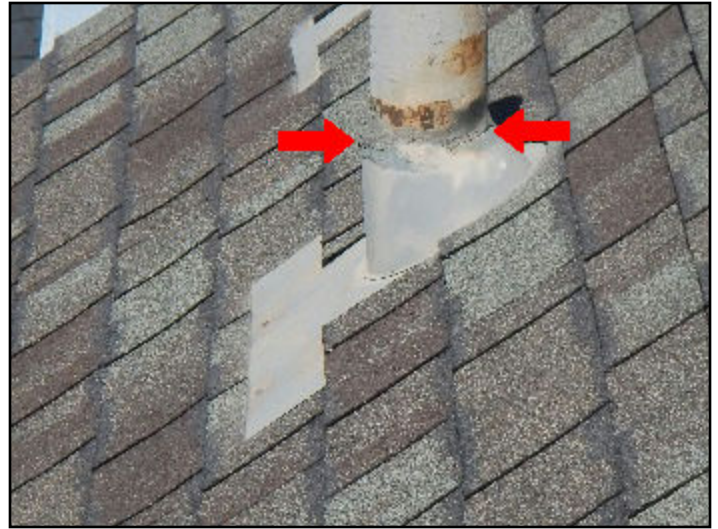
Several of the pipe stack flashings had deteriorated caulking exposing the joints and making them susceptible to moisture intrusion.

5. Exposed joint

6. Exposed joint

**Task:** Seal with appropriate sealant

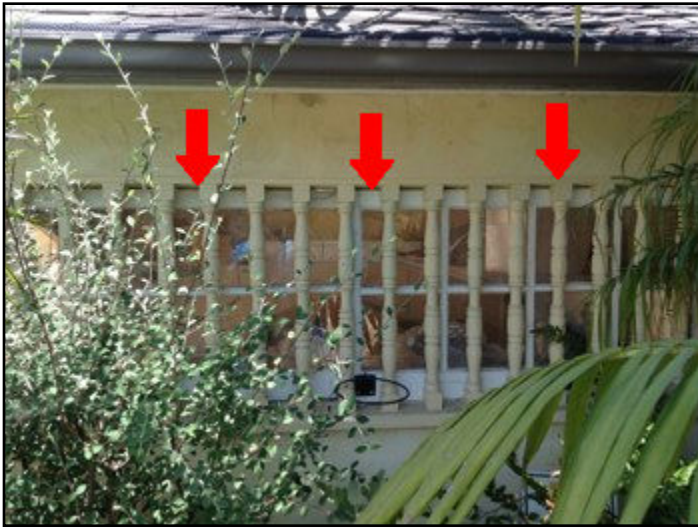
20. Sealing needed

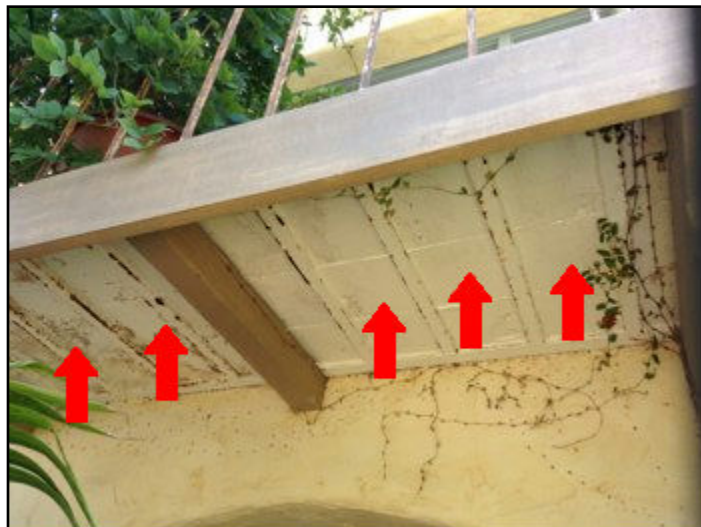
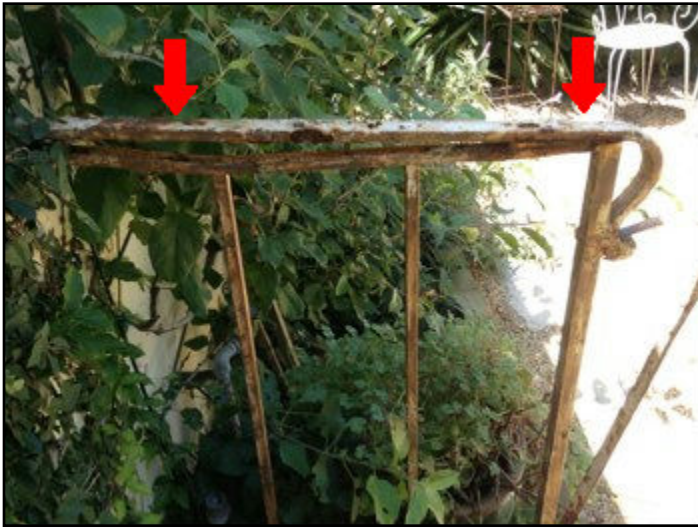
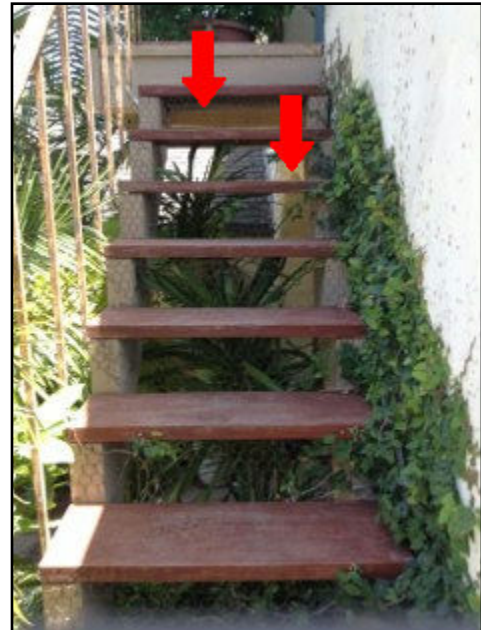
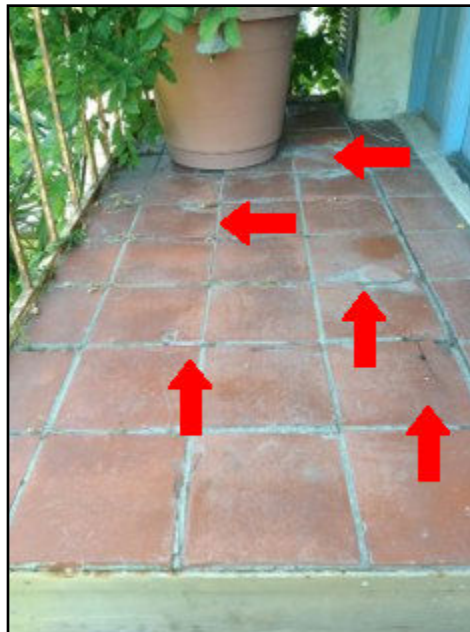
The front balcony, stairs and railing were in general disrepair. The balcony tiles were broken, loose or damaged. The railing was rusted, broken and did not meeting current safety standards.

30. Disrepair

31. Disrepair

32. Disrepair

33. Disrepair

**Task:** Repair or replace

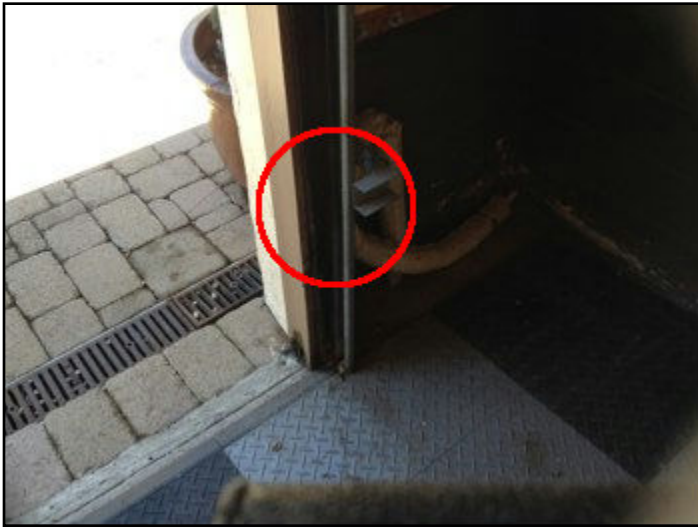
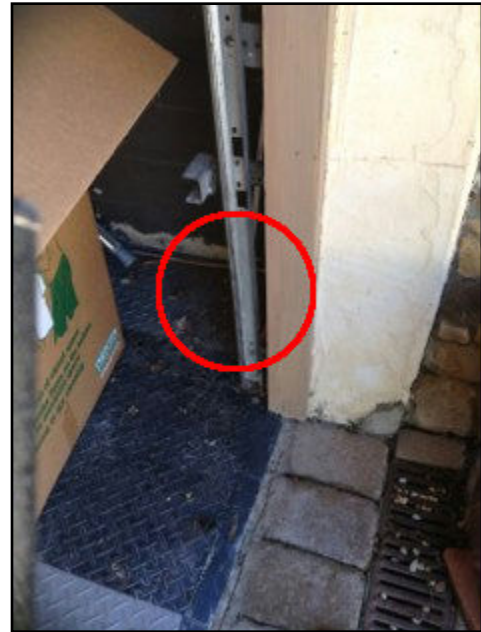
45. Sensors inoperative

46. Sensors inoperative

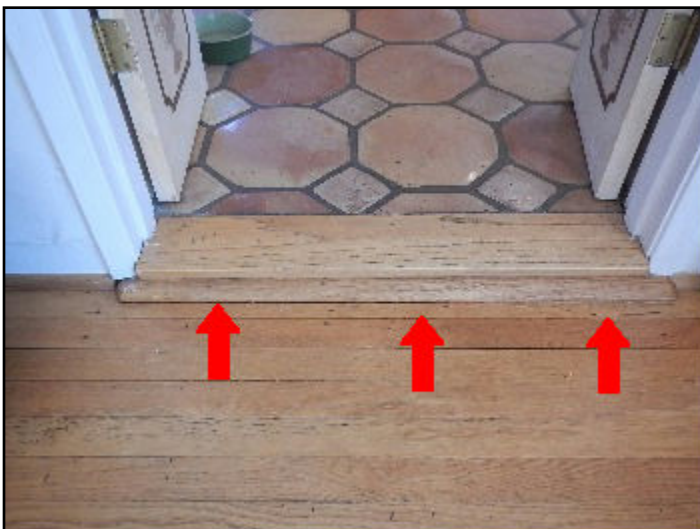
49. Settled

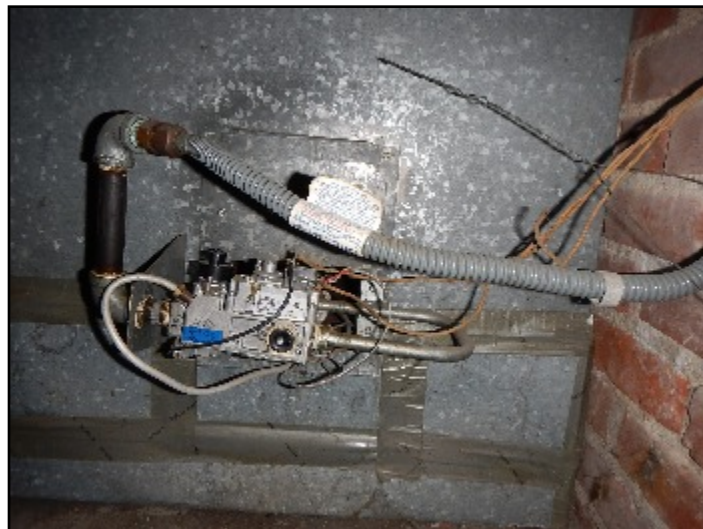
77. Near end of life expectancy

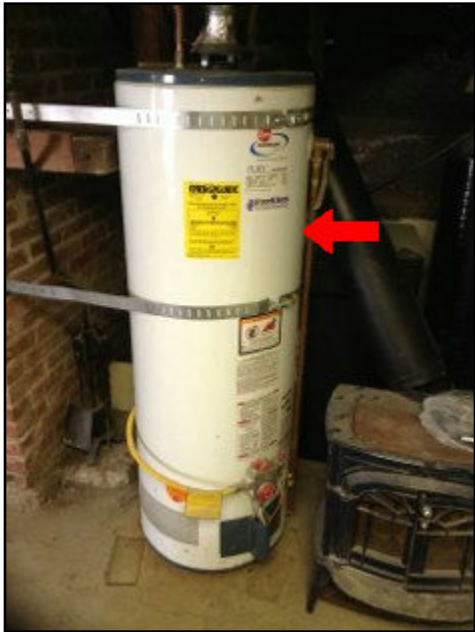
89. Conventional

**Water heater type:**

- [Conventional](#)

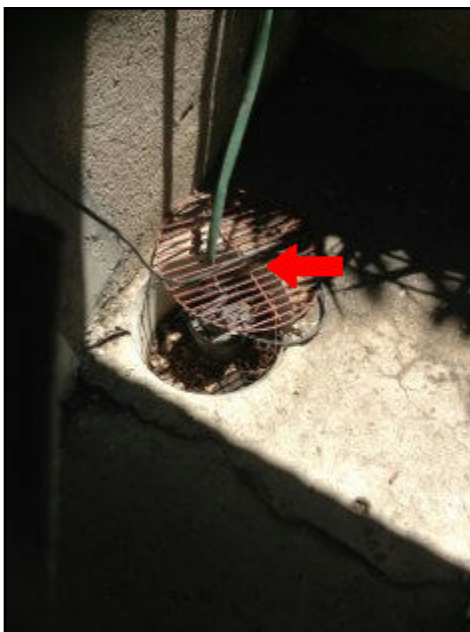
91. Sump pump

• [Sump pump](#)

Not operational at time of inspection

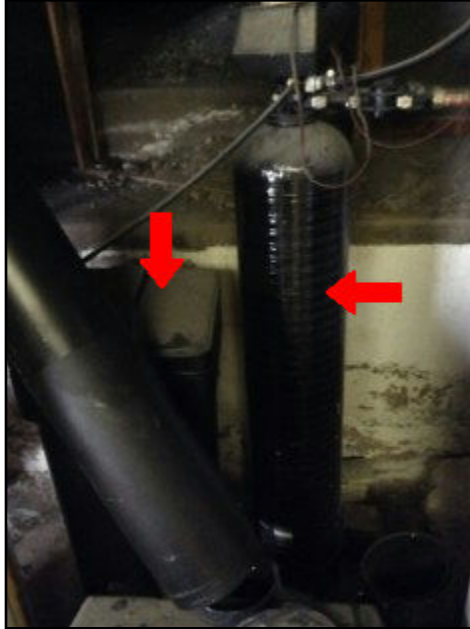
92. Water softener

- Water softener

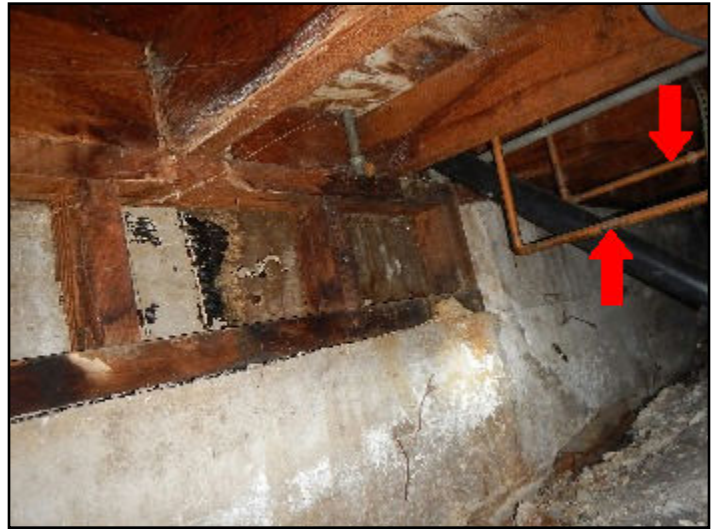
94. Poor support

48. Condition: • [Poor support](#)

Improper or poorly supported water lines were observed throughout the crawlspace.

**Implication(s):** Chance of water damage to contents, finishes and/or structure | Leakage

**Task:** Repair
